LIST OF FIGURES AND TABLES

RELIABILITY METRICS

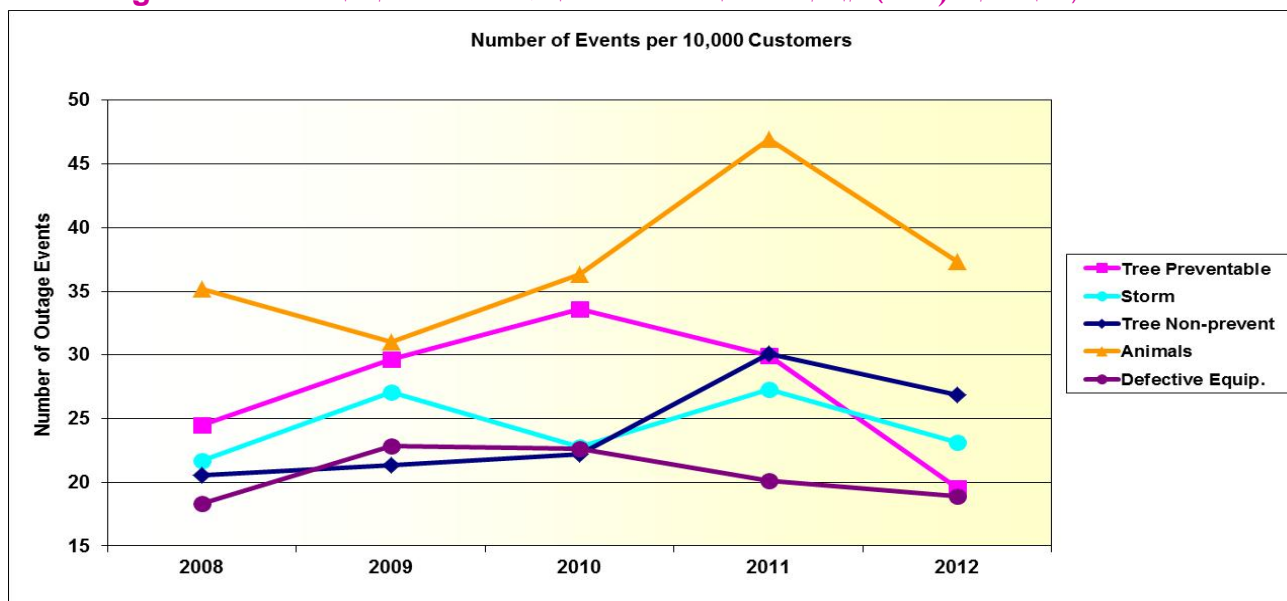
Figure 3-16 shows the top five causes of outage events on DEF's distribution system normalized to a 10,000-customer base. The figure is based on DEF's adjusted data and represents approximately 58 percent of the top ten causes of outage events that occurred during 2012. For the five-year period, the top five causes of outage events were animals (17 percent), tree non-preventable (12 percent), storm (11 percent), tree preventable (9 percent), and defective equipment (9 percent) on a cumulative basis. The outage events caused by animals, tree non-preventable, and storms are trending upward even though there were 21 percent, 11 percent, and 15 percent decreases, respectively, in the number of outages from 2011 to 2012. The outages caused by tree-preventable and defective equipment are both trending downward and there was a 35 percent and a 6 percent decrease, respectively, in the number of outages from 2011 to 2012.

Figure 3-16. DEF'S TOP FIVE OUTAGE CAUSES (ADJUSTED)

In **Figure 3-16**, DEF's Top Five Outage Categories, the category animals remains in the top spot representing 17 percent of the ten outage categories. The next two highest categories were tree non-preventable, i.e. fallen trees (12 percent) and storms (11 percent). All of DEF's top five outage categories decreased in 2012 when compared to the 2011 data. For the five-year period of 2008 to 2012, outages caused by animals, tree non-preventable, and storms are trending upward as outages caused by tree preventable and defective equipment are trending downward.

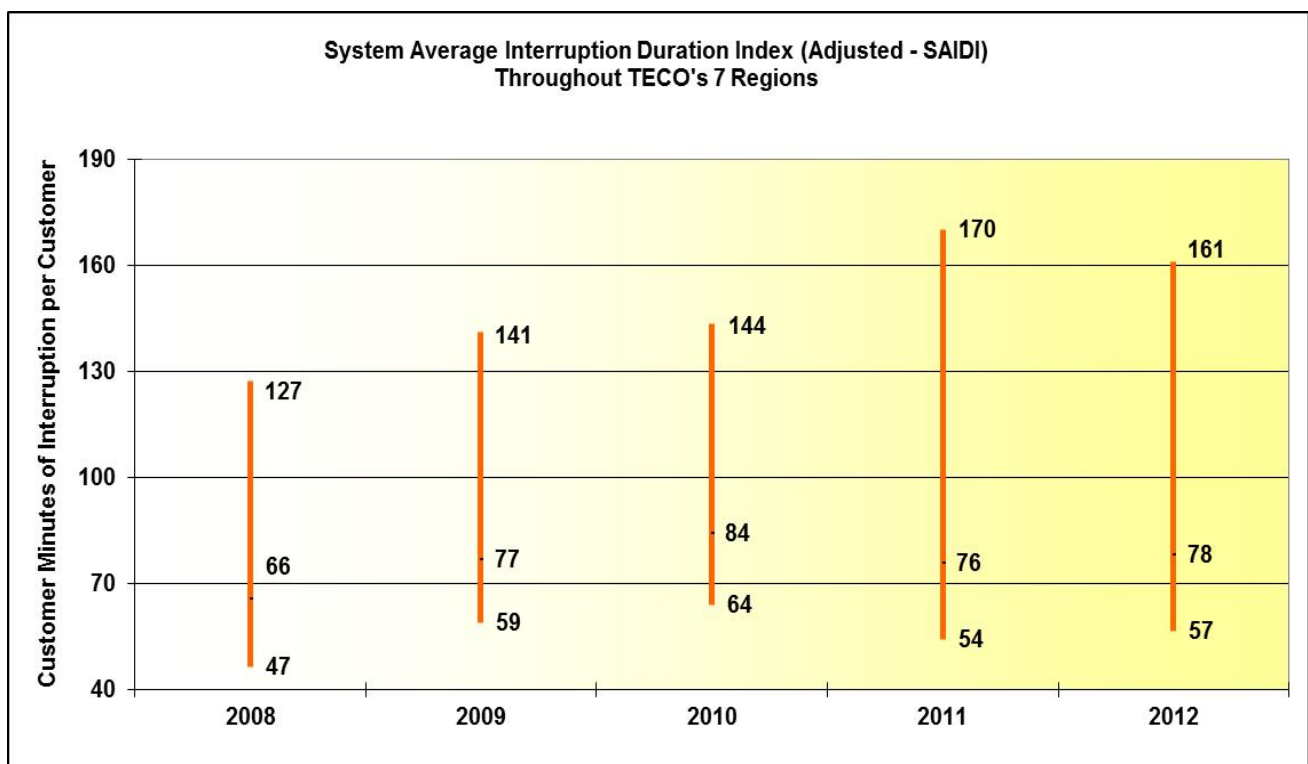
Figure 3-17 shows the adjusted SAIDI values recorded by TECO's system. Three of the seven TECO regions had an increase in SAIDI performance during 2012, with Plant City and Dade City having the highest SAIDI performance results for the five-year period of 2008 to 2012. The lowest SAIDI index for the seven regions appears to be trending upward. The average SAIDI index increased 3 percent from 2011 to 2012 and appears to be trending upward. The Central, Eastern, and Winter Haven regions recorded the lowest SAIDI indices for the five-year period. Dade City, Plant City, and South Hillsborough regions have the fewest customers and represent the most rural, lowest customer density per line mile in comparison to the other four TECO divisions.

Figure 3-17. SAIDI ACROSS TECO'S SEVEN REGIONS (ADJUSTED)

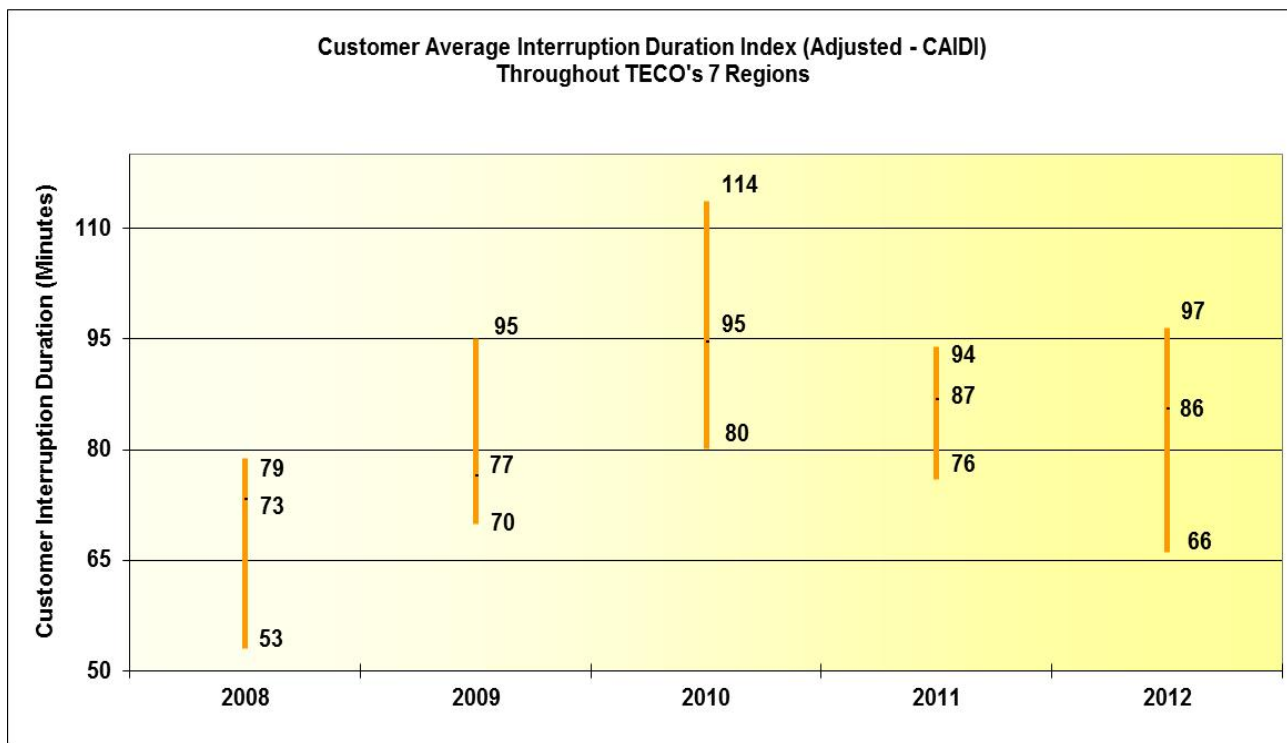
Figure 3-19 charts the length of time that a typical TECO customer experiences an outage, which is known as CAIDI. The highest CAIDI minutes do not appear to be confined to any particular service area. Winter Haven has had the lowest (best) results for four out of the last five years. The average CAIDI continues to be trending upward at this time suggesting TECO's customers are experiencing outages that are lasting longer, even though there was a 1 percent decrease from 2011 to 2012.

Figure 3-19. CAIDI ACROSS TECO'S SEVEN REGIONS (ADJUSTED)

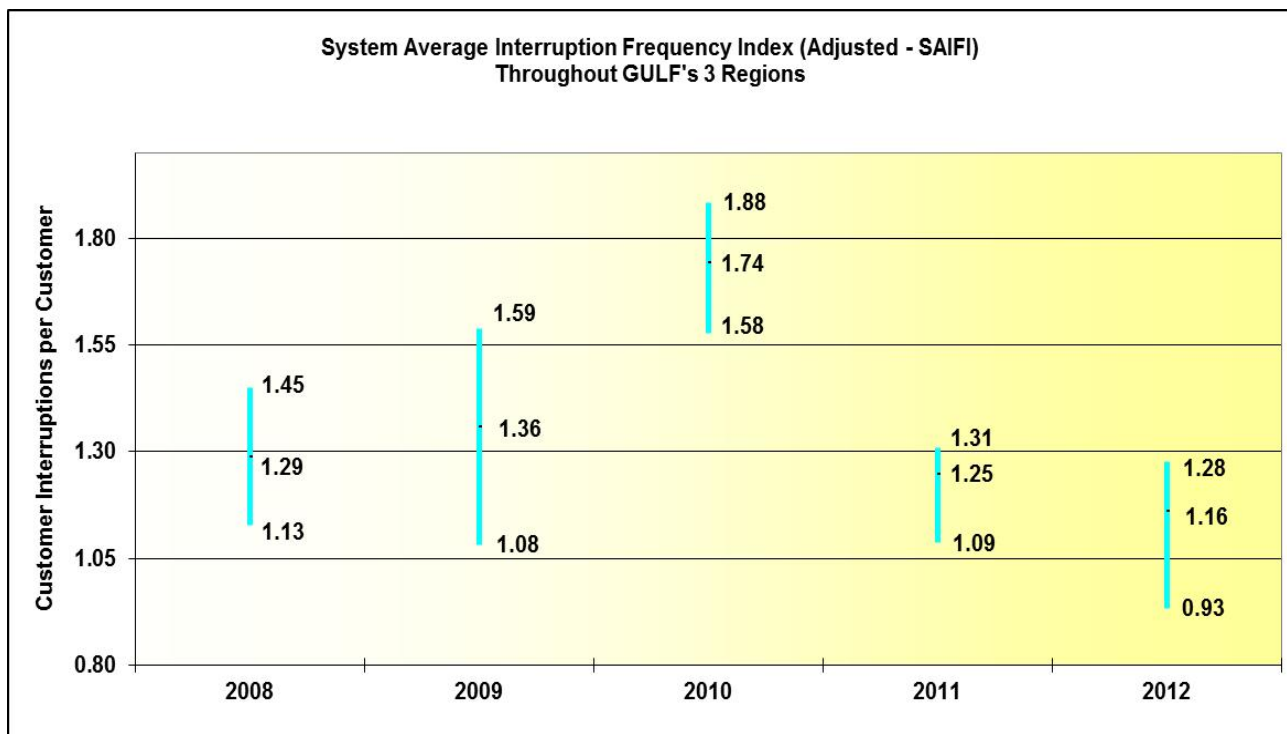
Figure 3-26. SAIFI ACROSS GULF'S THREE REGIONS (ADJUSTED)

Figure 3-26 illustrates that Gulf's SAIFI had a 7 percent decrease in 2012 when compared to 2011. Gulf's Western region had the highest SAIFI values in four of the last five years. The lowest values appear to fluctuate between the Central region and the Eastern region. The maximum, minimum, and average SAIFI values appear to be trending downward.
