*Review of
Florida's
Investor-Owned
Electric Utilities*

2 0 1 7

Service Reliability Reports

State of Florida
Florida Public Service Commission
Division of Engineering

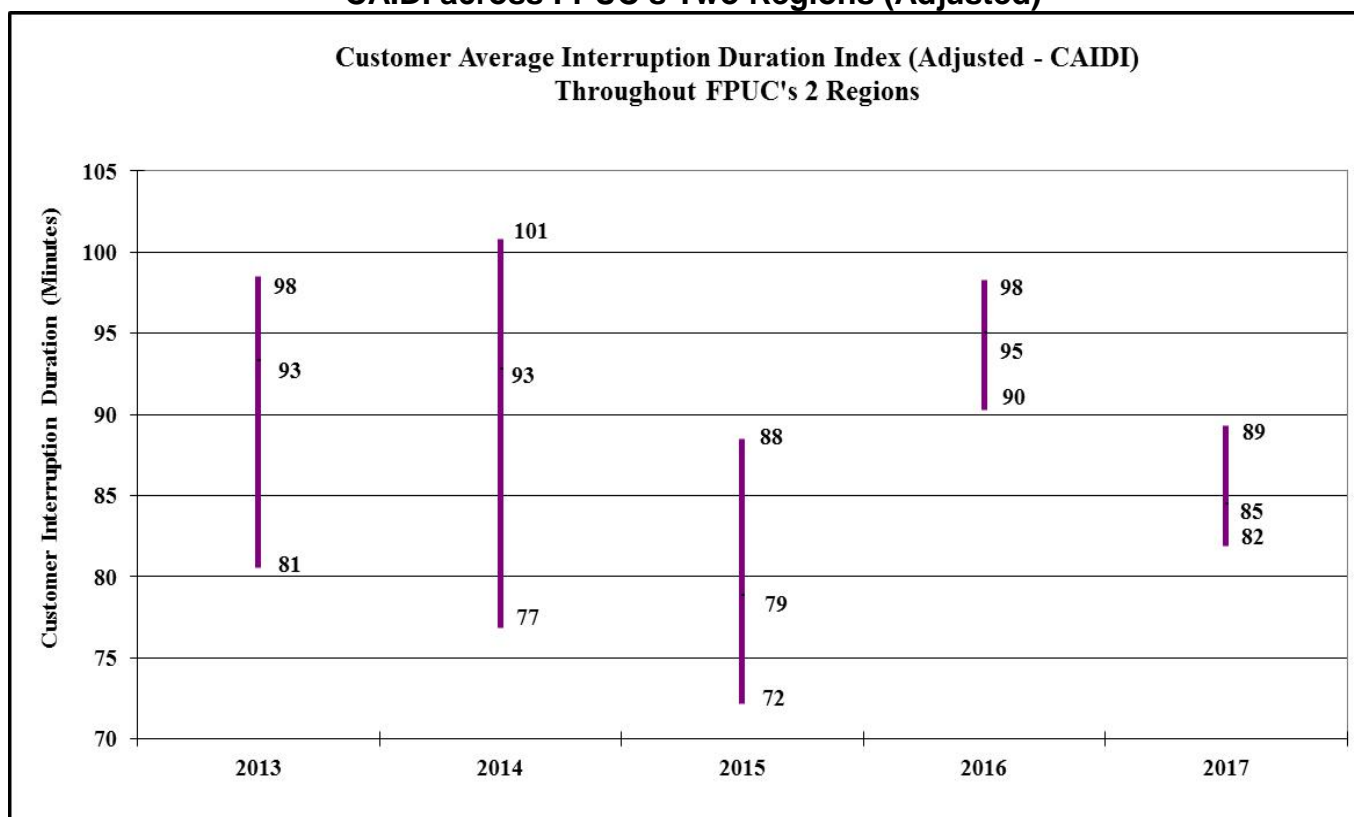
**Figure 3-19.
CAIDI across FPUC's Two Regions (Adjusted)**

Figure 3-19 shows the highest, average, and lowest adjusted CAIDI values across FPUC's system. FPUC's data shows the average CAIDI value decreased by 11 percent for 2017 (85 minutes) when compared to 2016 (95 minutes). For the past five years, the maximum, the minimum, and the average CAIDI values are trending downward.

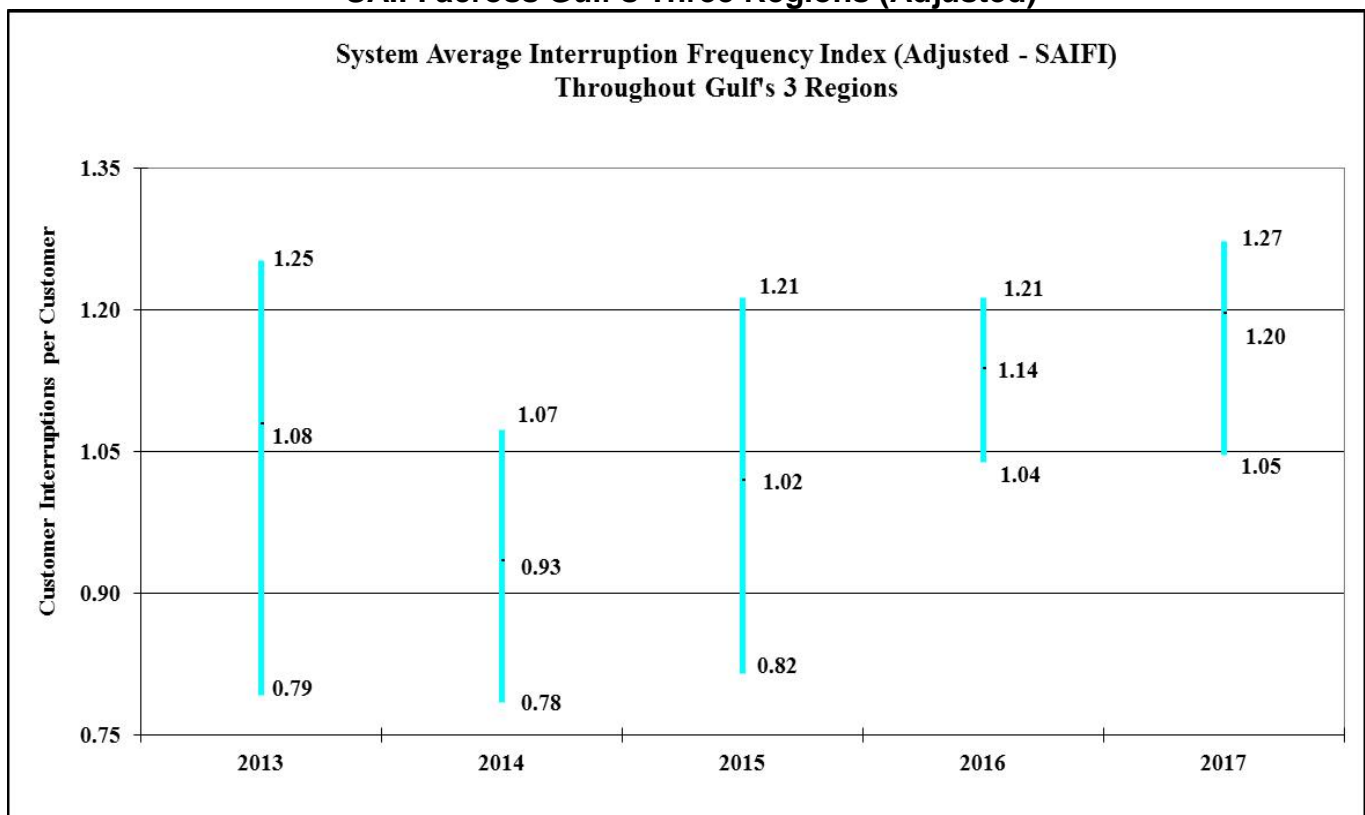
**Figure 3-23.
SAIFI across Gulf's Three Regions (Adjusted)**

Figure 3-23 illustrates that Gulf's SAIFI had a 5 percent increase in 2017 when compared to 2016. The highest SAIFI value for the past five years has fluctuated between the three regions. The lowest values appear to fluctuate between the Central region and the Eastern region. The maximum, average, and minimum SAIFI values appear to be trending upward.
