*Review of
Florida's
Investor-Owned
Electric Utilities*

*2 0 1 9
Service Reliability Reports*

State of Florida
Florida Public Service Commission
Division of Engineering

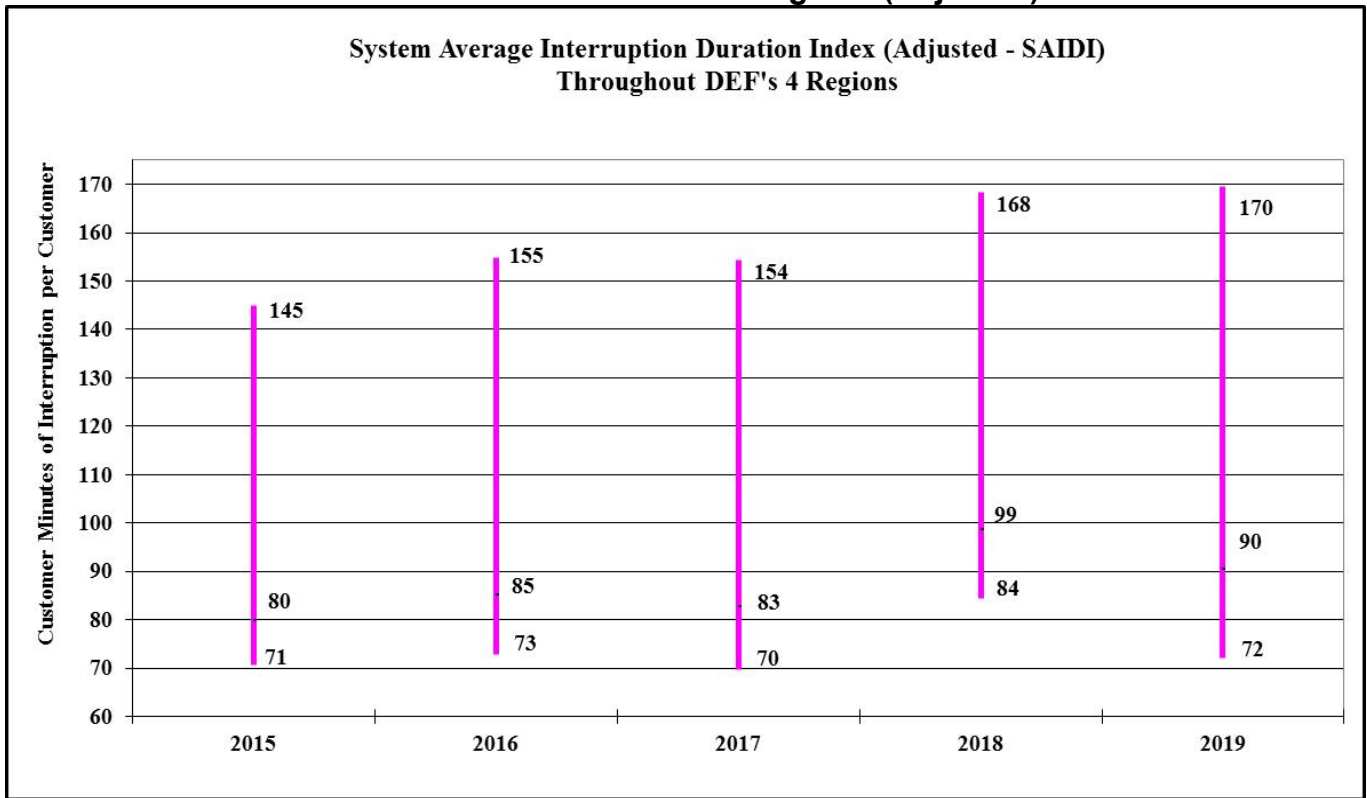
**Figure 3-1
SAIDI across DEF's Four Regions (Adjusted)**

Figure 3-1 charts the adjusted SAIDI recorded across DEF's system and depicts decreases in the lowest and the average values in 2019. DEF reported that it saw a drop in the Excluded Weather SAIDI compared to the prior three years. Even with the decrease in adjusted SAIDI, there were eight days in 2019 that caused increases to the SAIDI minutes. Those outages were weather related but not excludable per Rule because the events were not related to a named storm or a tornado. In addition, DEF reported the two named storms that it experienced caused increases to its SAIDI minutes in 2019.

DEF's service territory is comprised of four regions: North Coastal, South Coastal, North Central, and South Central. **Figure 3-1** illustrates that the North Coastal region continues to report the poorest SAIDI over the last five years, fluctuating between 145 minutes and 170 minutes. While the South Coastal and South Central regions have the best or lowest SAIDI for the same period. The North Coastal region is predominantly a rural area and has more square miles when compared to the other regions. This region is also served by predominantly long circuits with approximately 7,700 miles of overhead and underground main circuits. DEF explained that these factors result in higher exposure to outage causes and higher reliability indices.

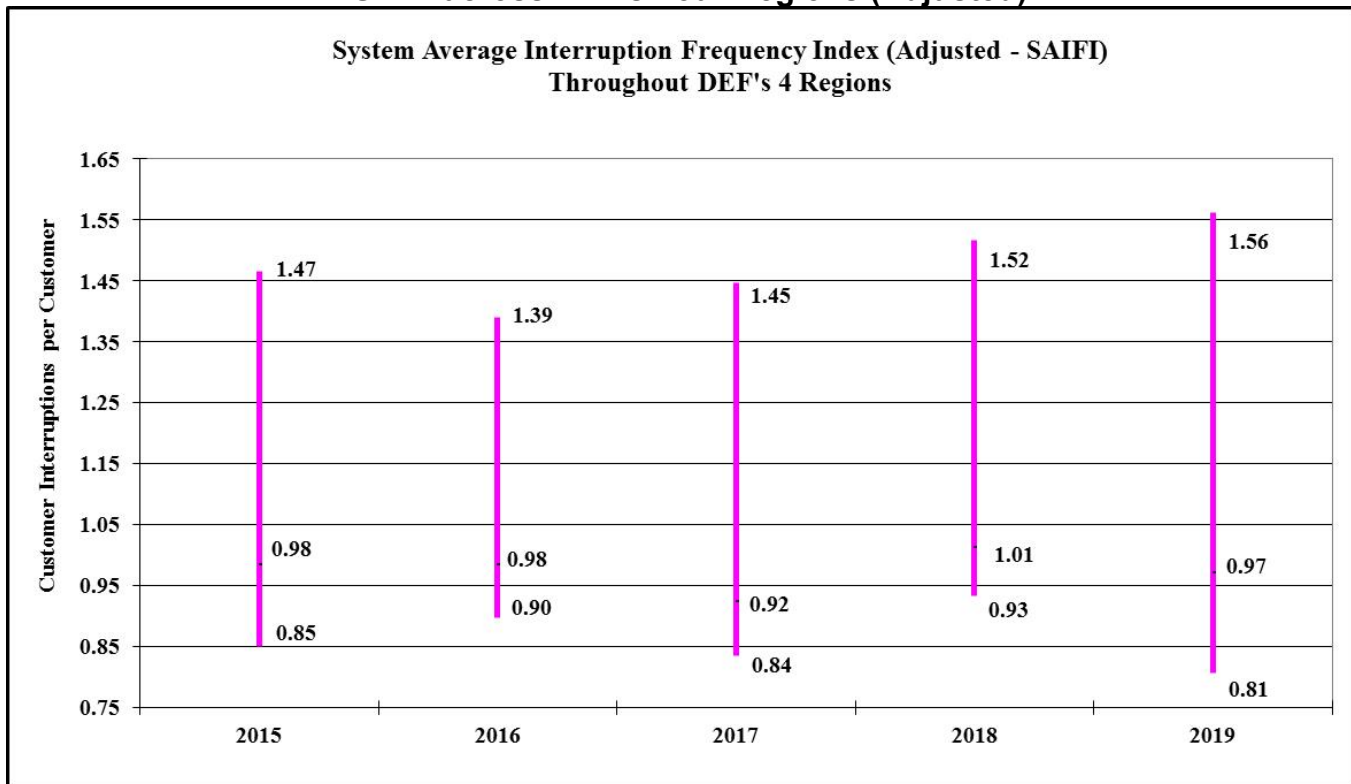
Figure 3-2
SAIFI across DEF's Four Regions (Adjusted)

Figure 3-2 shows the adjusted SAIFI across DEF's system. The minimum SAIFI is trending downward as the maximum SAIFI is trending upward for the five-year period of 2015 through 2019. It appears the average SAIFI remains relatively flat for the same period. There was a 13 percent decrease for the minimum value, a 4 percent decrease for the average value, and a 3 percent increase for the maximum value. The North Central region had the lowest number of interruptions, while the North Coastal region continues to have the highest number of interruptions.

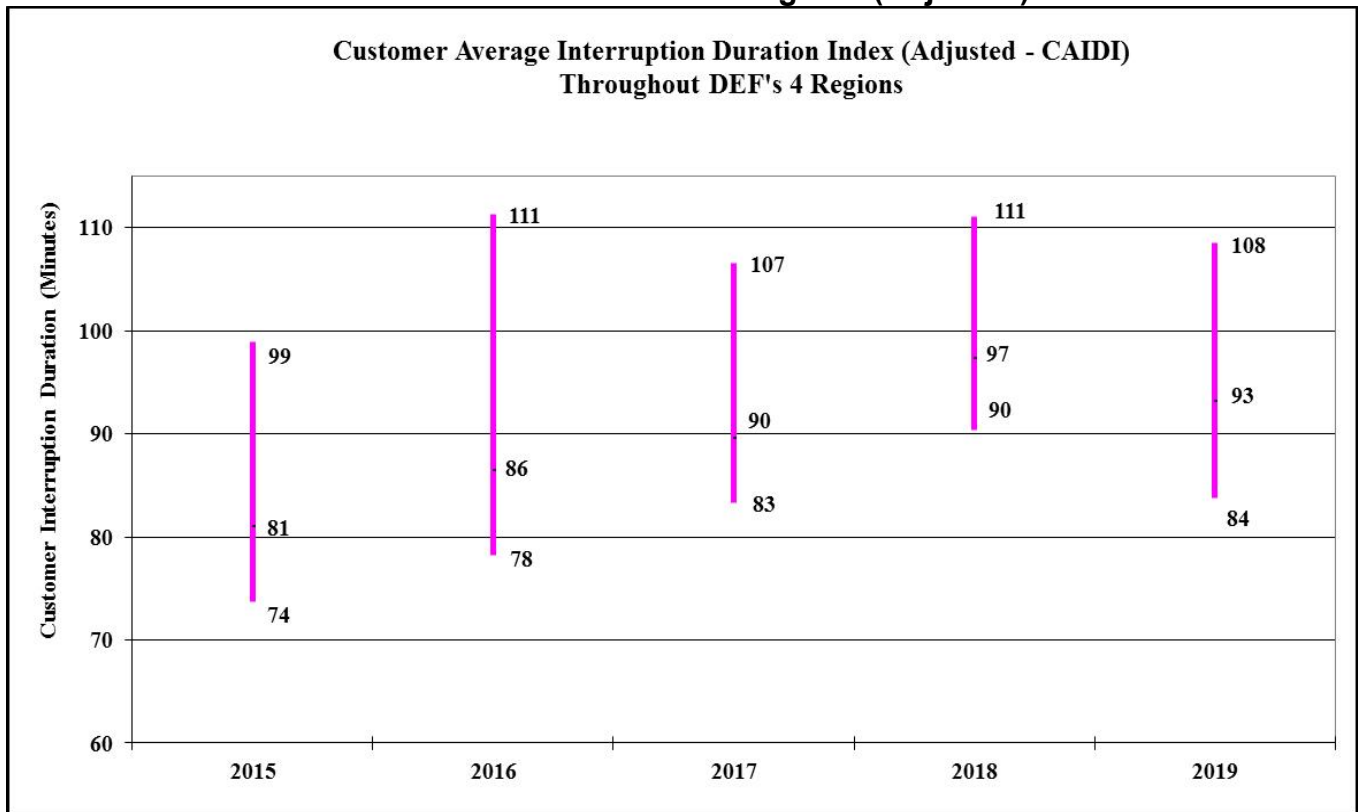
Figure 3-3
CAIDI across DEF's Four Regions (Adjusted)

Figure 3-3 illustrates the CAIDI, or the average number of minutes a customer is without power when a service interruption occurs, for DEF's four regions. DEF's adjusted CAIDI is increasing for a five-year period from 81 minutes in 2015 to 93 minutes in 2019. The North Coastal region has continued to have the highest CAIDI level for the past five years with the maximum CAIDI trending upward. The South Coastal region had the lowest CAIDI level during the same period with the minimum CAIDI trending upward.

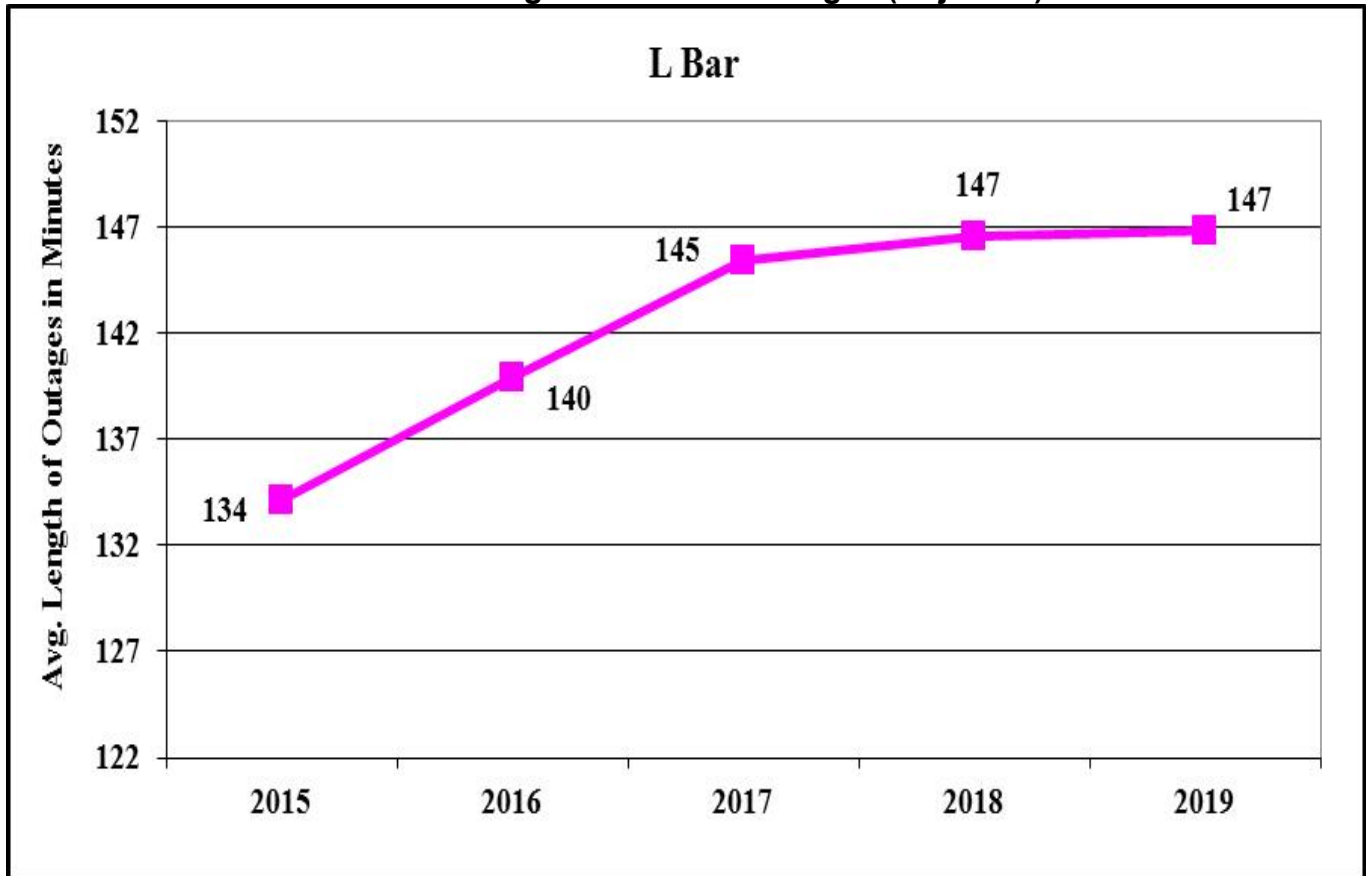
Figure 3-4
DEF's Average Duration of Outages (Adjusted)

Figure 3-4 is the average length of time DEF spends restoring customers affected by outage events, excluding hurricanes and certain other outage events. This is displayed by the index L-Bar in the graph below. The data demonstrates an overall 8 percent increase of outage durations since 2015, however, the L-Bar remained unchanged from 2018 to 2019. DEF's overall L-Bar index is trending upward, indicating that DEF is spending more time restoring service from outage events.

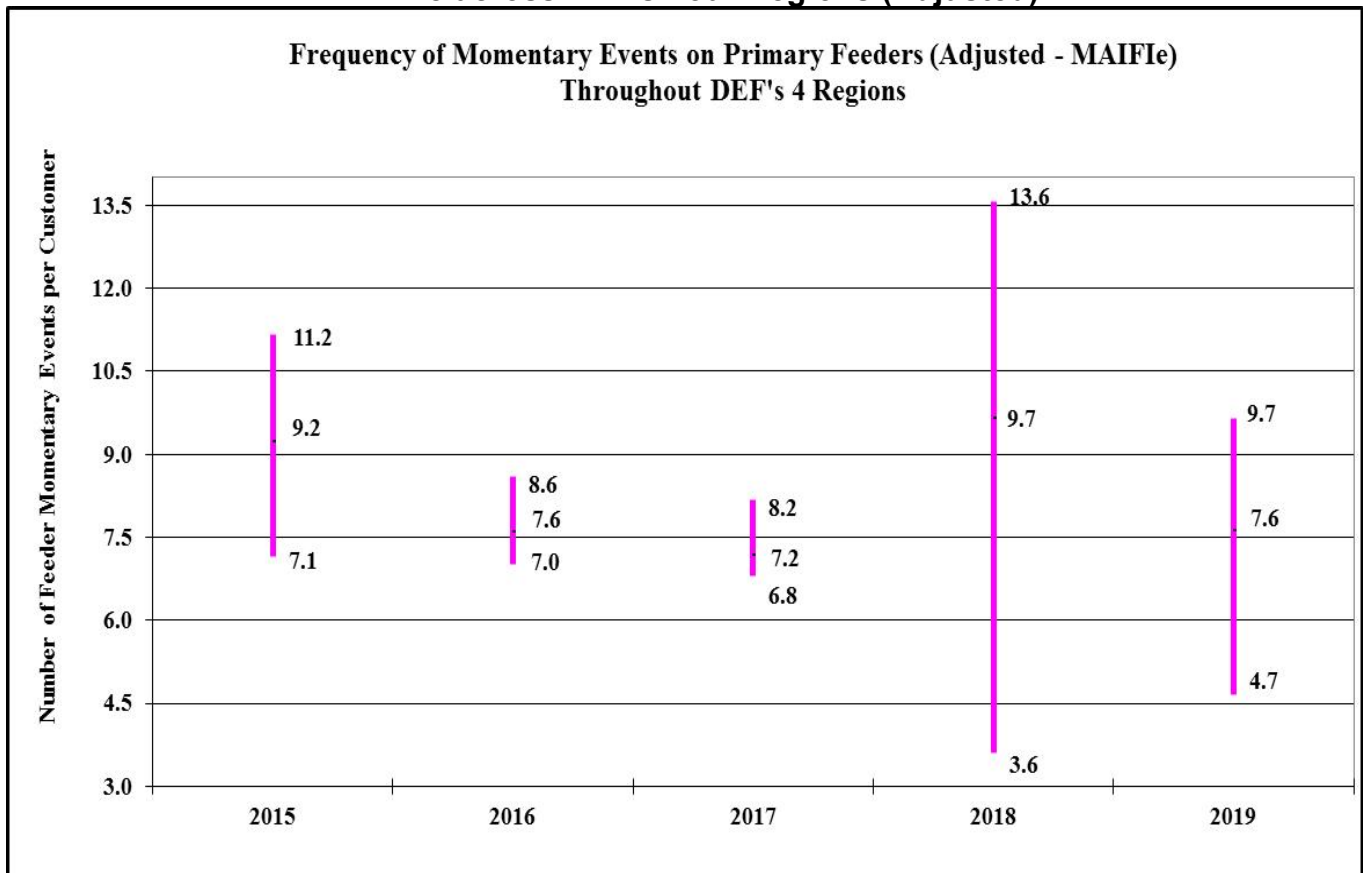
Figure 3-5
MAIFle across DEF's Four Regions (Adjusted)

Figure 3-5 illustrates the frequency of momentary events on primary circuits for DEF's customers recorded across its system. These momentary events often affect a small group of customers. A review of the supporting data suggests that the MAIFle results between 2015 and 2019 appear to be trending downward showing improvement and there was a decrease in the average MAIFle of 22 percent from 2018 to 2019. All four regions appear to fluctuate between having the best (lowest) results to having the worst (highest) results. From 2018 to 2019, the lowest MAIFle increased 31 percent and the highest MAIFle decreased 29 percent.

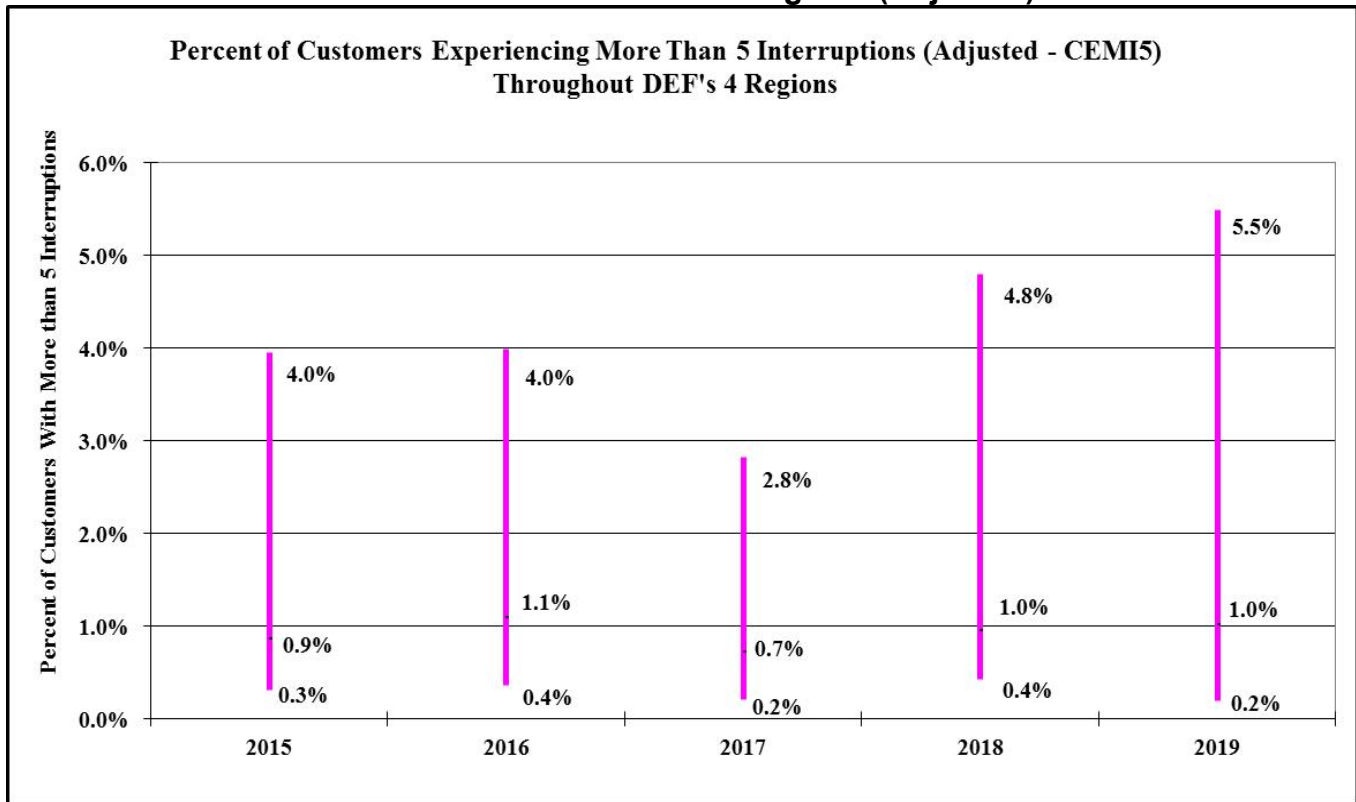
Figure 3-6
CEMI5 across DEF's Four Regions (Adjusted)

Figure 3-6 charts the percentage of DEF's customers experiencing more than five interruptions over the last five years. DEF reported no change in the average CEMI5 performance from 2018 to 2019. The average CEMI5 is trending upward over the past five years. The South Coastal region has the lowest reported percentage for all of DEF's regions and the North Coastal region continues to have the highest reported percentage.

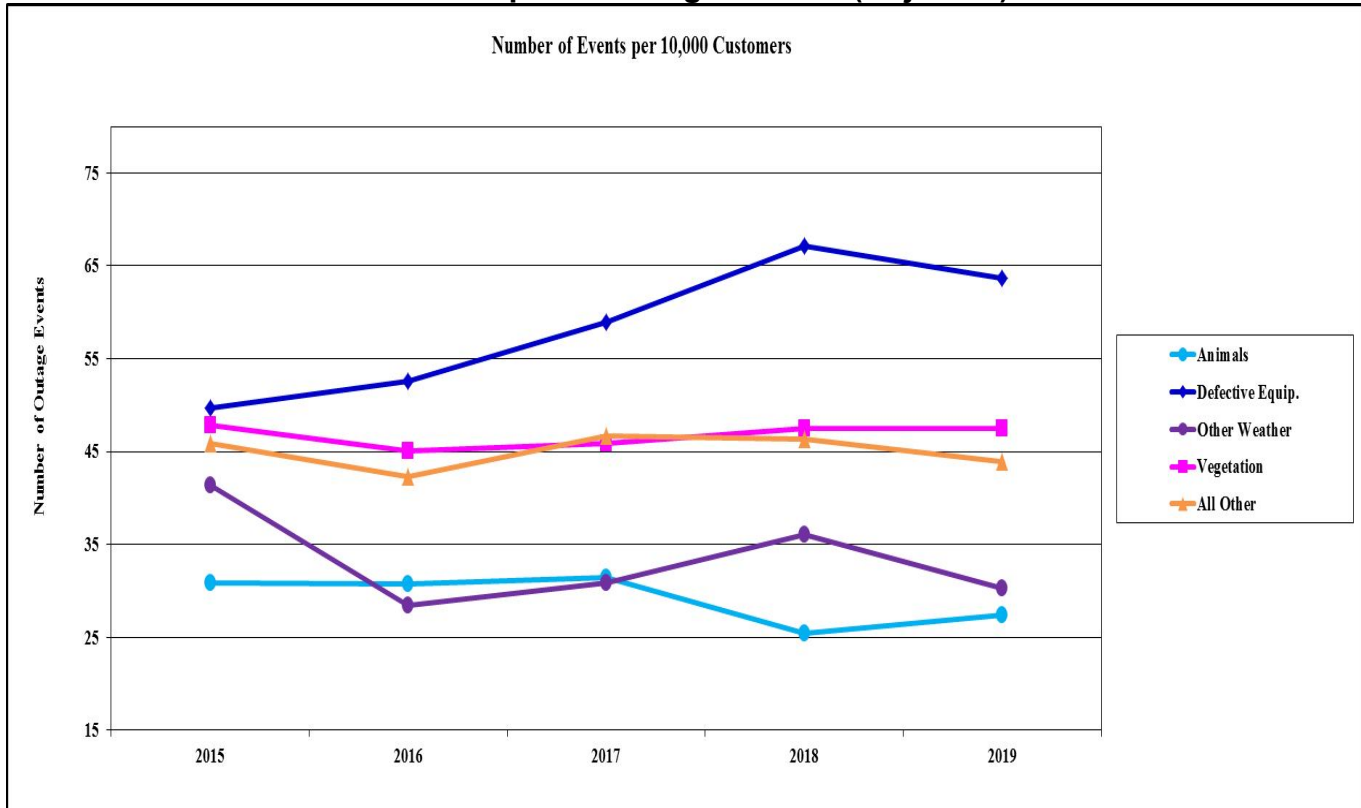
Figure 3-8
DEF's Top Five Outage Causes (Adjusted)

Figure 3-8 shows the top five causes of outage events on DEF's distribution system normalized to a 10,000-customer base. The Figure is based on DEF's adjusted data and represents approximately 95 percent of the top 10 causes of outage events that occurred during 2019. For the five-year period, the top five causes of outage events were "Defective Equipment" (28 percent), "Vegetation" (21 percent), "Other Causes" (20 percent), "Other Weather" (14 percent), and "Animals" (13 percent) on a cumulative basis. The outage events caused by "Other Weather," and "Animals" are trending downward even though the "Other Weather" category had a 11 percent decrease and "Animals" category had an 14 percent increase in 2019. DEF reported that it prioritizes the reliability improvements action plan by balancing historical and current year performance. In addition, current year performance is monitored monthly to identify emergent and seasonal issues including load balancing for cold weather and the need for foot patrols of devices experiencing multiple interruptions.

DEF will continue several programs that help mitigate outages. The Self-Optimizing Grid Team program will help reduce the impact of all types of outages. The Targeted Underground program will reduce the impact of "Vegetation," "Other Weather," and "Animals" related outages. The Transformer Retrofit Program will reduce the risk of "Defective Equipment" and "Animals" related outages. The Deteriorated Conductor Program will help mitigate the outages caused by "Defective Equipment," "Vegetation," "Animals," and "Other Weather" outage causes. In addition, DEF has five other programs to help reduce outages from "Defective Equipment," "Other Weather," "Animals," and "Vegetation."

In **Figure 3-8**, DEF’s Top Five Outage Categories, the category “Defective Equipment” is in the top spot representing 28 percent of the top 10 outage categories. The subsequent categories were “Vegetation” (21 percent) and “Other Causes” (20 percent), followed by “Other Weather” (14 percent) and “Animals” (13 percent). The “Animals” and “Other Weather” outage categories are trending downward for the five-year period of 2015 to 2019 even though the “Animals” category had a 14 percent increase in 2019 and the “Other Weather” category had an 11 percent decrease. The “Defective Equipment” category had an increase between 2018 and 2019 and continued to trend upward for the five-year period. The “Vegetation” and “Other Causes” categories had increases in 2019 and the “Vegetation” category is trending upward as the “Other Causes” category is remaining relatively flat for the five-year period.

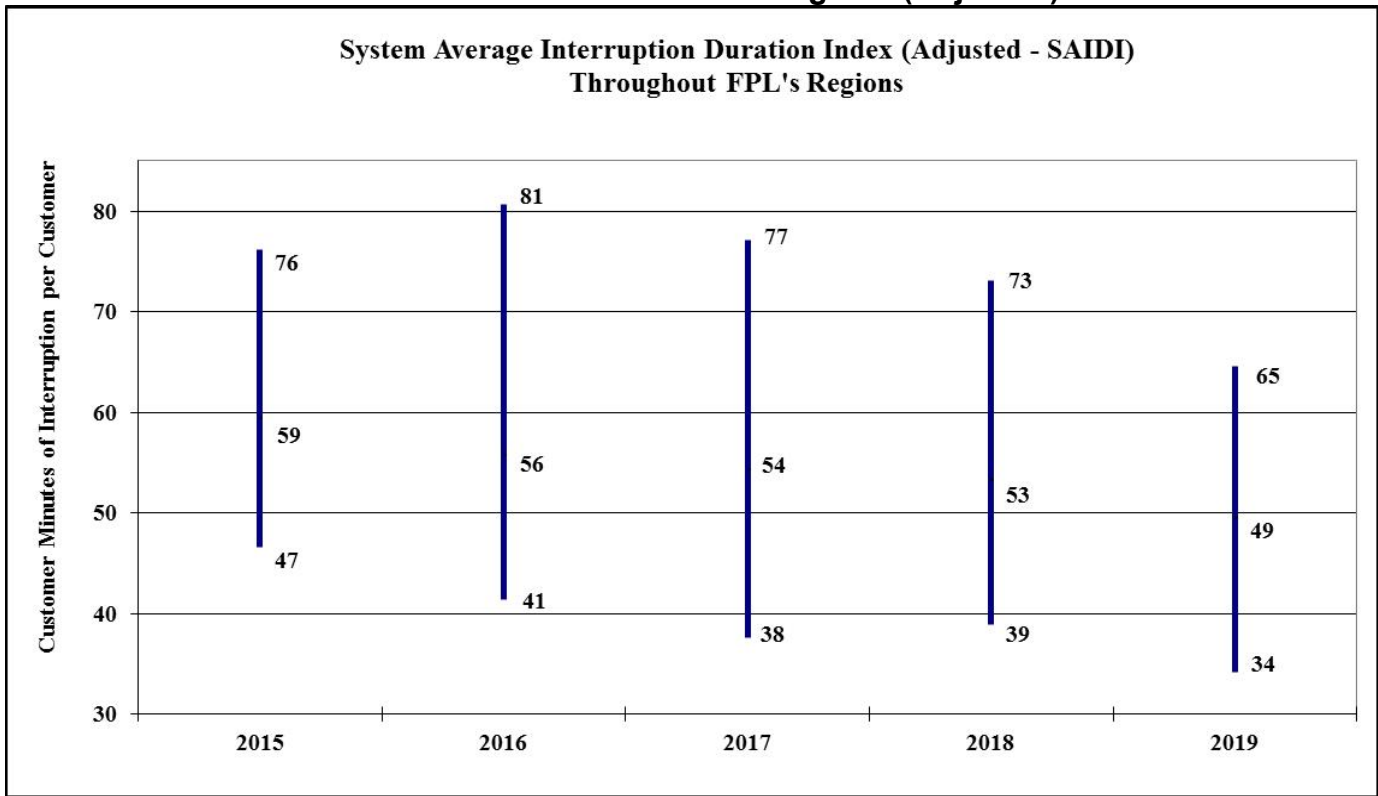
Figure 3-9
SAIDI across FPL's Sixteen Regions (Adjusted)

Figure 3-9 shows the highest, average, and lowest adjusted SAIDI recorded across FPL's system that encompasses four management regions with 16 service areas. The highest and lowest SAIDI values are the values reported for a particular service area. FPL had an overall decrease of 4 minute (8 percent) to its average SAIDI results for 2019 compared to 2018. The average SAIDI appears to be trending downward over the five-year period of 2015 to 2019. The Manasota region had the best SAIDI results for 2019.

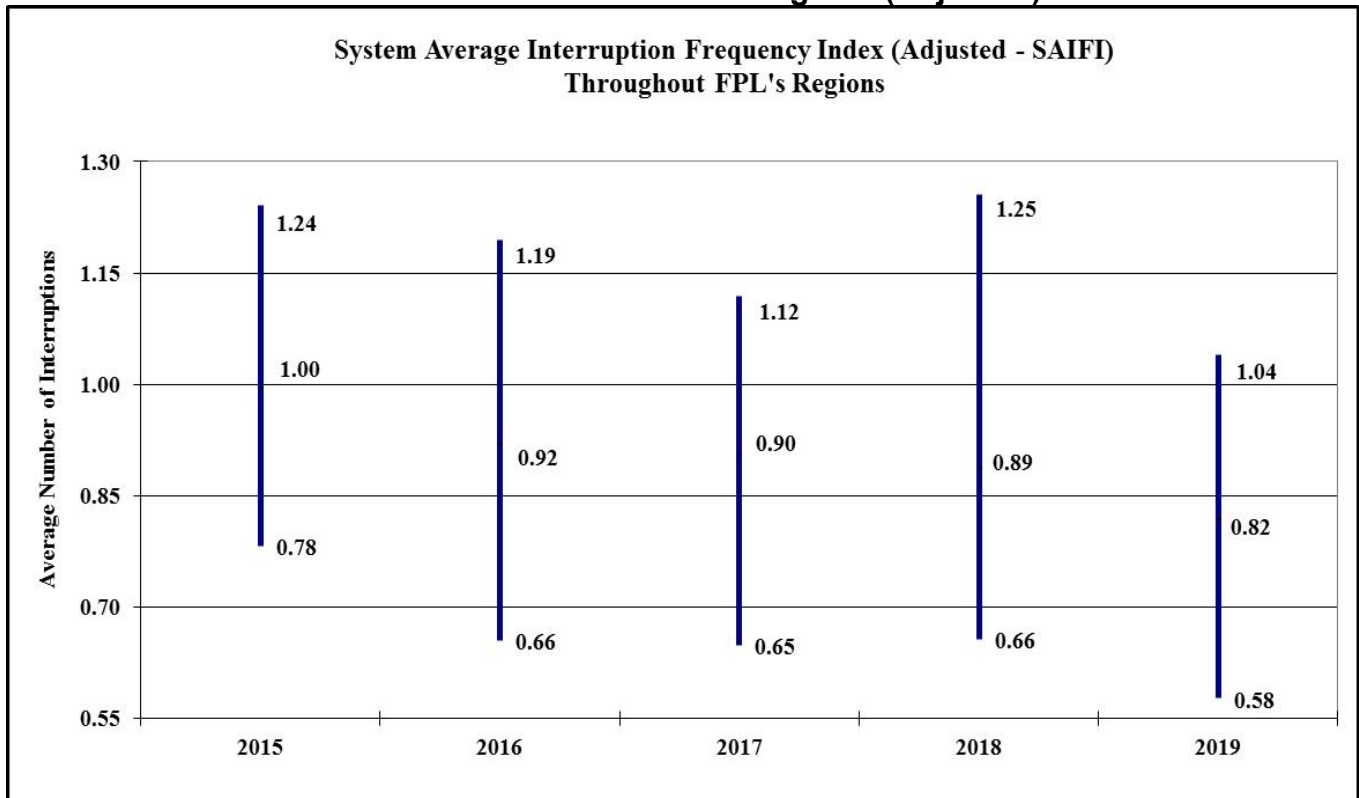
Figure 3-10
SAIFI across FPL's Sixteen regions (Adjusted)

Figure 3-10 is a chart of the highest, average, and lowest adjusted SAIFI across FPL's system. FPL had a decrease in the system average results to 0.82 outages in 2019, compared to 0.89 outages in 2018, which is a 9 percent decrease. FPL reported a decrease in the highest SAIFI of 1.04 interruptions in 2019 compared to 1.25 interruptions in 2018. The region reporting the lowest adjusted SAIFI for 2019 was Manasota at 0.58 interruptions compared to 0.66 interruptions in the North Broward region in 2018. During the period of 2015 to 2019 the highest, average, and lowest SAIFI appears to be trending downward.

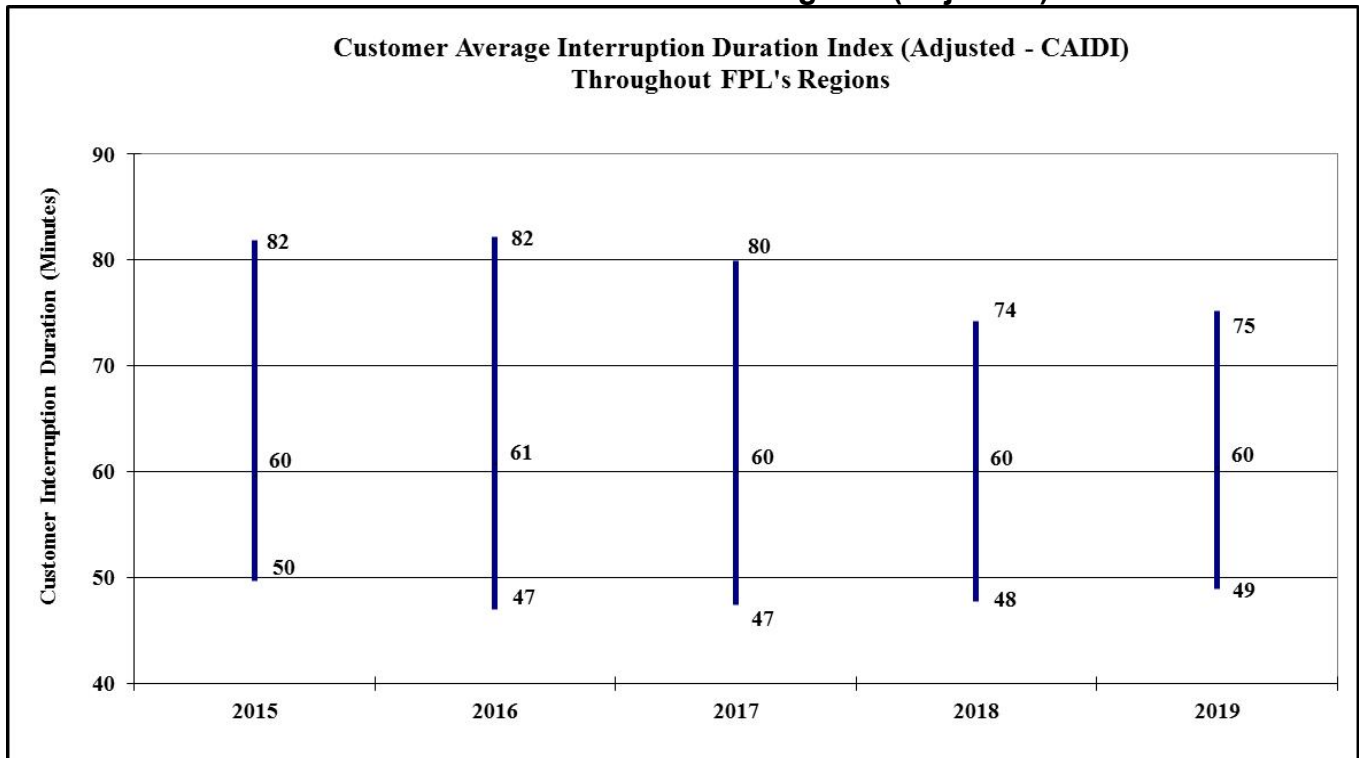
Figure 3-11
CAIDI across FPL's Sixteen Regions (Adjusted)

Figure 3-11 depicts FPL's highest, average, and lowest CAIDI expressed in minutes. FPL's adjusted average CAIDI did not decrease or increase and remained at 60 minutes for both 2018 and 2019. The average duration of CAIDI remains relatively flat. For 2019, the West Palm service area reported the lowest duration of CAIDI at 49 minutes. The highest duration of CAIDI was 75 minutes for the South Dade service area for 2019.

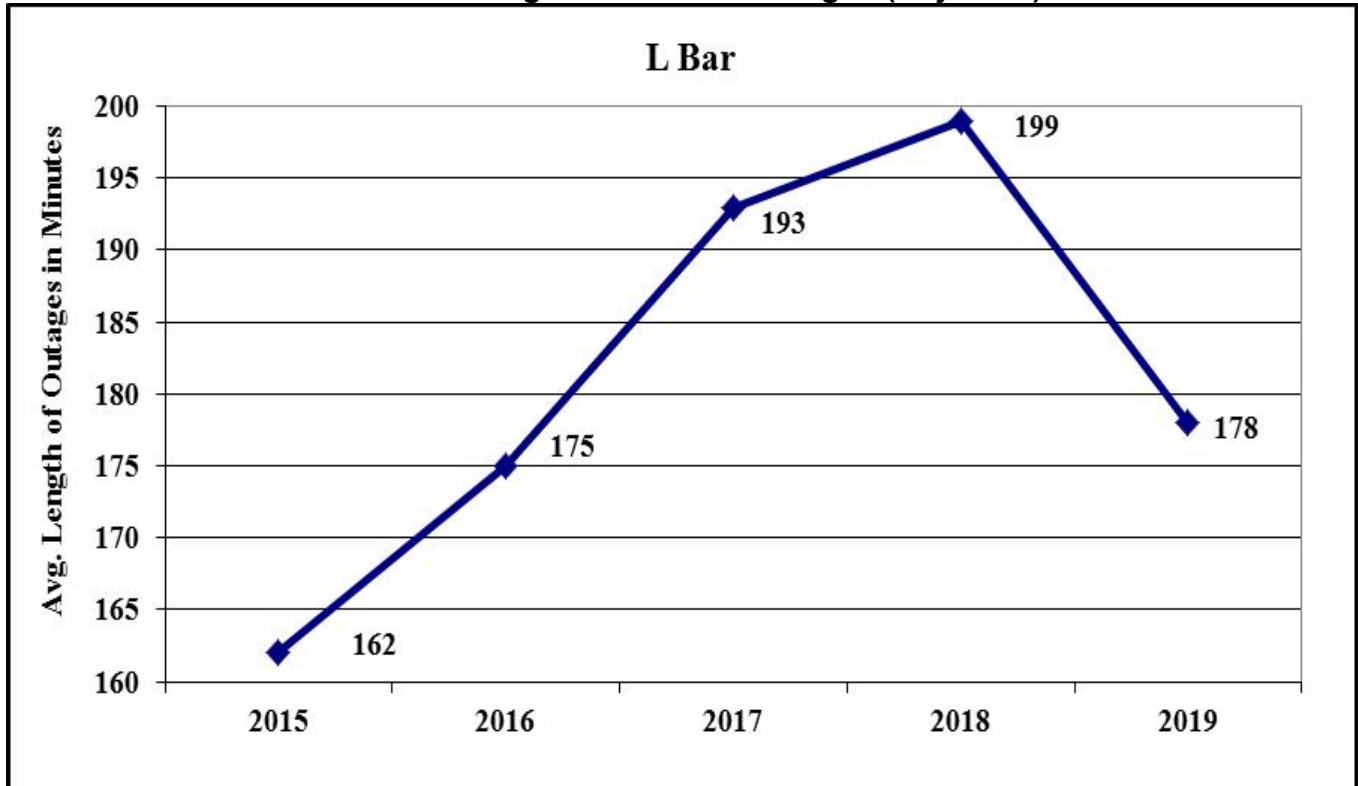
Figure 3-12
FPL's Average Duration of Outages (Adjusted)

Figure 3-12 depicts the average length of time that FPL spends recovering from outage events, excluding hurricanes and other extreme outage events and is the index known as L-Bar (Average Service Restoration Time). FPL had an 11 percent decrease in L-Bar from 199 minutes in 2018 to 178 minutes in 2019. However, there is a 10 percent overall increase since 2015 and the L-Bar is trending upward, indicating FPL is spending more time restoring service to the last customer for that given outage.

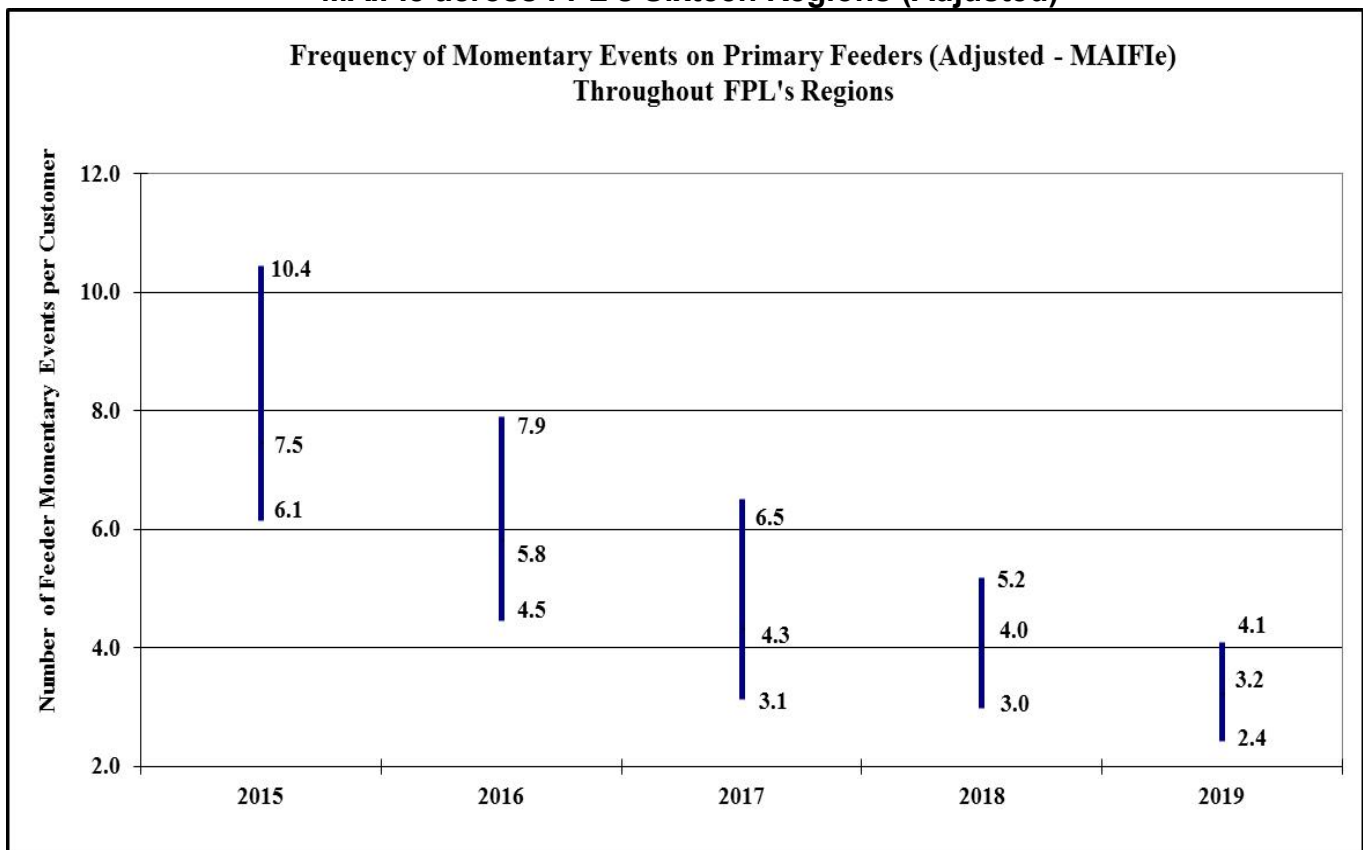
Figure 3-13
MAIFle across FPL's Sixteen Regions (Adjusted)

Figure 3-13 is the highest, average, and lowest adjusted MAIFle recorded across FPL's system. FPL's Wingate, Toledo Blade, and West Palm service areas have experienced the least reliable MAIFle results of the 16 service areas of FPL since 2015. The Pompano, Central Dade, and Manasota service areas had the fewest momentary events since 2015. The results have been trending downward (improving) over the last five years. There is a 20 percent decrease in the average MAIFle results from 2018 to 2019. As a note, FPL calculates MAIFle differently. Specifically, if a feeder begins in one region and crosses another region, all customers on that feeder are impacted by the MAIFle event and are counted in the starting region. Therefore, the number of customers per region will be different.

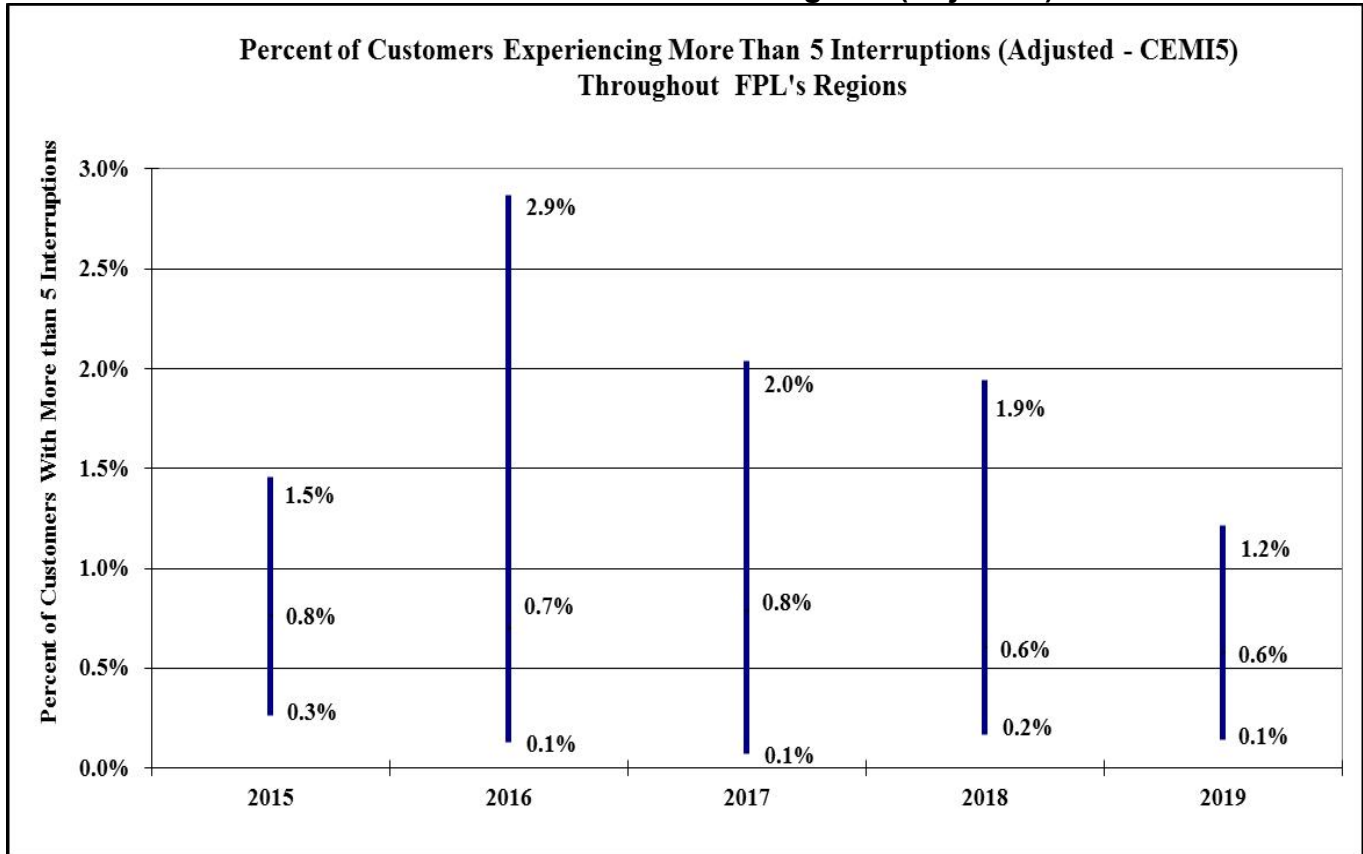
Figure 3-14
CEMI5 across FPL's Sixteen Regions (Adjusted)

Figure 3-14 shows the highest, average, and lowest adjusted CEMI5. FPL's customers with more than five interruptions per year appear to be slightly trending downward. The service areas experiencing the highest CEMI5 over the five-year period appear to fluctuate among West Dade, Treasure Coast, West Palm, and Toledo Blade. Pompano, South Broward (Gulf Stream), Brevard, and Central Dade are reported as having the lowest percentages in the last five years. The average CEMI5 result for 2019 was 0.6 percent, which remains the same as in 2018.

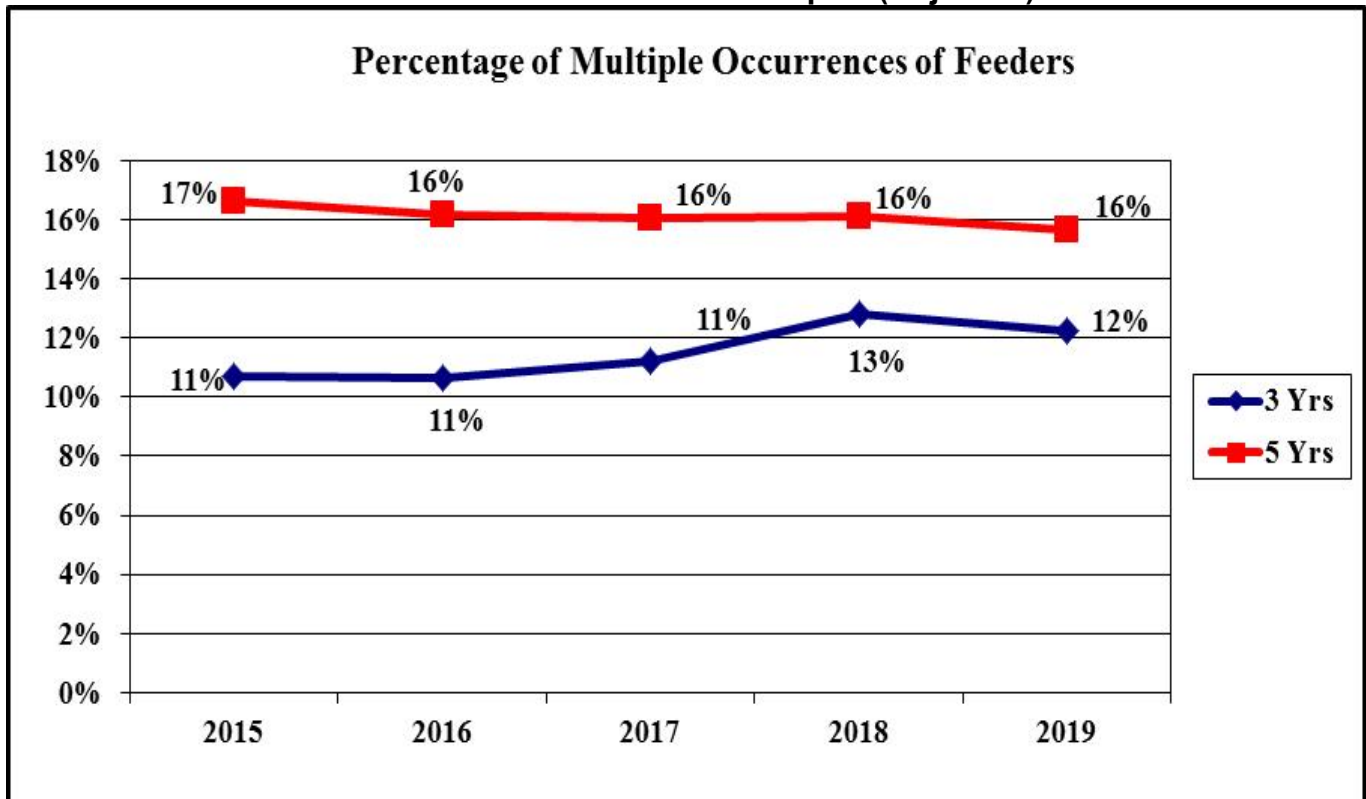
Figure 3-15
FPL's Three Percent Feeder report (Adjusted)

Figure 3-15 is a graphical representation of the percentage of multiple occurrences of FPL's feeders and is derived from The Three Percent Feeder Report, which is a listing of the top three percent of problem feeders reported by the Utility. The fraction of multiple occurrences is calculated from the number of recurrences divided by the number of feeders reported. The three-year percentage had a decrease to 12 percent in 2019 from 13 percent in 2018. The five-year percentage was 16 percent in 2018 and 2019. The five-year percentage appears to be trending downward as the three-year percentage appears to be trending upward.

Staff notes ten feeders were on the Three Percent Feeder Report the last two years. FPL reported that visual/thermovision assessment follow-up work is scheduled for two feeders, repairs have been completed on six feeders, and automated feeder switches will be installed on seven feeders. FPL also reported that in 2019, approximately 157 miles of trimming was performed on these nine feeders, which is about 90 percent of the feeders' overhead facilities. FPL will continue repairs on four of the feeders and plans to harden four additional feeders during 2020 through 2022.

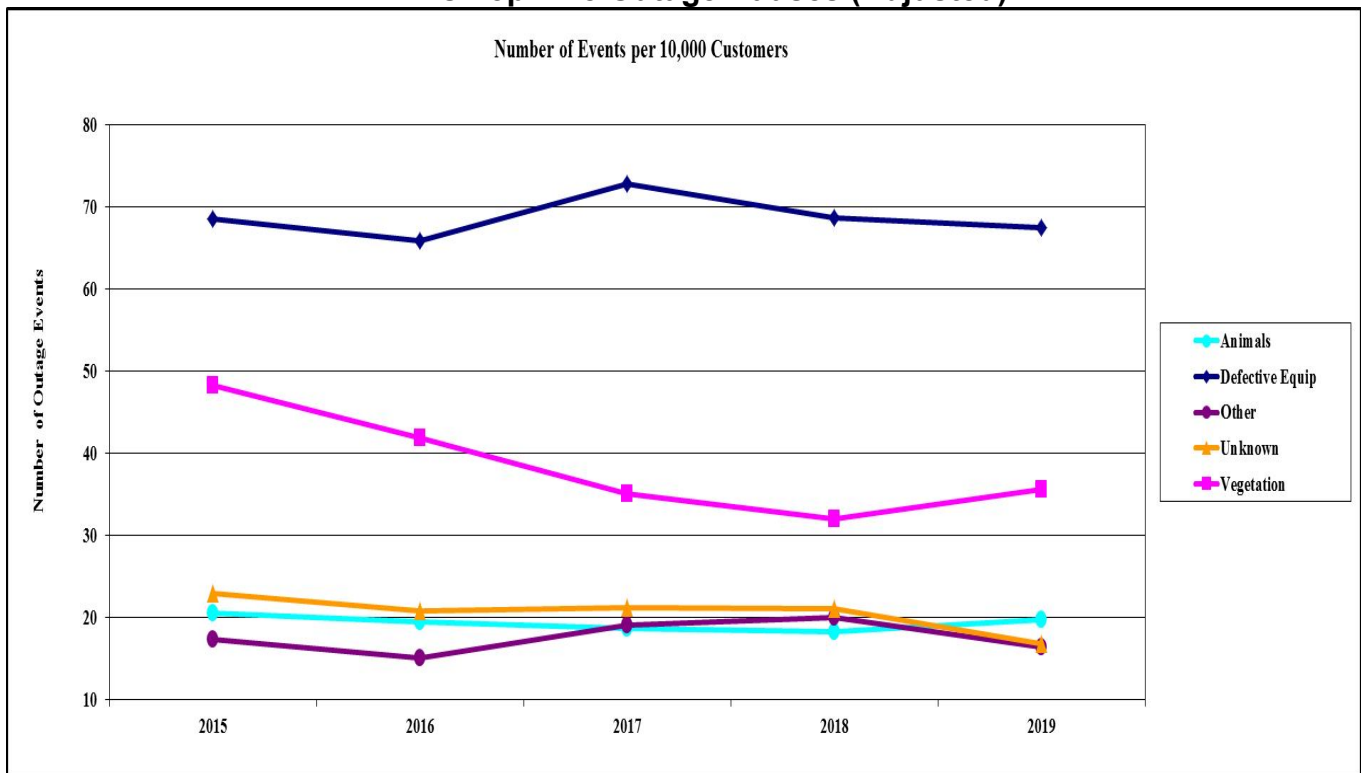
Figure 3-16
FPL’s Top Five Outage Causes (Adjusted)

Figure 3-16 depicts the top five causes of outage events on FPL’s distribution system normalized to a 10,000-customer base. The graph is based on FPL’s adjusted data of the top 10 causes of outage events. For the five-year period, the five top causes of outage events included “Defective Equipment” (37 percent), “Vegetation” (20 percent), “Animals” (11 percent), “Unknown Causes” (9 percent), and “Other Causes” (9 percent) on a cumulative basis. The outage events due to “Vegetation” and “Unknown Causes” are trending downward as the “Defective Equipment” and “Animals” categories are remaining relatively flat. The category “Other Causes” is slightly trending upward. The category “Defective Equipment” dominates the highest percentage of outage causes throughout the FPL regions and there was a 2 percent increase in the number of outages from 2018 to 2019.

Annually, FPL evaluates its current reliability remediation programs and verifies the program’s need and/or existence. In addition, FPL proposes new reliability remediation programs to improve its reliability performance concentrating on the highest cause codes and those cause codes that have shown trends needing attention. FPL has 21 reliability programs listed for its 2020 budget. The programs include: distribution automation, system expansion, reduce the number of direct buried feeder and lateral cables, install feeder line covers to reduce vegetation related interruptions, and replace oil circuit reclosers with electronic reclosers. Sixteen programs are designed to improve the “Defective Equipment” cause code. Eleven programs will improve the “Vegetation” cause code and eight programs will improve the “Animals” cause code, both of which had increases in 2019.

“Defective Equipment” (37 percent) and “Vegetation” (20 percent) outages were the leading causes of outage events per customer for 2019. The next three outage causes are “Animals” (11 percent), “Other Causes” (9 percent), and “Unknown Causes” (9 percent). **Figure 3-16** shows an increasing trend in the number of outage events attributed to “Other Cause,” which had decreased by 14 percent from 2018 to 2019. The analysis shows a decrease in the number of outage events caused by “Unknown Causes” in which it is trending downward. In addition, “Vegetation” is also trending downward. The analysis shows that the “Animals” and “Defective Equipment” categories are remaining relatively flat.

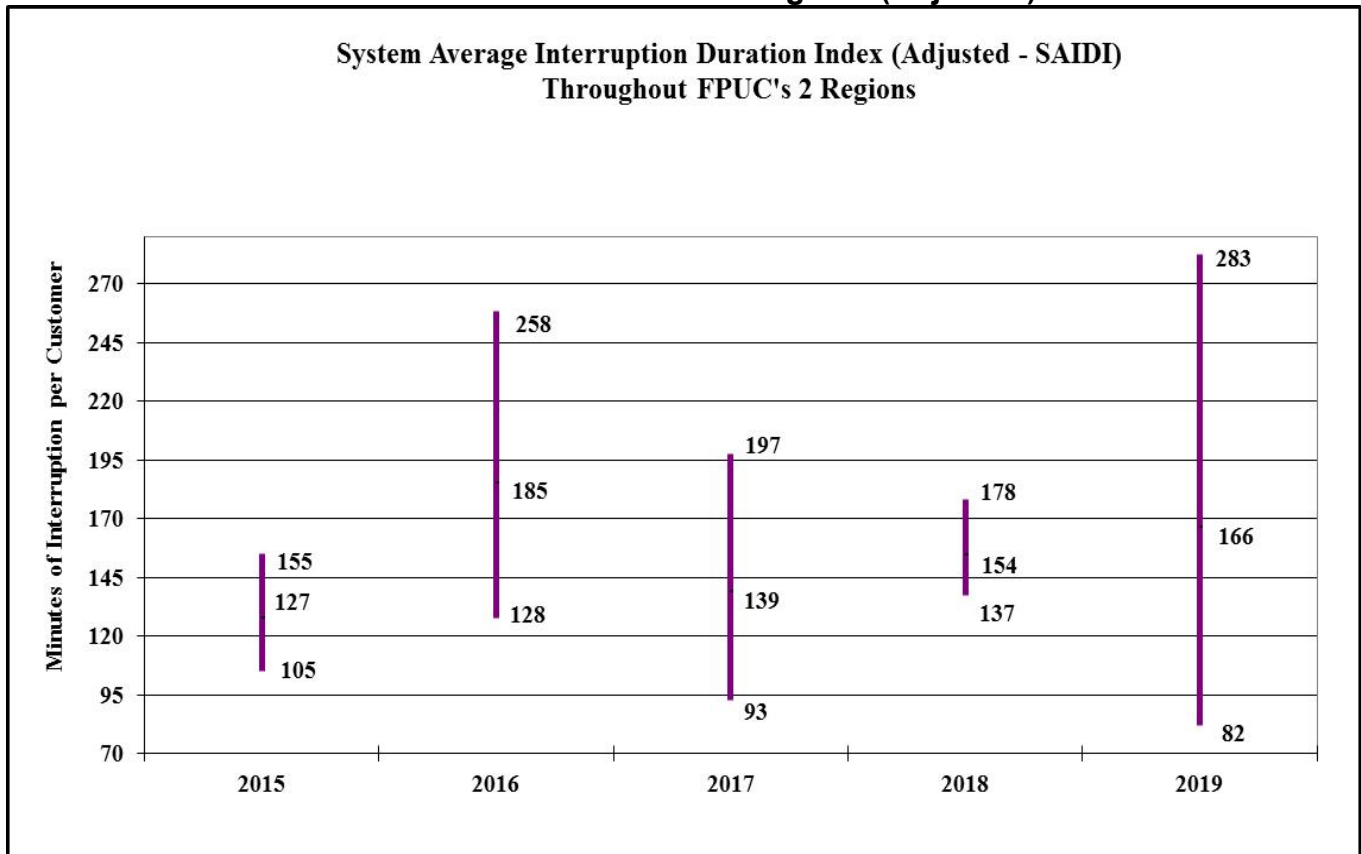
Figure 3-17
SAIDI across FPUC's Two Regions (Adjusted)

Figure 3-17 shows the highest, average, and lowest adjusted SAIDI values recorded by FPUC's system. The data shows the average SAIDI index is trending upward for the five-year period of 2015 to 2019 and there was an 8 percent increase from 2018 to 2019.
