*Review of
Florida's
Investor-Owned
Electric Utilities*

*2 0 1 9
Service Reliability Reports*

State of Florida
Florida Public Service Commission
Division of Engineering

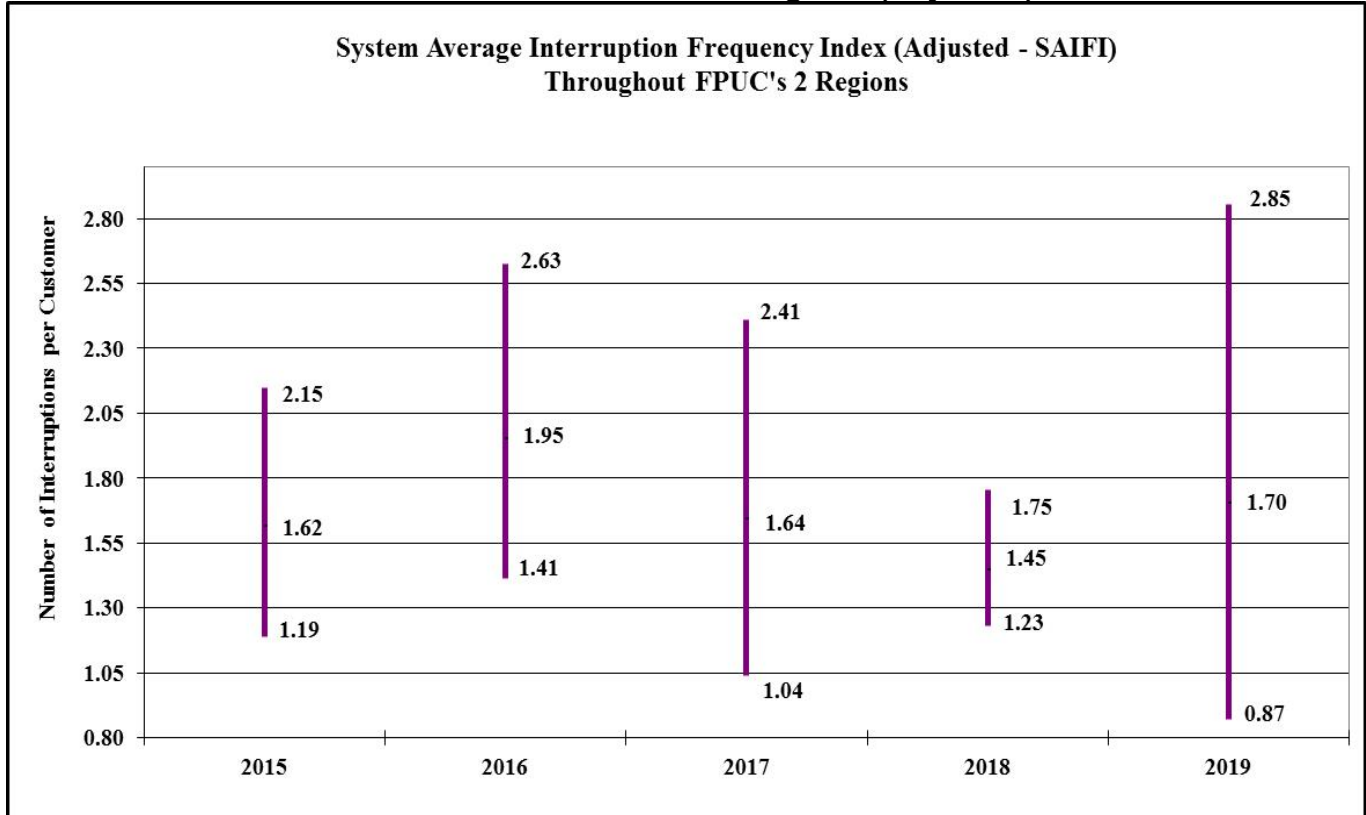
Figure 3-18
SAIFI across FPUC's Two Regions (Adjusted)

Figure 3-18 shows the adjusted SAIFI across FPUC's two divisions. The data depicts a 17 percent increase in the 2019 average SAIFI reliability index from 2018. The data for the average and maximum SAIFI values are trending downward as the minimum SAIFI value is trending upward over the five-year period of 2015 to 2019.

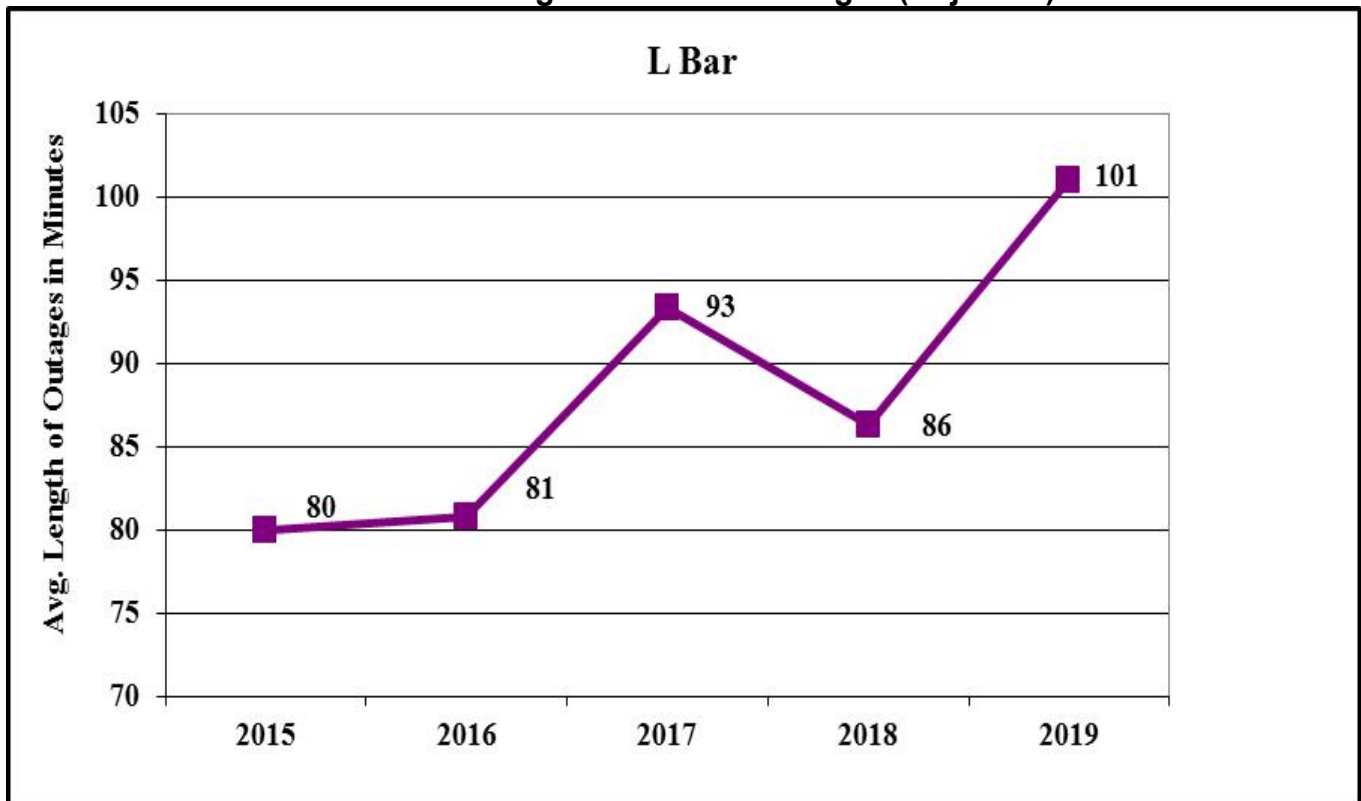
Figure 3-20
FPUC's Average Duration of Outages (Adjusted)

Figure 3-20 is the average length of time FPUC spends recovering from outage events (adjusted L-Bar). There was a 17 percent increase in the L-Bar value from 2018 to 2019. The data for the five-year period of 2015 to 2019 suggests that the L-Bar index is trending upward indicating FPUC is taking additional time to restore service after an outage event.

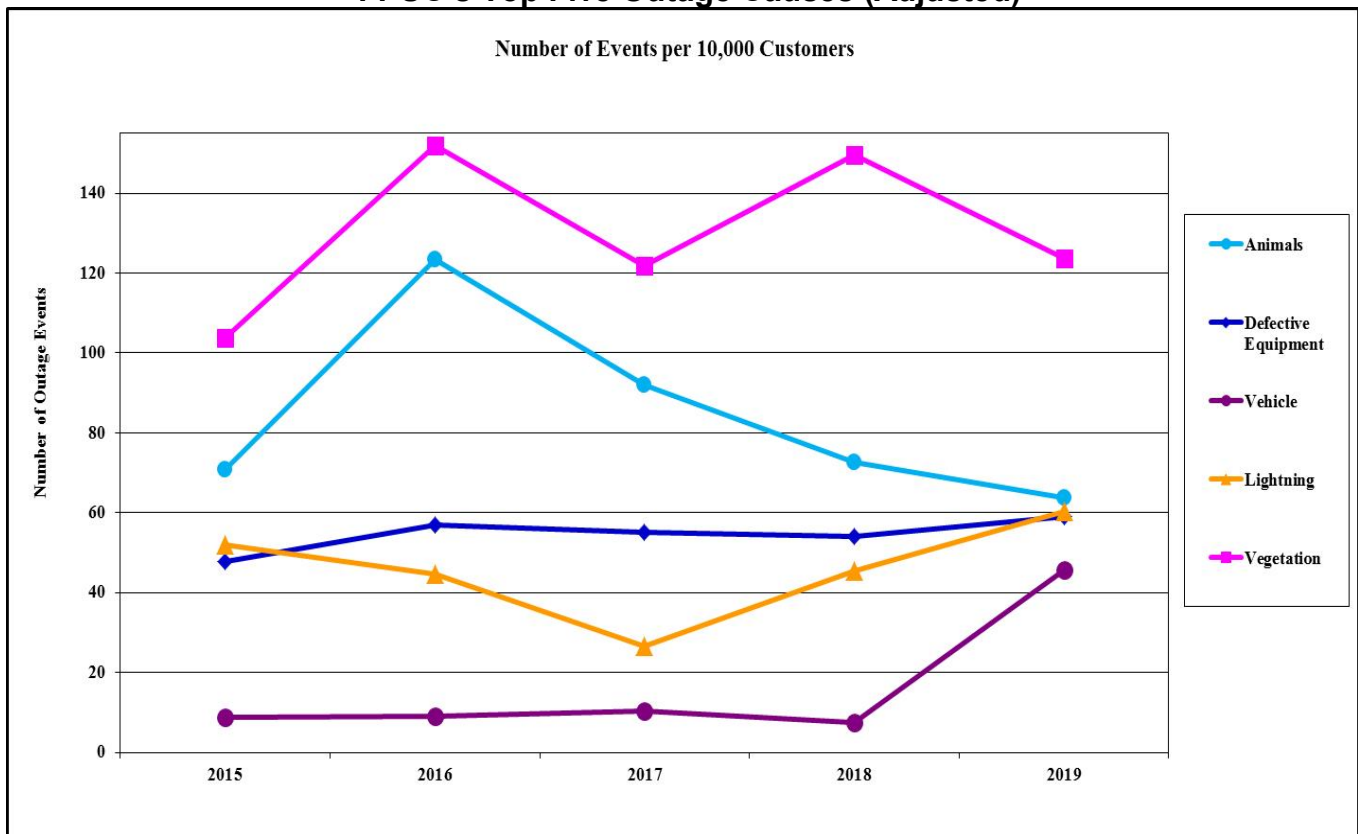
Figure 3-21
FPUC’s Top Five Outage Causes (Adjusted)

Figure 3-21 shows the top five causes of outage events on FPUC’s distribution system normalized to a 10,000-customer base. The figure is based on FPUC’s adjusted data of the top 10 causes of outages. For 2019, the top five causes of outage events were “Vegetation” (27 percent), “Animals” (14 percent), “Defective Equipment” (13 percent), “Lightning” (13 percent), and “Vehicle” (10 percent). These five factors represent 76 percent of the total adjusted outage causes in 2019. The “Vegetation” category is trending upward even though there was a 15 percent decrease from 2018 to 2019. The causes by “Defective Equipment,” “Lightning,” and “Vehicle” are also trending upward. “Defective Equipment” increased 12 percent from 2018 to 2019. The “Lightning” and “Vehicle” category increased 36 percent and 80 percent during the same time period, respectively. The “Animals” category caused outages is trending downward over the five-year period of 2015 to 2019 and there was a 10 percent decrease from 2018 to 2019.

FPUC’s top five causes of outages included “Vegetation,” “Animals,” “Defective Equipment,” “Lightning,” and “Unknown” events. As shown in **Figure 3-21**, “Vegetation” (27 percent) was the number one cause of outages in 2019 followed by “Animals” (14 percent), “Defective Equipment” (13 percent), “Lightning” (13 percent), and “Vehicle” (10 percent). “Animals,” and “Vegetation” attributed outages decreased in 2019, as “Defective Equipment,” “Lightning,” and “Vehicle” caused outages increased.

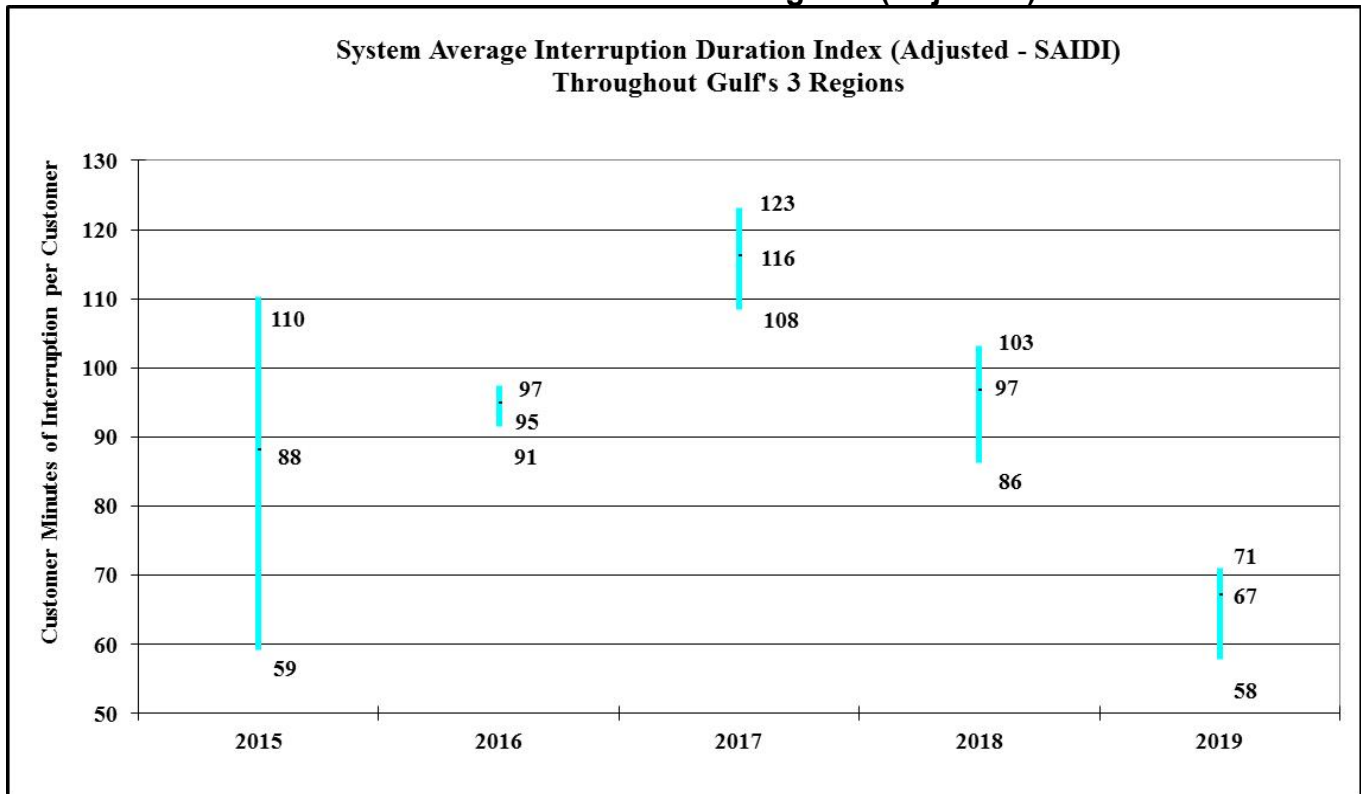
Figure 3-22
SAIDI across Gulf's Three Regions (Adjusted)

Figure 3-22 illustrates Gulf's SAIDI minutes, or the interruption duration minutes on a system basis. The chart depicts a 31 percent decrease in the average SAIDI in Gulf's combined regions when compared to the 2018 results. Gulf's 2019 average performance was 67 minutes compared to 97 minutes in 2018. The highest SAIDI value for 2018 was the Western region as the Central region had the best or lowest SAIDI value. The maximum, minimum, and average SAIDI indices are trending downward.

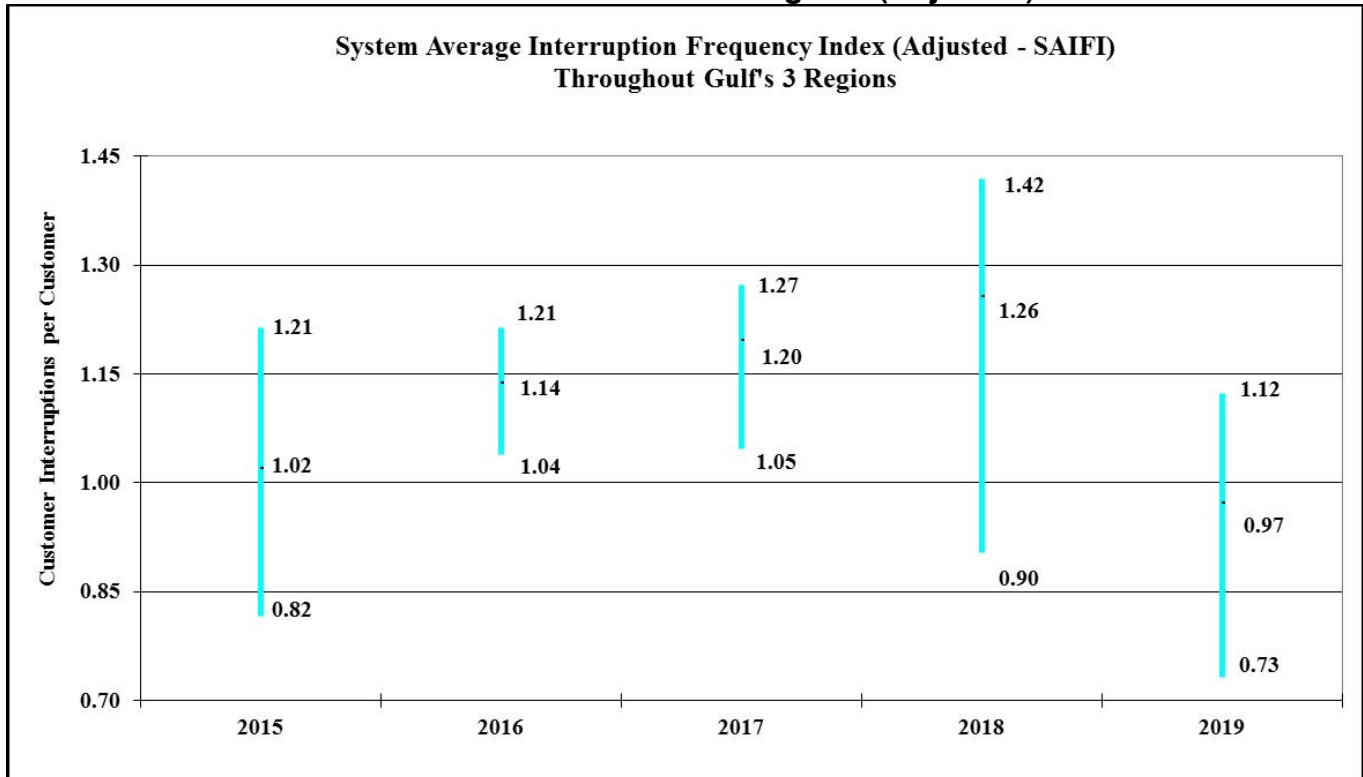
Figure 3-23
SAIFI across Gulf's Three Regions (Adjusted)

Figure 3-23 illustrates that Gulf's SAIFI had a 23 percent decrease in 2019 when compared to 2018. The highest SAIFI value for the past five years has fluctuated between the Eastern and Western regions. The lowest values appear to be in the Central region. The maximum and average SAIFI values appear to be trending upward while the minimum SAIFI value appears to be trending downward.

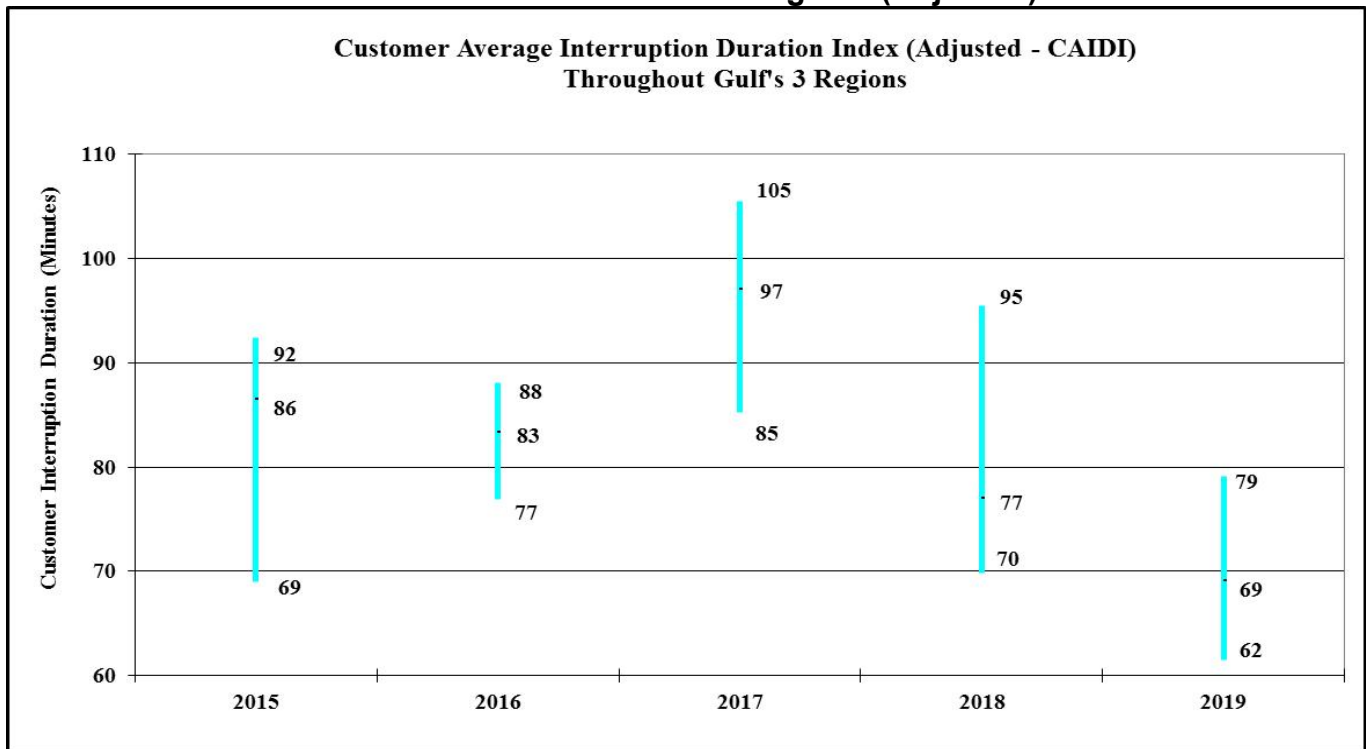
Figure 3-24
CAIDI across Gulf's Three Regions (Adjusted)

Figure 3-24 is Gulf's adjusted CAIDI. For 2019, the average CAIDI is 69 minutes and represents a 10 percent decrease from the 2018 value of 77 minutes. In 2019, the Central region continued to have the highest CAIDI value, as the Eastern region had the lowest CAIDI. Staff notes that the average, maximum, and minimum CAIDI values are trending downward.

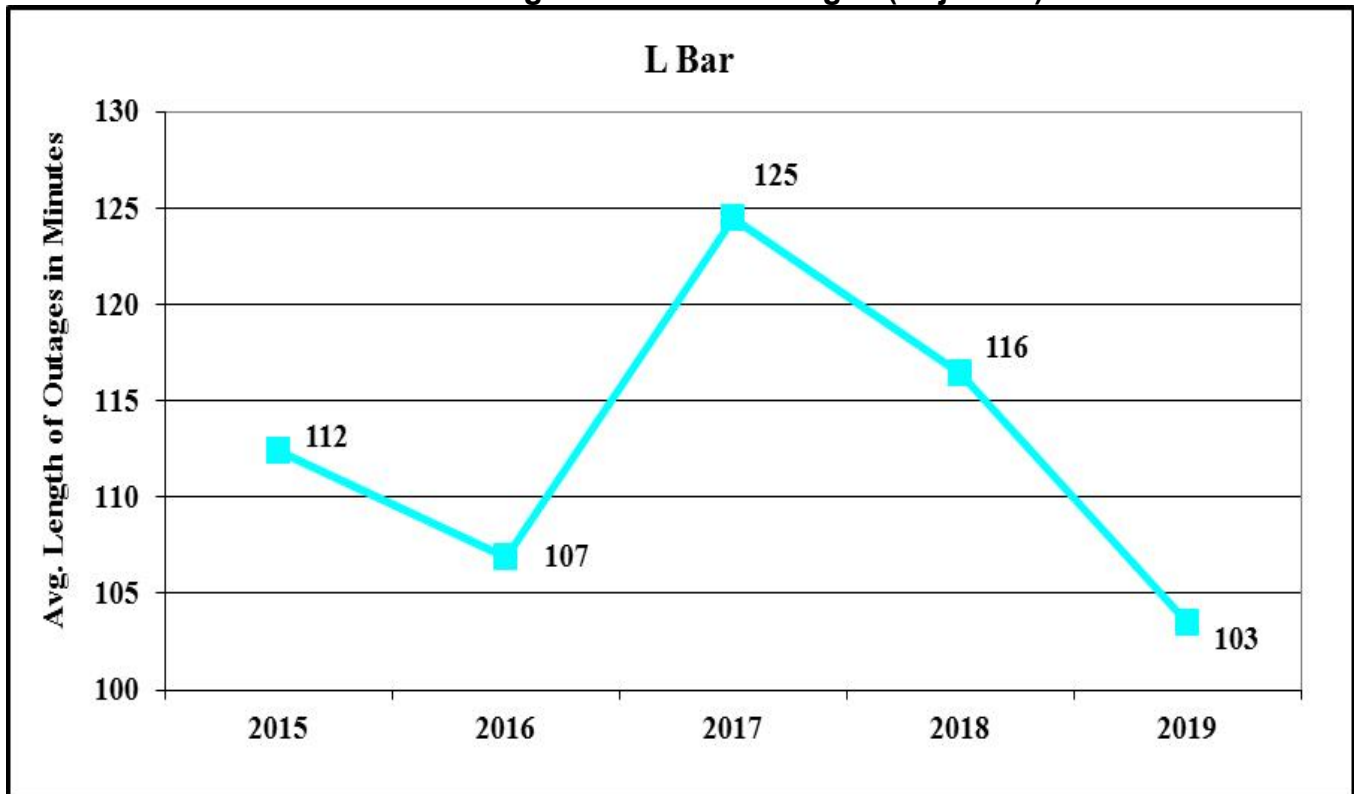
Figure 3-25
Gulf's Average Duration of Outages (Adjusted)

Figure 3-25 illustrates Gulf's L-Bar or the average length of time Gulf spends recovering from outage events, excluding hurricanes and other allowable excluded outage events. Gulf's L-Bar showed an 11 percent decrease from 2018 to 2019. In addition, the data for the five-year period of 2015 to 2019 shows a downward trend. This indicates that Gulf is spending less time restoring service to customers.

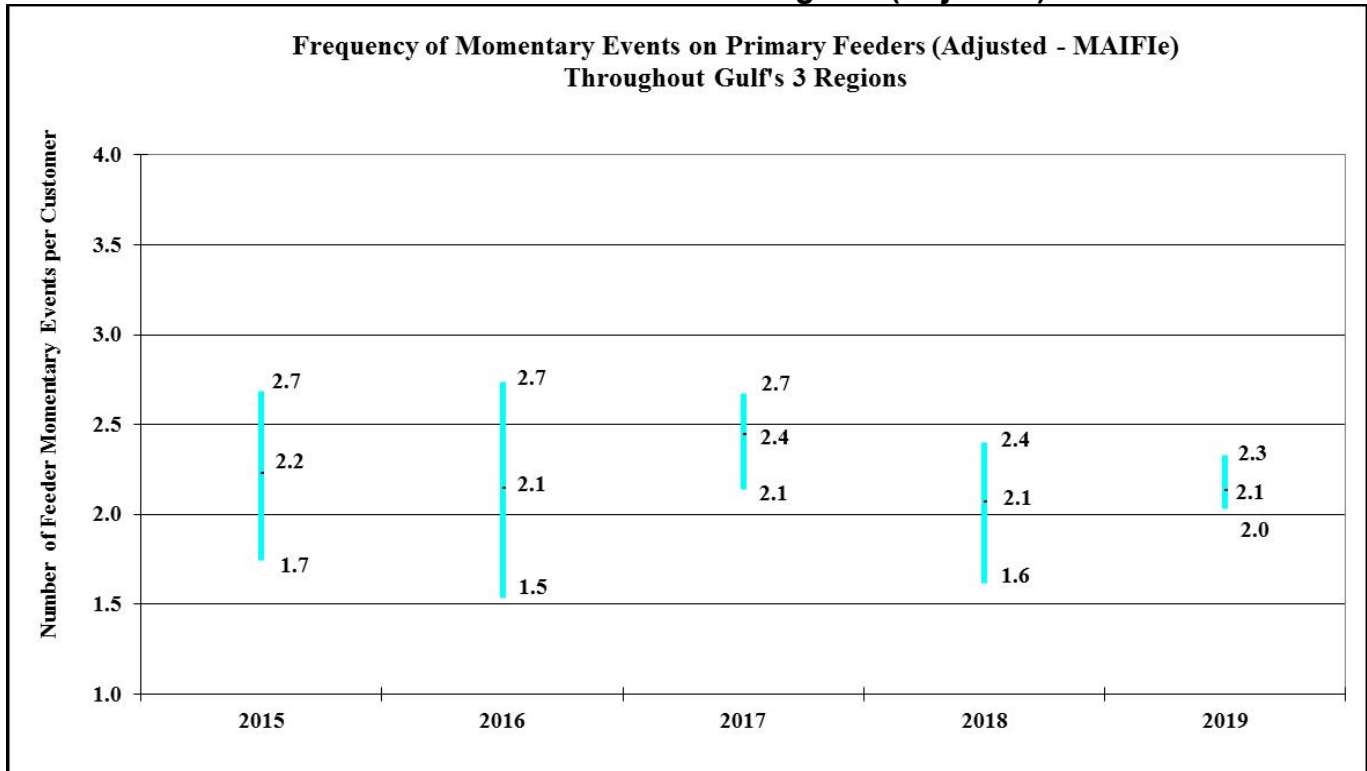
Figure 3-26
MAIFle across Gulf's Three Regions (Adjusted)

Figure 3-26 is the adjusted MAIFle recorded across Gulf's system. The adjusted MAIFle results by region show that the Central region had the lowest frequency of momentary events on primary feeders. The Eastern region has the highest MAIFle index in 2019. The average MAIFle remained the same as in 2018. The data suggest that the highest, average, and lowest MAIFle are all continuing to trend downward, suggesting improvement.

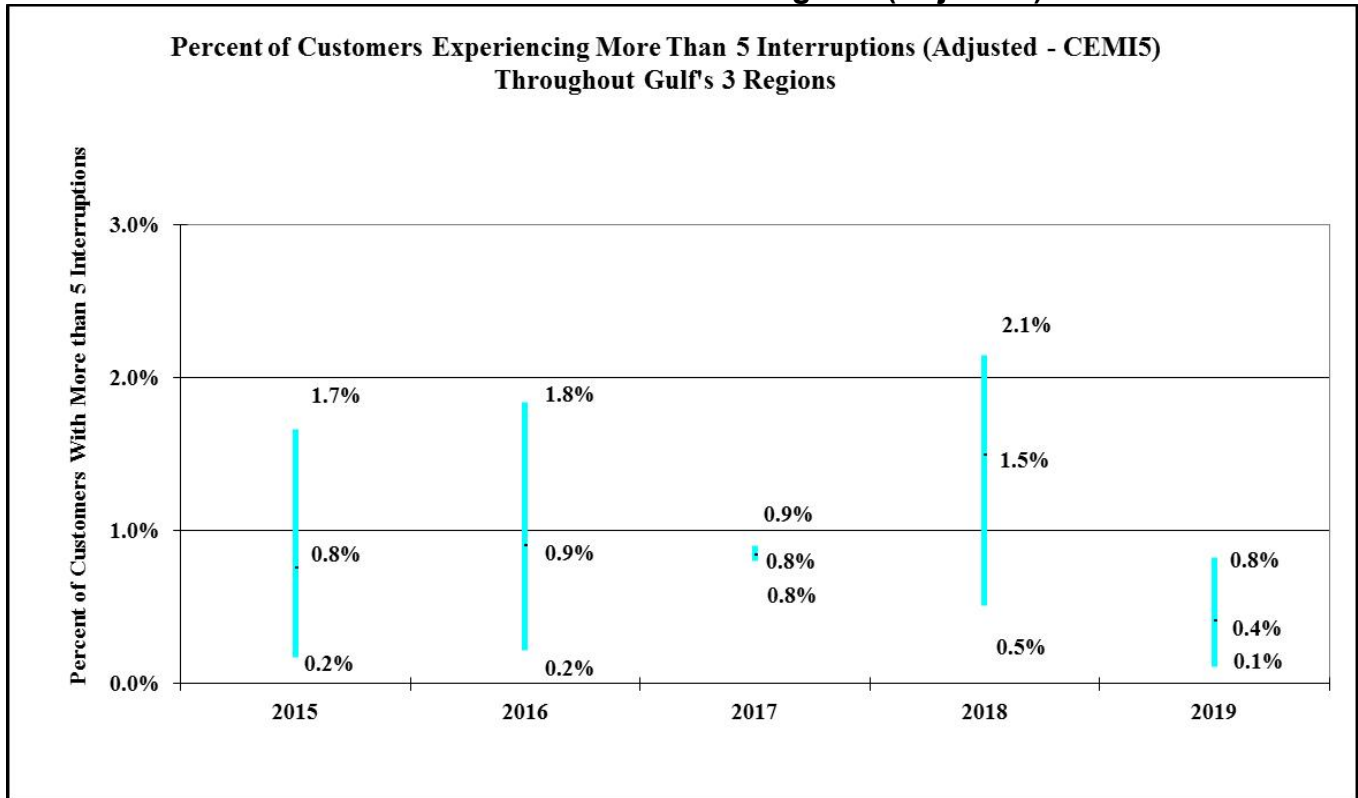
Figure 3-27
CEMI5 across Gulf's Three Regions (Adjusted)

Figure 3-27 shows the highest, average, and lowest adjusted CEMI5 across Gulf's Western, Central, and Eastern regions. Gulf's 2019 results illustrate a 73 percent decrease in the average CEMI5 percentage when compared to 2018. The minimum CEMI5 appears to be trending upward over the five-year period of 2015 to 2019 as the maximum CEMI5 appears to be trending downward. The average CEMI5 appears to remain relatively flat.

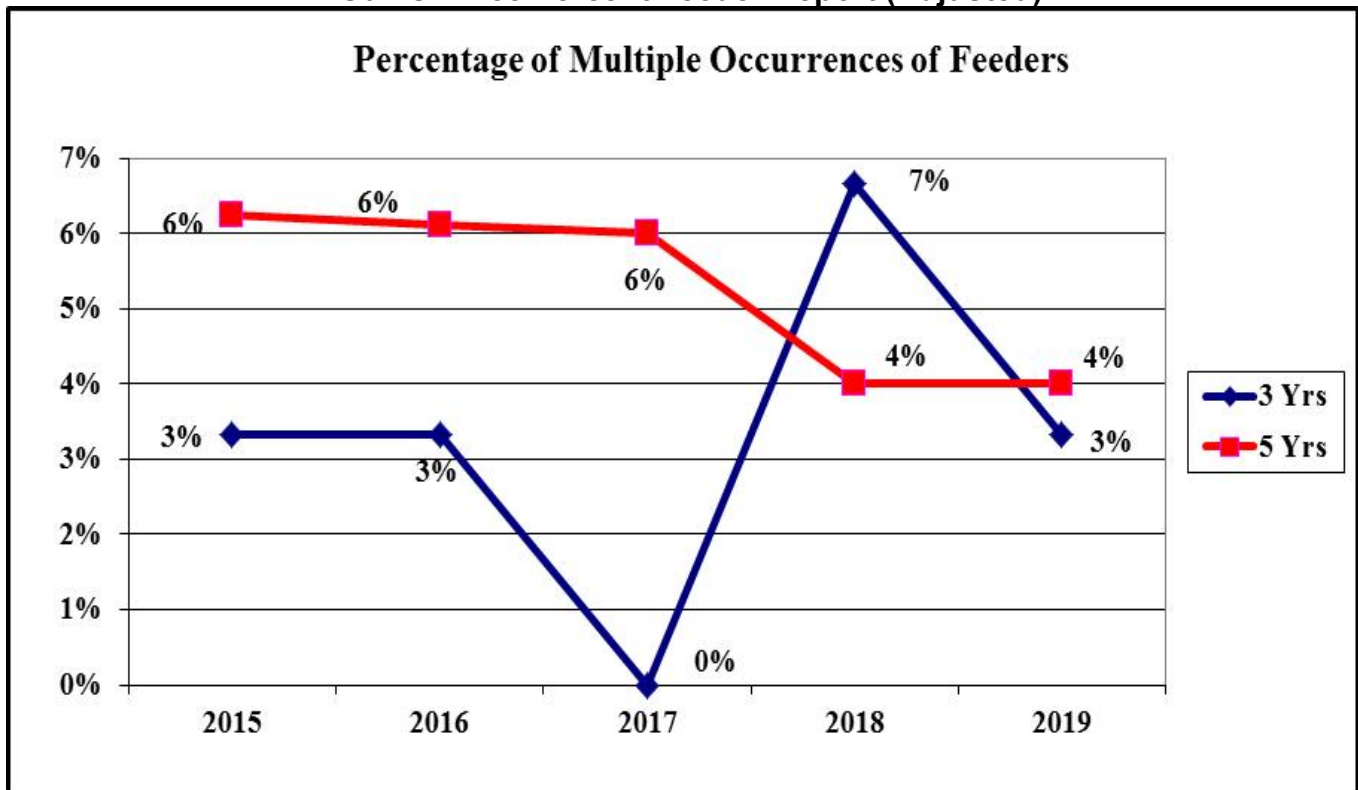
Figure 3-28
Gulf’s Three Percent Feeder Report (Adjusted)

Figure 3-28 shows the multiple occurrences of feeders using the Utility’s Three Percent Feeder Report and is analyzed on a three- and five-year basis. The Three Percent Feeder Report is a listing of the top 3 percent of feeders that have the most feeder outage events. The supporting data illustrates that the five-year multiple occurrences were unchanged from 2018 to 2019 as the three-year multiple occurrences decreased by 57 percent. The five-year period of 2015 to 2019 indicates overall that the five-year index is trending downward, as the three-year multiple occurrences index is trending upward.

There were 10 feeders on the Three Percent Feeder Report. Gulf reported that the three top causes of the outages associated with the 10 feeders listed were “Other Causes,” “Lightning,” and “Vegetation.” Gulf reported that the “Other Causes” category is used to track outages associated with manually opening a device to safely make repairs or safely operate downstream devices that need to be de-energized. Gulf continues to focus on eliminating breaker outages by installing additional lightning protection, installing Automatic Feeder Switches, and creating Self-Healing Networks. Gulf continues to maintain its vegetation trimming cycle on feeders to reduce tree related outages. In addition, Gulf continues to seek additional vegetation trimming easements as it upgrades/reconfigures its mainline circuits as part of the feeder hardening program.

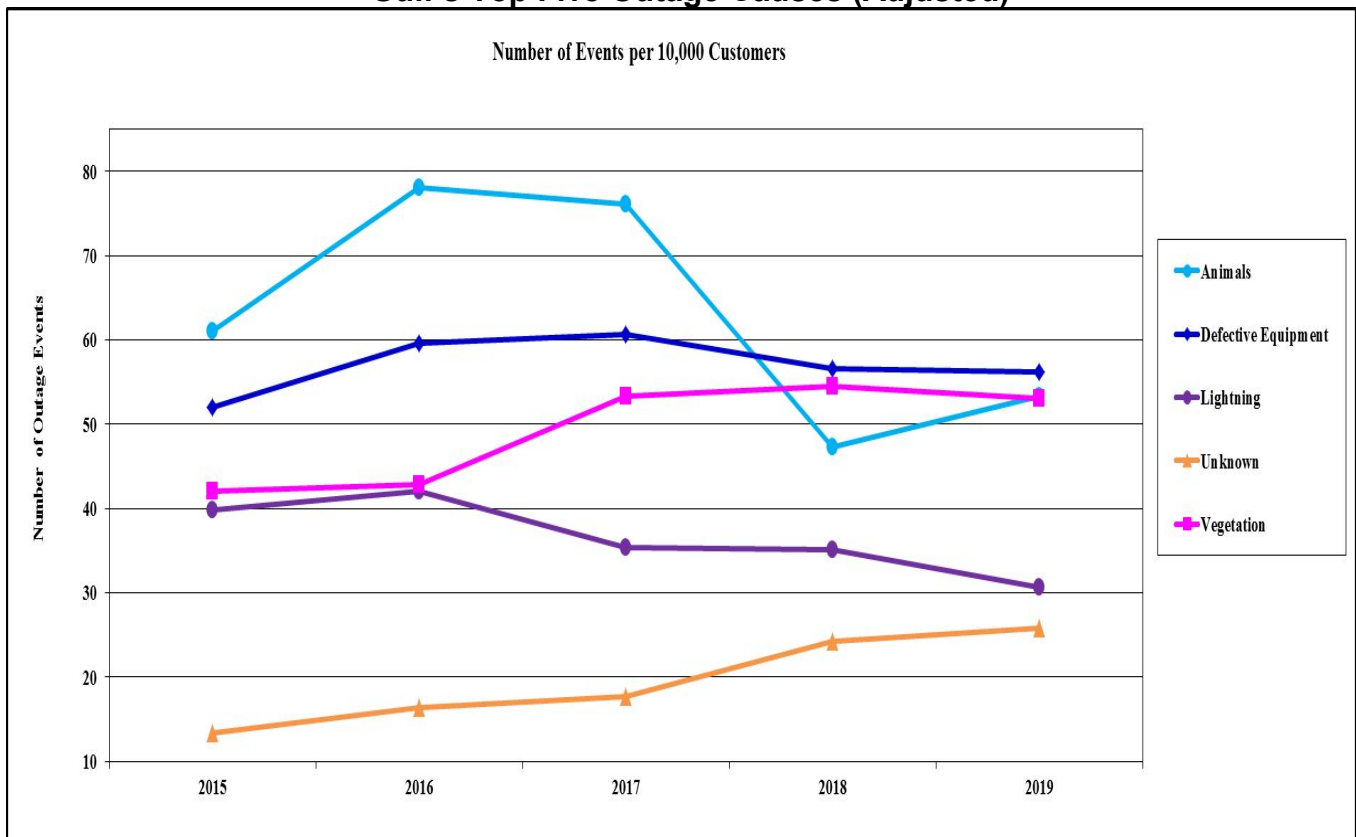
Figure 3-29
Gulf’s Top Five Outage Causes (Adjusted)

Figure 3-29 shows the top five causes of outage events on Gulf’s distribution system normalized to a 10,000-customer base. The figure is based on Gulf’s adjusted data of the top 10 causes of outage events and represents 88 percent of the total adjusted outage events that occurred during 2019. The top five causes of outage events were “Defective Equipment” (23 percent), “Vegetation” (21 percent), “Animals” (21 percent), “Lightning” (12 percent), and “Unknown Causes” (10 percent). The percentage of outages due to “Defective Equipment” was the highest cause of outages. The number of outage events due to “Defective Equipment” is trending upward and there was a 0.5 percent increase in 2019. The numbers of outage events due to “Vegetation” and “Unknown Causes” are trending upward. The number of outages due to “Animals” and “Lightning” are trending downward.

Gulf's top five causes of outages were "Defective Equipment" (23 percent), "Vegetation" (21 percent), "Animals" (21 percent), "Lightning" (12 percent), and "Unknown Causes" (10 percent). As shown in **Figure 3-29**, the number of outages decreased for "Vegetation" and "Lightning" in 2019 when compared to 2018.

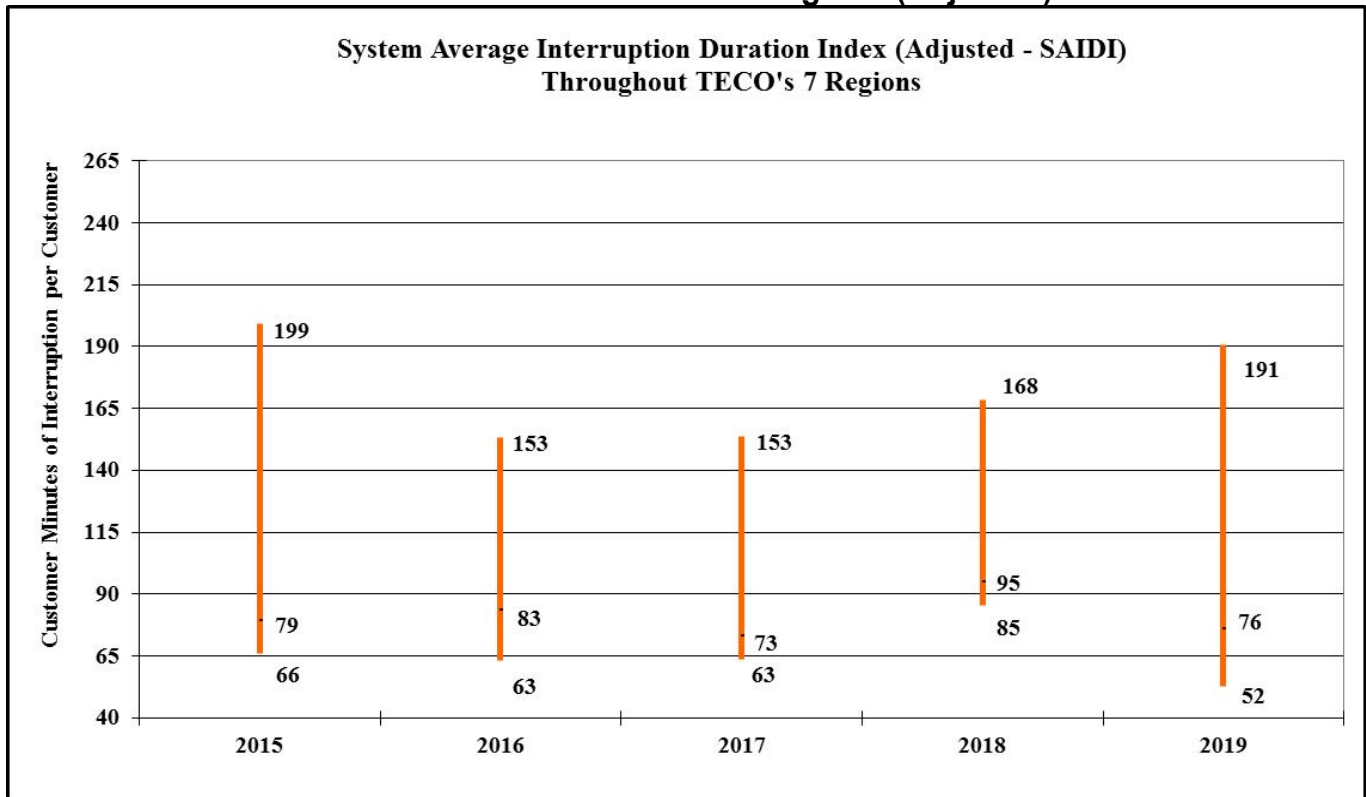
Figure 3-30
SAIDI across TECO's Seven Regions (Adjusted)

Figure 3-30 shows the adjusted SAIDI values recorded by TECO's system. Five of the seven TECO regions had improvements in SAIDI performance during 2019, with the South Hillsborough region having the lowest SAIDI performance results. The Dade City region continues to have the poorest SAIDI performance results for the five-year period of 2015 to 2019. The lowest SAIDI index for the seven regions appears to be trending downward. The average SAIDI index decreased 20 percent from 2018 to 2019. Even with the decrease, the average SAIDI index appears to be trending upward. The Central, Eastern, South Hillsborough, and Winter Haven regions recorded the lowest SAIDI indices for the five-year period. Dade City, Plant City, and South Hillsborough regions have the fewest customers and represent the most rural, lowest customer density per line-mile in comparison to the other four TECO regions.

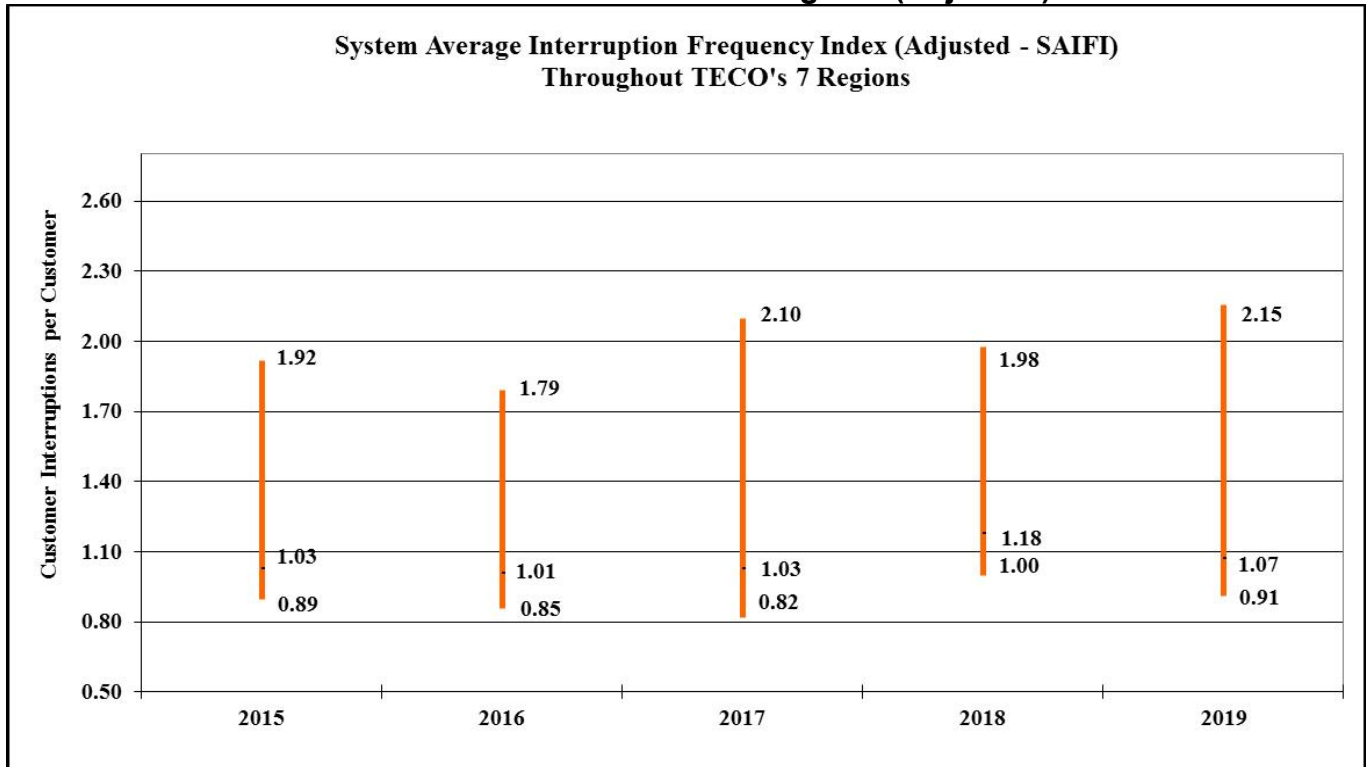
Figure 3-31
SAIFI across TECO's Seven Regions (Adjusted)

Figures 3-31 illustrates TECO's adjusted frequency of interruptions per customer reported by the system. TECO's data represent a 9 percent decrease in the SAIFI average from 1.18 interruptions in 2018 to 1.07 interruptions in 2019. TECO's Dade City region continues to have the highest frequency of service interruptions when compared to TECO's other regions. The maximum, minimum, and average SAIFI are trending upward.

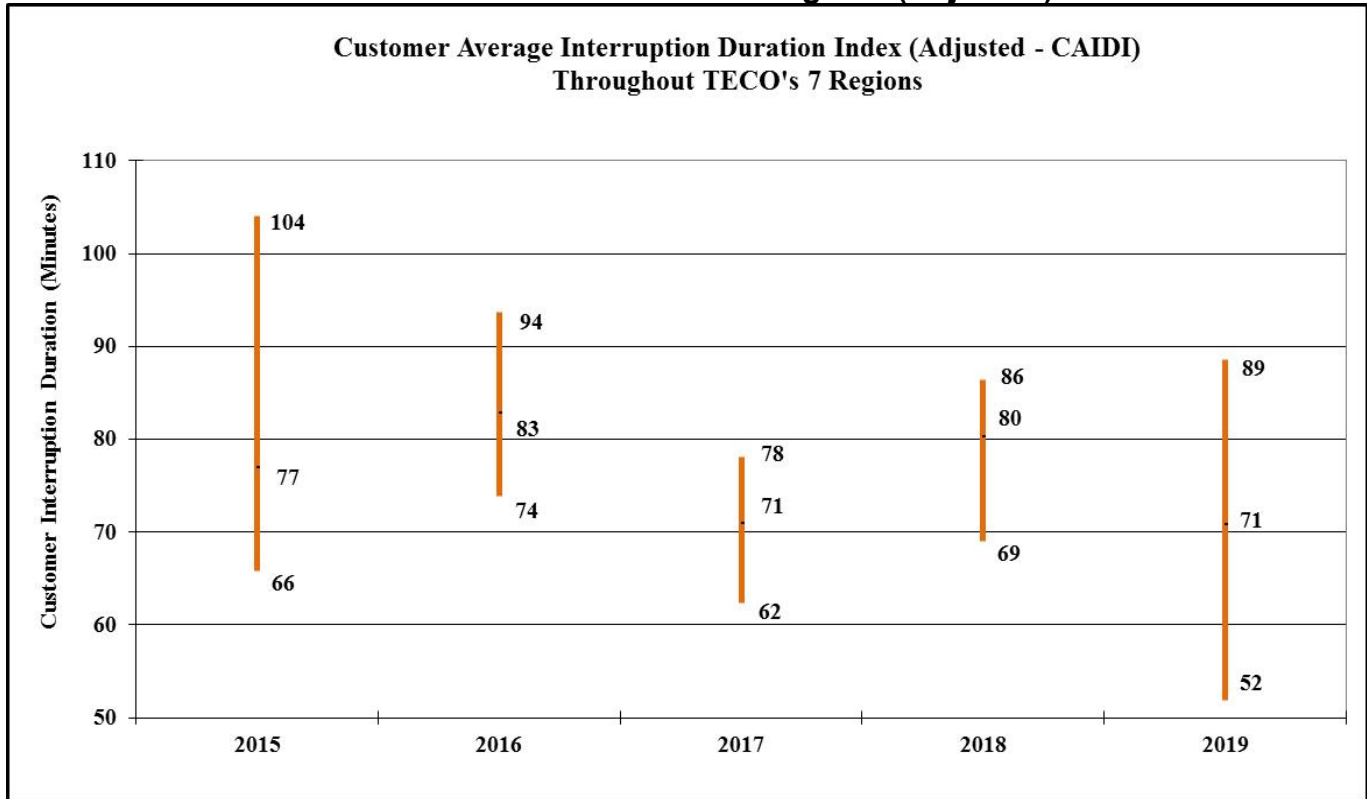
Figure 3-32
CAIDI across TECO's Seven Regions (Adjusted)

Figure 3-32 charts the length of time that a typical TECO customer experiences an outage, which is known as CAIDI. The highest CAIDI minutes appear to be confined to the Dade City, Plant City, and Western regions. Winter Haven, Central, and South Hillsborough regions have had the lowest (best) results for the last five years. The average CAIDI is trending downward at this time suggesting TECO's customers are experiencing shorter outages, with the 11 percent decrease in the average CAIDI when comparing 2018 to 2019.

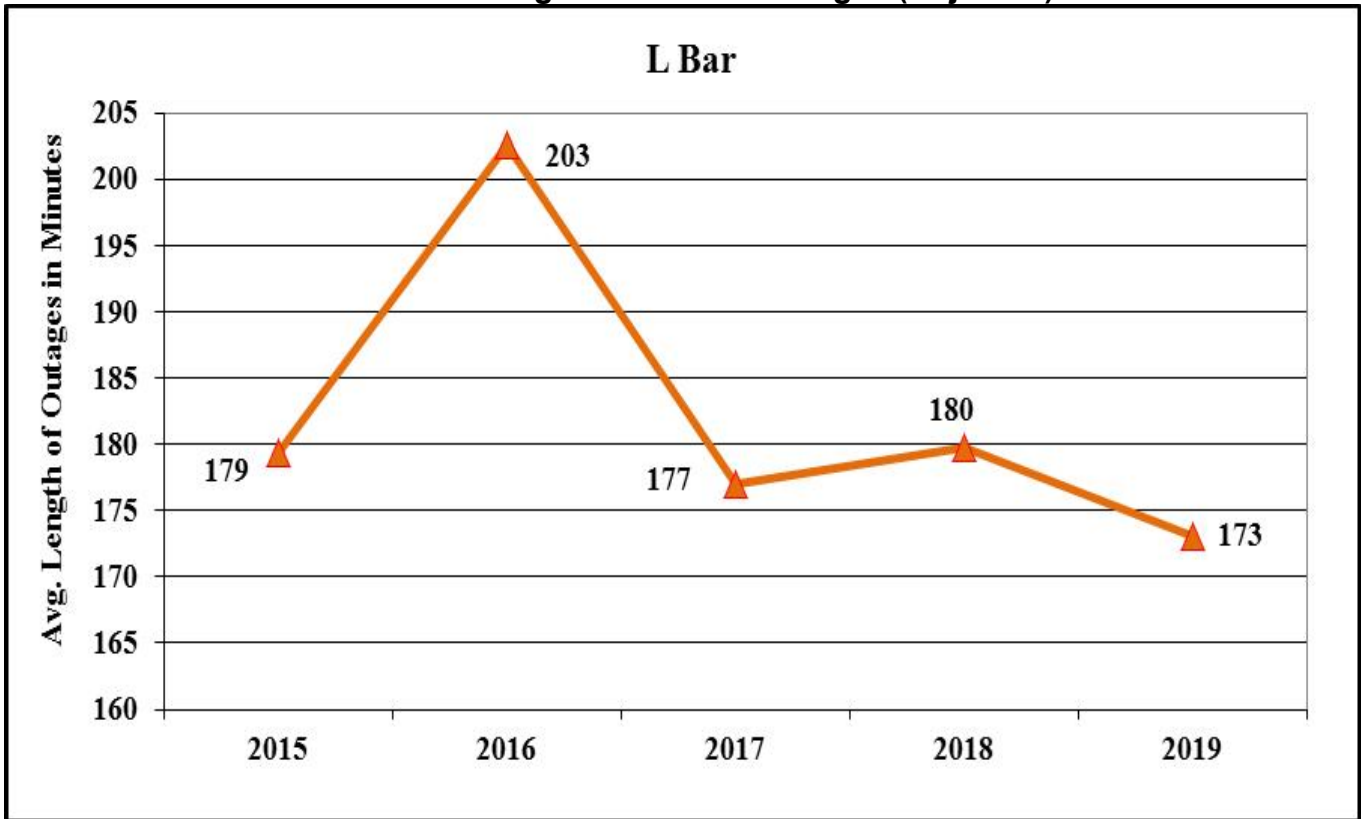
Figure 3-33
TECO's Average Duration of Outages (Adjusted)

Figure 3-33 denotes a 3.9 percent decrease in outage durations for the period from 2018 to 2019 for TECO. The average length of time TECO spends restoring service to its customers affected by outage events, excluding hurricanes and other allowable excluded outage events is shown in the L-Bar index. The L-Bar index appears to trend downward for the five-year period of 2015 to 2019, suggesting shorter restoration times.

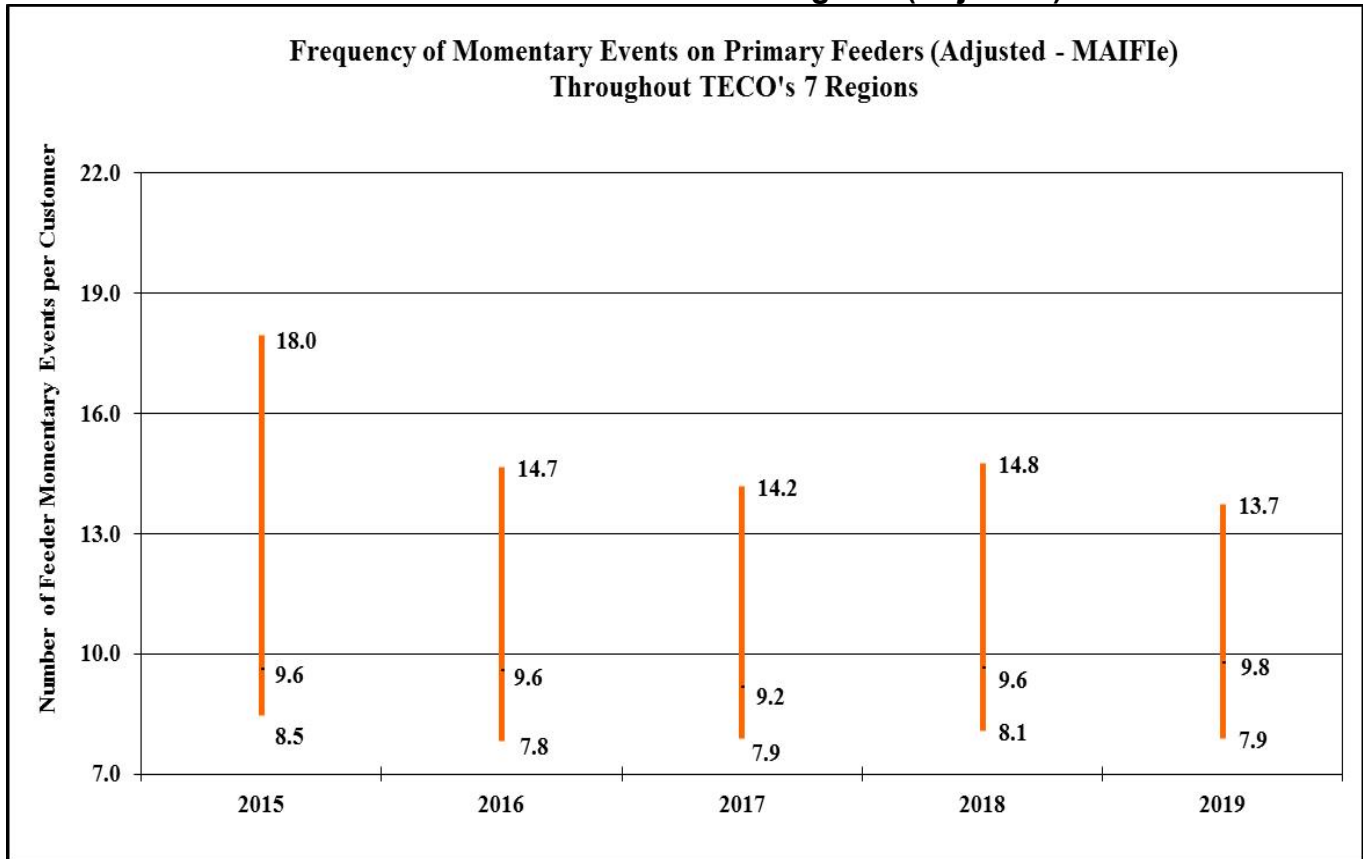
Figure 3-34
MAIFle across TECO's Seven Regions (Adjusted)

Figure 3-34 illustrates TECO's number of momentary events on primary circuits per customer recorded across its system. In 2019, the MAIFle performance improved over the 2018 results in all regions except Eastern, Western, and Winter Haven regions. The average MAIFle increased by 2 percent from 2018 to 2019. Figure 3-34 also indicates that the average MAIFle is trending upward, which suggests a decline in performance over the five-year period of 2015 to 2019.

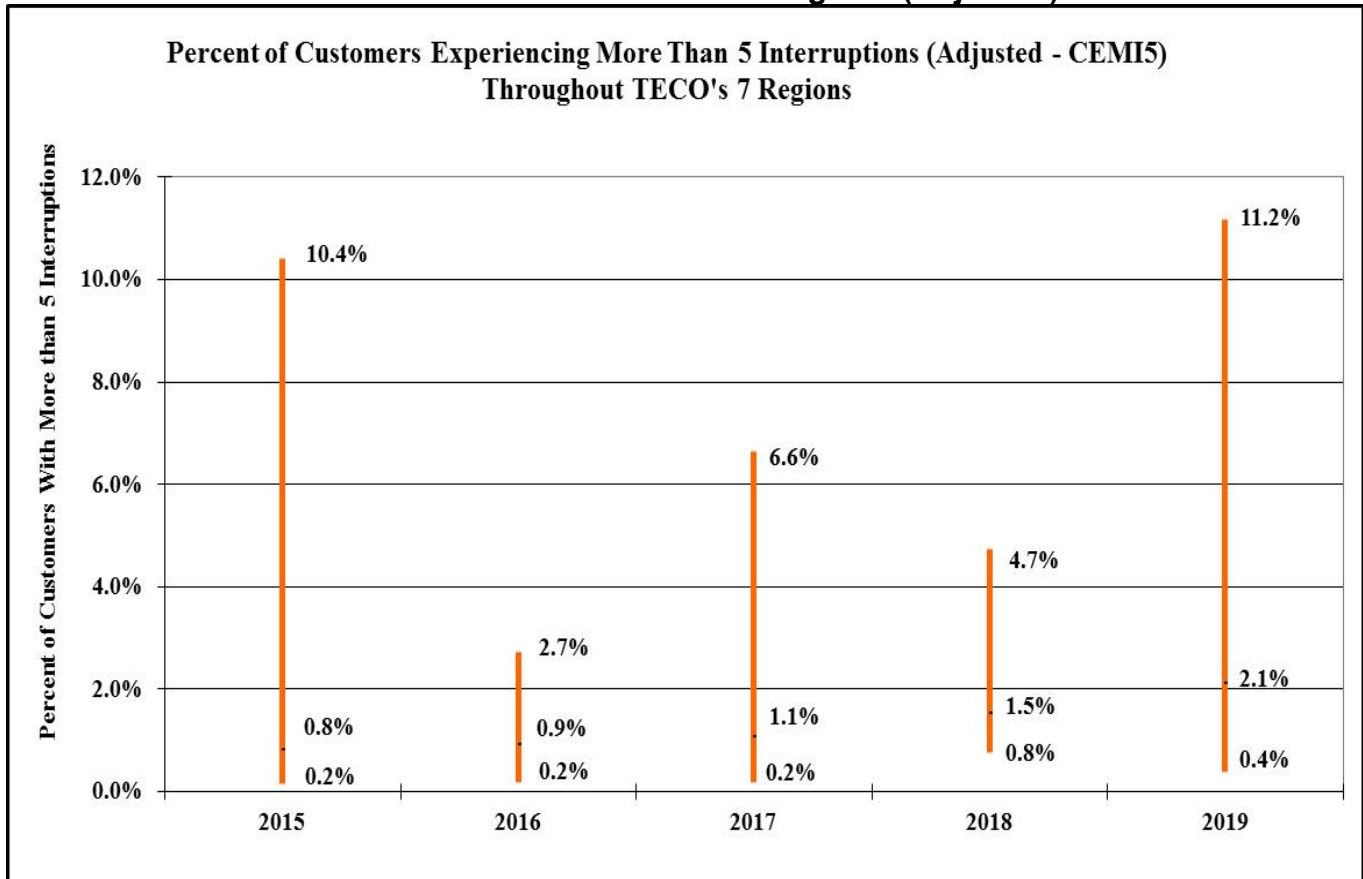
Figure 3-35
CEMI5 across TECO's Seven Regions (Adjusted)

Figure 3-35 indicates that the percent of TECO's customers experiencing more than five interruptions. Two regions in TECO's territory experienced a decrease in the CEMI5 results for 2019. The Dade City, Eastern, Plant City, South Hillsborough, and Western regions experienced an increase in the CEMI5 index. Dade City reported the highest CEMI5 percentage for 2019. With TECO's results for this index varying for the past five years, the average CEMI5 index appears to be trending upward indicating a decline in performance. There was a 40 percent increase in the average CEMI5 index from 2018 to 2019.
