*Review of
Florida's
Investor-Owned
Electric Utilities*

*2 0 1 9
Service Reliability Reports*

State of Florida
Florida Public Service Commission
Division of Engineering

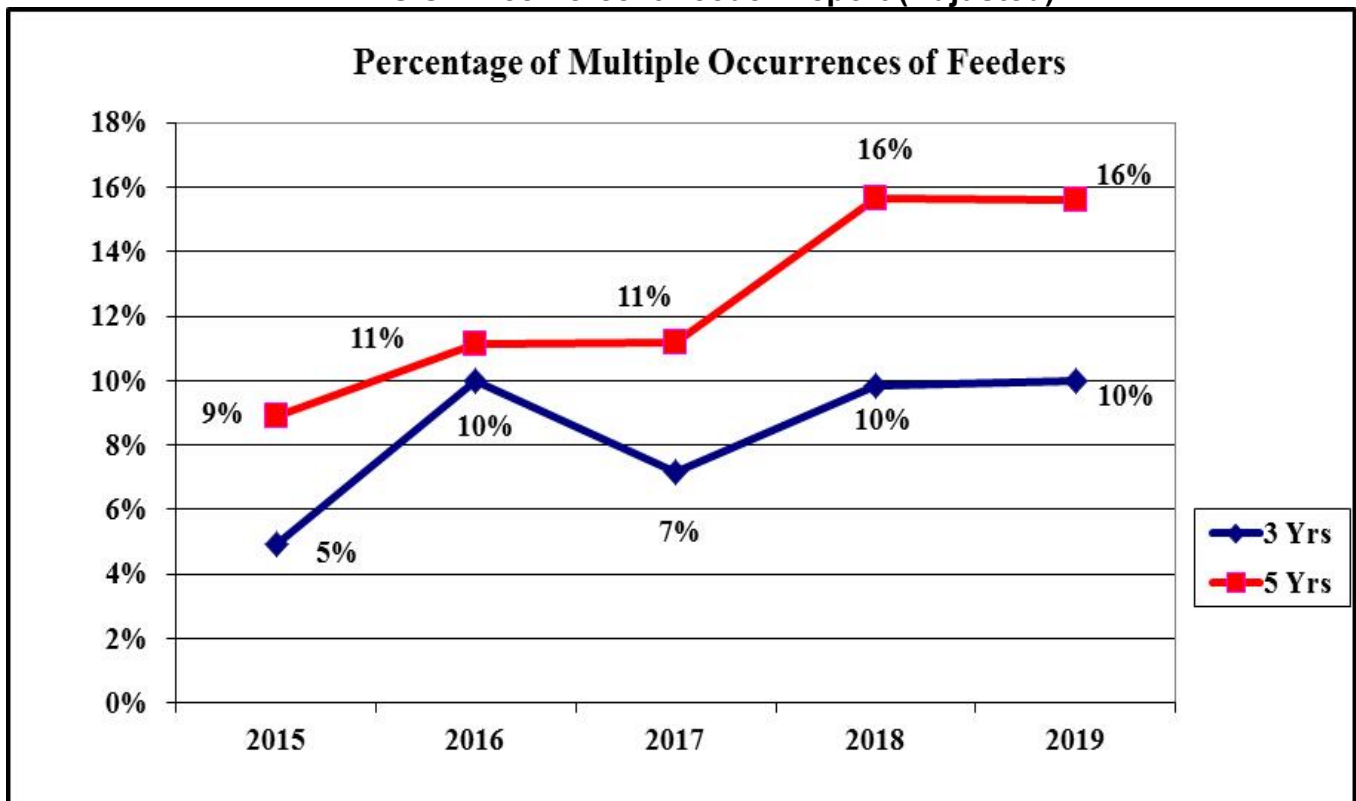
Figure 3-36
TECO's Three Percent Feeder Report (Adjusted)

Figure 3-36 represents an analysis of TECO's top 3 percent of problem feeders that have reoccurred (appeared on the Three Percent Feeder Report) on a five-year and three-year basis. The graph is developed using the number of recurrences divided by the number of feeders reported. The five-year average of outages per feeder remained the same from 2018 to 2019. The three-year average of outages also remained the same at 10 percent in 2018 and 2019. However, both the five-year average of outages per feeder and the three-year average of outages appear to continue to trend upward for the five-year period of 2015 to 2019.

Staff notes that there were three feeders on the Three Percent Feeder Report for the last two years consecutively. Eight, six, and two circuit outages were reported for these feeders in 2019. The causes for the outages varied from lightning to vehicle accidents that resulted in electrical wire/pole damage. Damaged equipment was repaired, poles were replaced, and trees and vegetation were trimmed in 2019. TECO stated that it will continue to monitor circuit outage performance as part of its daily and ongoing review of system reliability and will respond accordingly at a regional level.

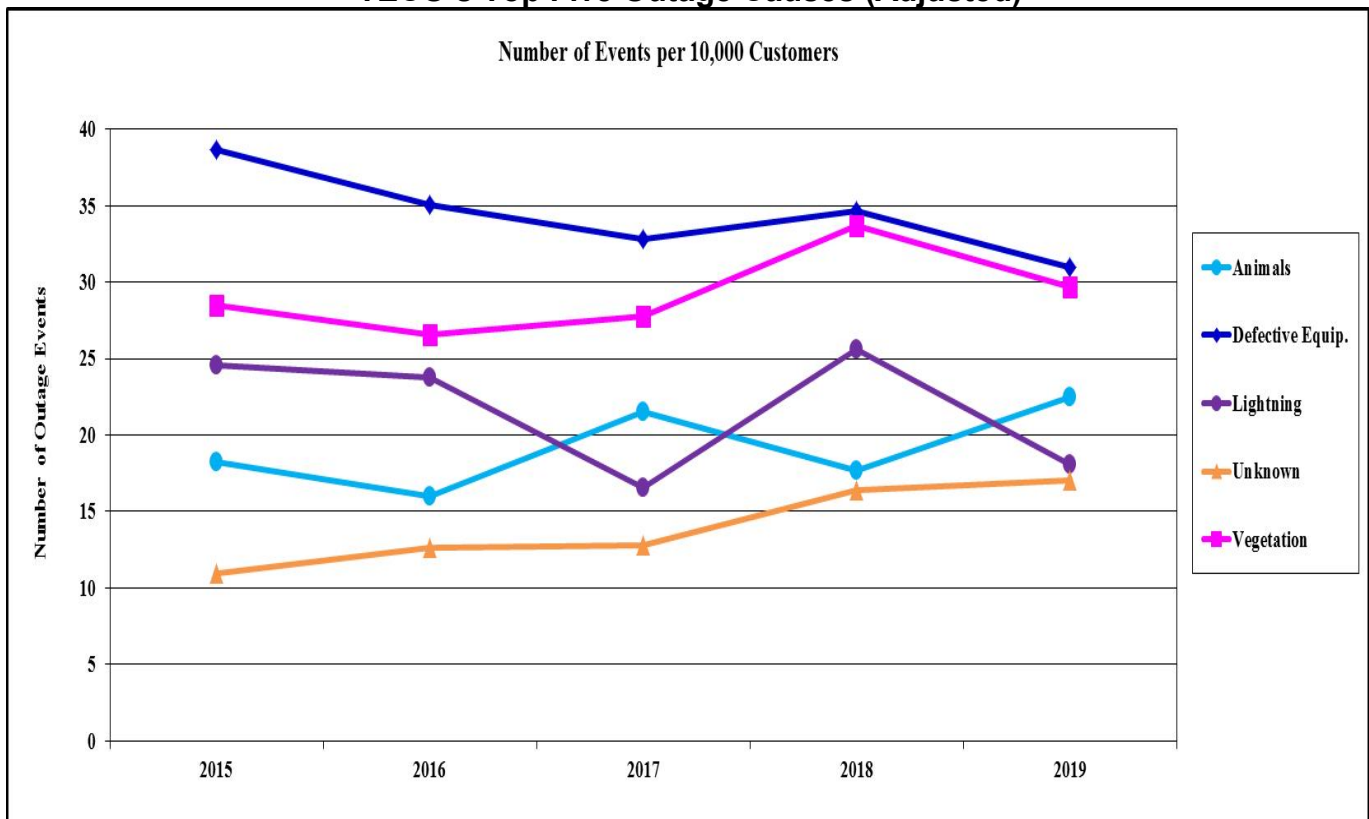
Figure 3-37
TECO’s Top Five Outage Causes (Adjusted)

Figure 3-37 indicates that the top five causes of outage events on TECO’s distribution system normalized to a 10,000-customer base. The figure is based on TECO’s adjusted data of the top 10 causes of outage events and represents 90 percent of the total outage events that occurred during 2019. For the five-year period, the five top causes of outage events included “Defective Equipment” (23 percent), “Vegetation” (22 percent), “Animals” (17 percent), “Lightning” (14 percent), and “Unknown Causes” (13 percent) on a cumulative basis. “Defective Equipment” is the highest cause of outages for 2019. “Vegetation” and “Animals” causes are the next two top problem areas for TECO. The outages due to “Animals” increased 37 percent from 2018 to 2019. The outages from “Unknown Causes” increased 13 percent for the same time period. The numbers of outages due to “Vegetation,” “Animals,” and “Unknown Causes” are trending upward while the number of outages due to “Defective Equipment” and “Lightning” are trending downward.

“Defective Equipment” (23 percent) and “Vegetation” (22 percent) were the largest contributors to TECO’s causes of outage events followed by “Animals” (17 percent), “Lightning” (14 percent), and “Unknown Causes” (13 percent). **Figure 3-37** illustrates the top five outage causes. “Defective Equipment,” the leading cause of outages, has been trending downward since 2015 and “Defective Equipment” had a 3 percent decrease in outages when compared to the previous year. “Lightning” related causes are also trending downward. “Vegetation,” “Animals,” and “Unknown Causes” related causes are trending upward.

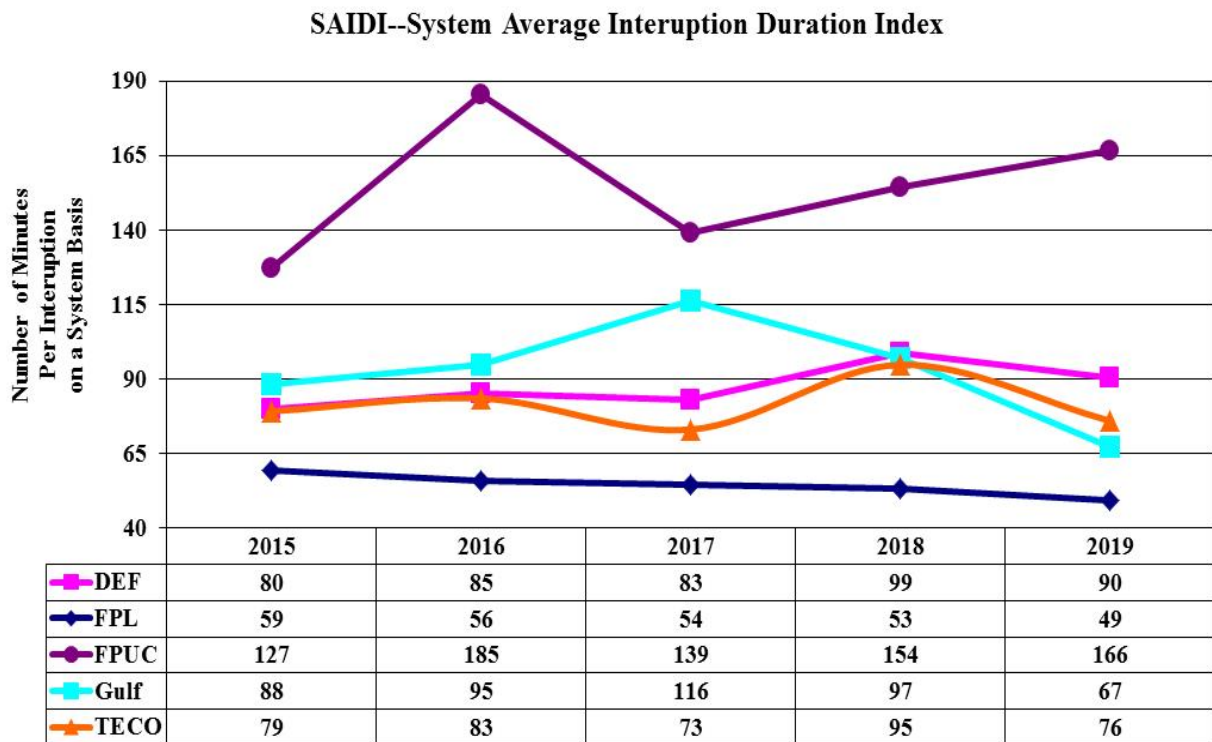
Figure 4-1
System Average Interruption Duration (Adjusted SAIDI)

Figure 4-1 indicates that DEF's, FPUC's, and TECO's SAIDI has been trending upward since 2015, while FPL and Gulf are trending downward. Comparing the 2018 and 2019 SAIDI values, all utilities have improved except for FPUC; FPUC's SAIDI value increased by 8 percent from 2018 to 2019. Gulf's SAIDI value decreased 31 percent, DEF decreased 9 percent, TECO decreased 20 percent, and FPL decreased 8 percent from 2018 to 2019.

SAIDI is the average amount of time a customer is out of service per retail customers served within a specified area of service over a given period. It is determined by dividing the total Customer Minutes of Interruption by total Number of Customers Served for the respective area of service.

The inter-utility trend comparison focuses on a graphical presentation that combines all of the IOUs' distribution reliability indices for the years 2015 to 2019. **Figures 4-1** through **4-3** apply to all five utilities while **Figures 4-4** and **4-5** do not apply to FPUC because it is not required to report MAIFle and CEMI5 due to the size of its customer base. The adjusted data is used in generating the indices in this report and is based on the exclusion of certain events allowed by Rule 25-6.0455(4), F.A.C. Generalizations can be drawn from the side-by-side comparisons; however, any generalizations should be used with caution due to the differing sizes of the distribution systems, the degree of automation, and the number of customers. The indices are unique to each IOU.

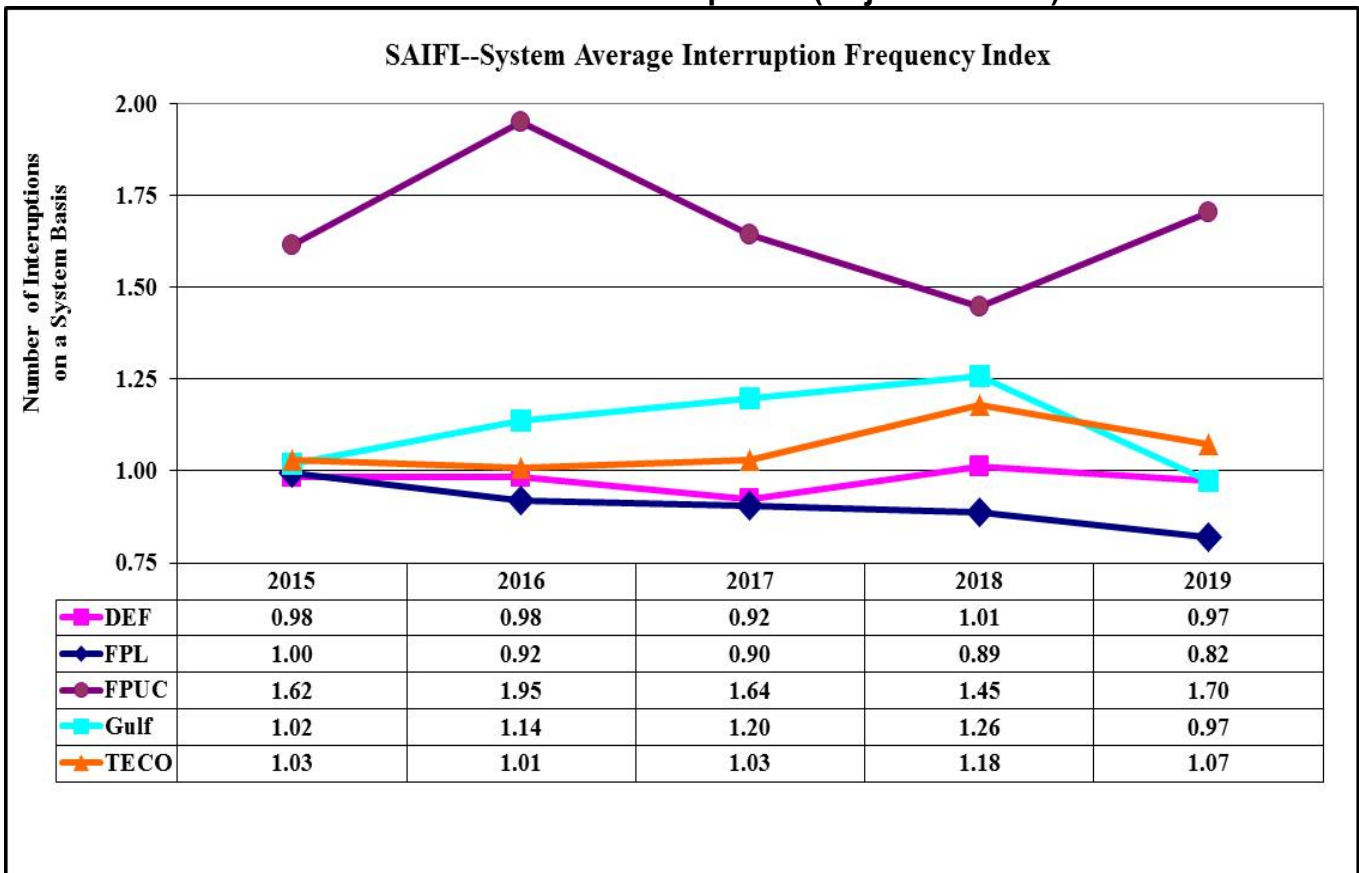
Figure 4-2
Number of Service Interruptions (Adjusted SAIFI)

Figure 4-2 shows a five-year graph of the adjusted SAIFI for each IOU. The 2019 data shows FPL, Gulf, DEF, and TECO's SAIFI values decreased (improved) from the 2018 results as FPUC's SAIFI values increased. Over the five-year period of 2015 to 2019, Gulf and TECO's SAIFI values are all trending upward as DEF's SAIFI value appears to remain relatively flat. FPL and FPUC's SAIFI value is trending downward for the period of 2015 to 2019.

SAIFI is the average number of service interruptions per retail customer within a specified area of service over a given period. It is determined by dividing the Sum of Service (a/k/a Customer) Interruptions (CI) by the total Number of Customers Served for the respective area of service.

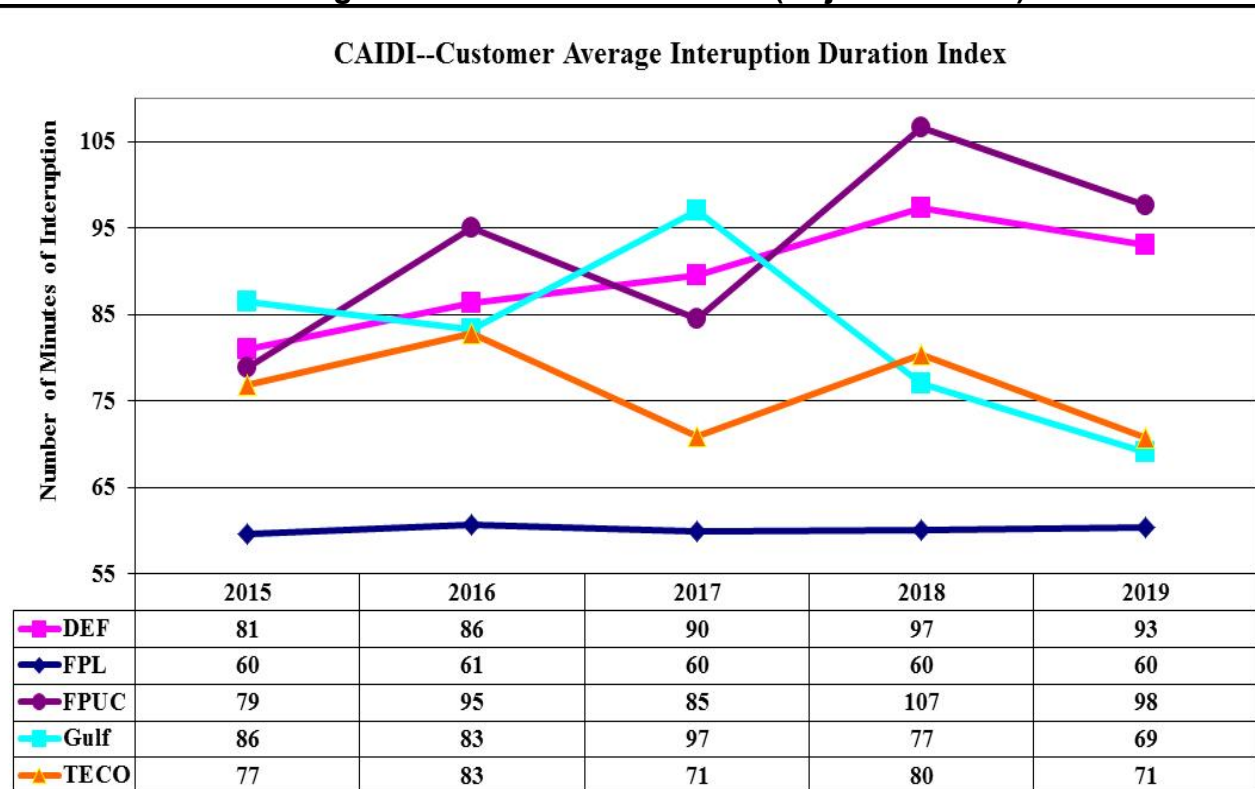
Figure 4-3
Average Service Restoration Time (Adjusted CAIDI)

Figure 4-3 shows a five-year graph of the adjusted CAIDI for each IOU. All the utilities, except FPL, had decreases in the CAIDI from 2018 to 2019. FPL's CAIDI value was the same for 2019 as it was for 2018. Gulf and TECO's CAIDI values are trending downward for the five-year period of 2015 to 2019. DEF's and FPUC's CAIDI value is trending upward for the same period. It appears that FPL remains relatively flat for the same period.

CAIDI is the average interruption duration or the time to restore service to interrupted customers. CAIDI is calculated by dividing the total system CMI by the number of customer interruptions, which is also SAIDI, divided by SAIFI.

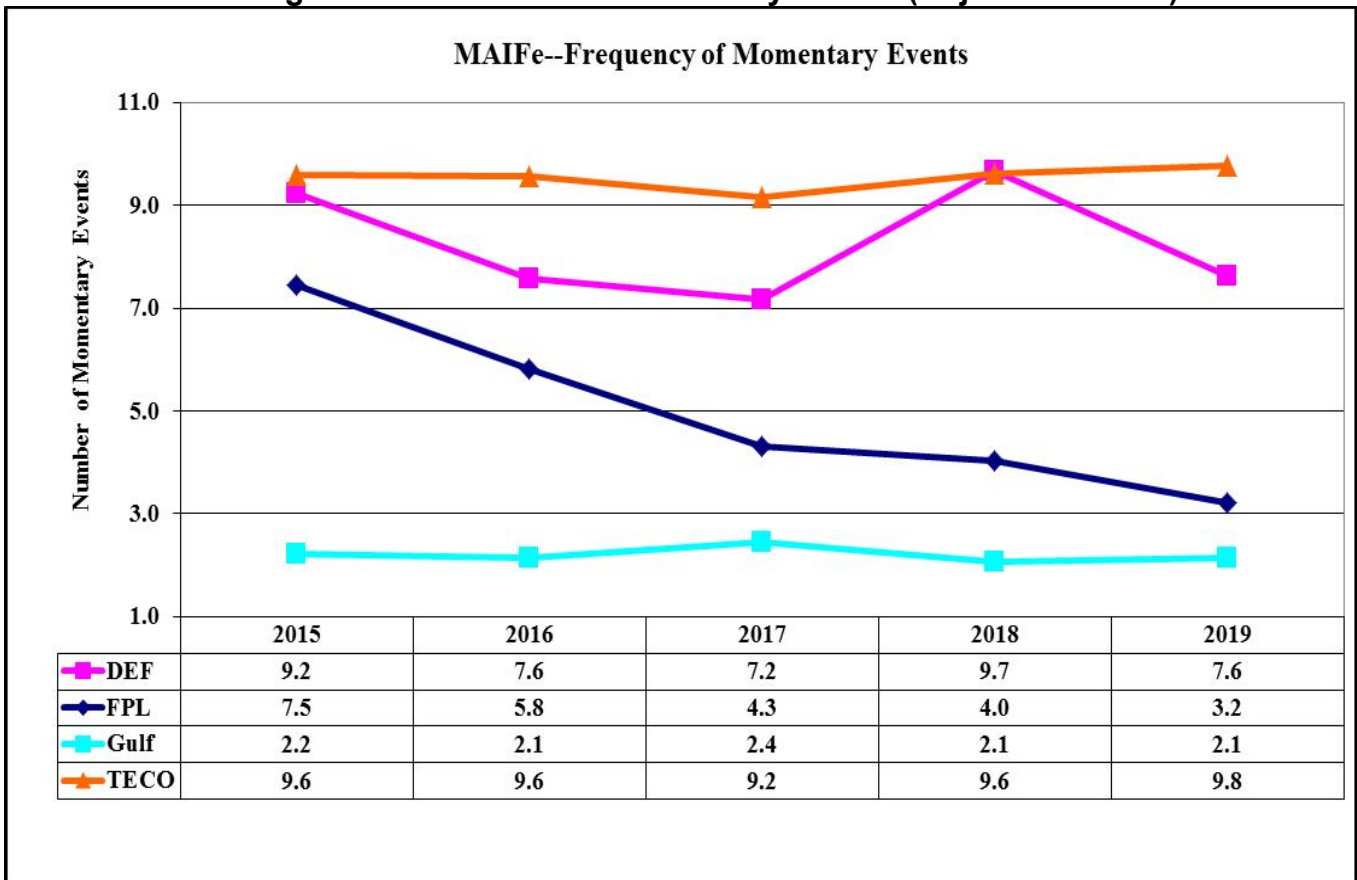
Figure 4-4
Average Number of Feeder Momentary Events (Adjusted MAIFle)

Figure 4-4 shows a five-year graph of the adjusted MAIFle for DEF, FPL, Gulf, and TECO. DEF, FPL, and Gulf's MAIFle indices are all trending downward for the five-year period of 2015 to 2019. TECO's MAIFle index is trending upward for the five-year period. Comparing the MAIFle for 2018 to 2019, DEF decreased by 22 percent, FPL decreased by 20 percent, Gulf had no change and TECO increased by 40 percent. FPUC is exempt from reporting MAIFle and CEMI5 because it has fewer than 50,000 customers.

MAIFle is the average frequency of momentary interruptions events or the number of times there is a loss of service of less than one minute. MAIFle is calculated by dividing the number of momentary interruptions events recorded on primary circuits (CME) by the number of customers served.

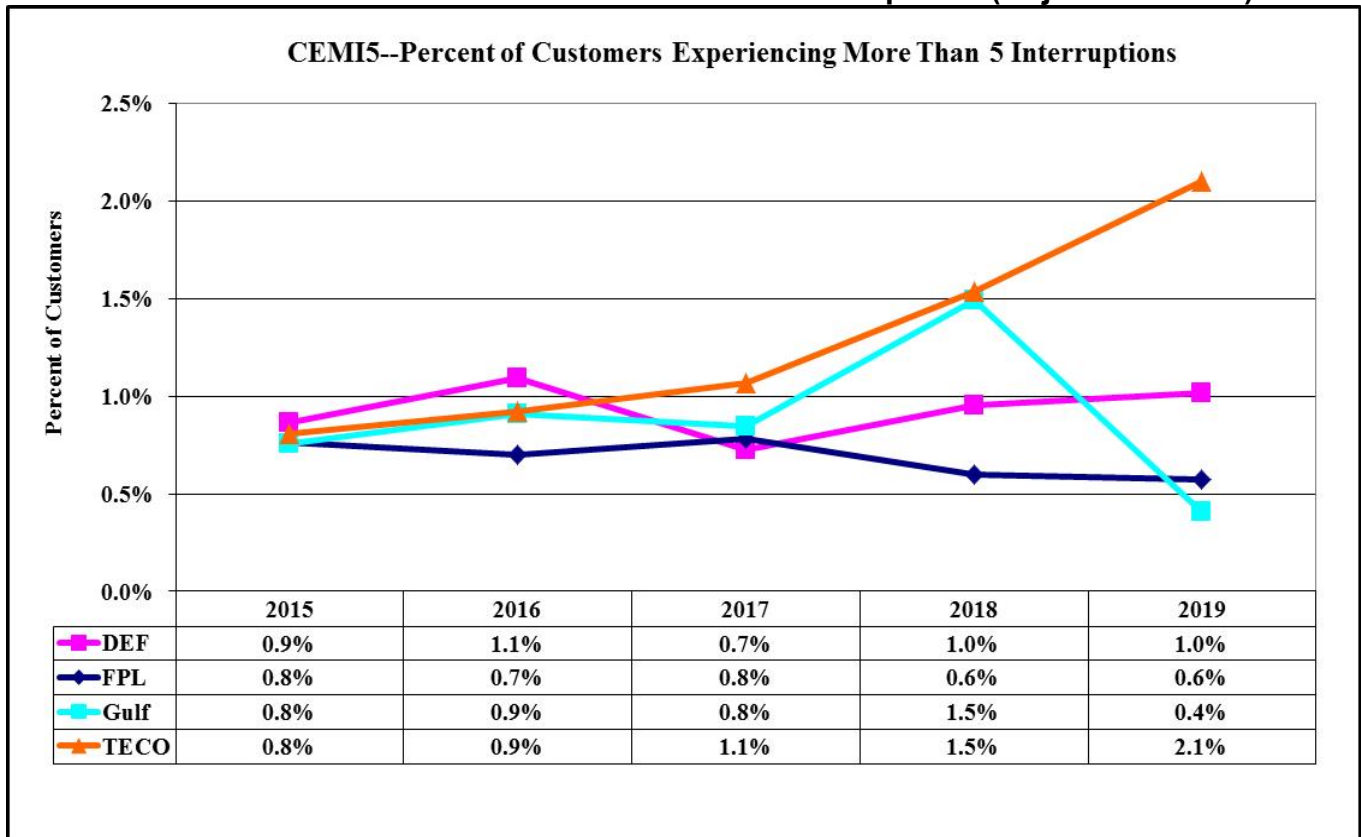
Figure 4-5
Percent of Customers with More Than Five Interruptions (Adjusted CEMI5)

Figure 4-5 shows a five-year graph of the adjusted CEMI5 for FPL, Gulf, DEF, and TECO. CEMI5 is a percentage. It represents the number of customers that experienced more than five service interruptions in the year divided by the total number of customers. In 2019, TECO's CEMI5 percent increased to 2.1 percent from 1.5 percent in 2018 as Gulf's CEMI5 percentage decreased from 1.5 percent in 2018 to 0.4 percent in 2019. DEF and FPL had no change in their CEMI5 percentages between 2018 and 2019. FPL is trending downward as DEF and TECO are trending upward for the period of 2015 to 2019. For the period of 2015 to 2019, Gulf's CEMI5 percentage trended upward, but sharply declined between 2018 and 2019.

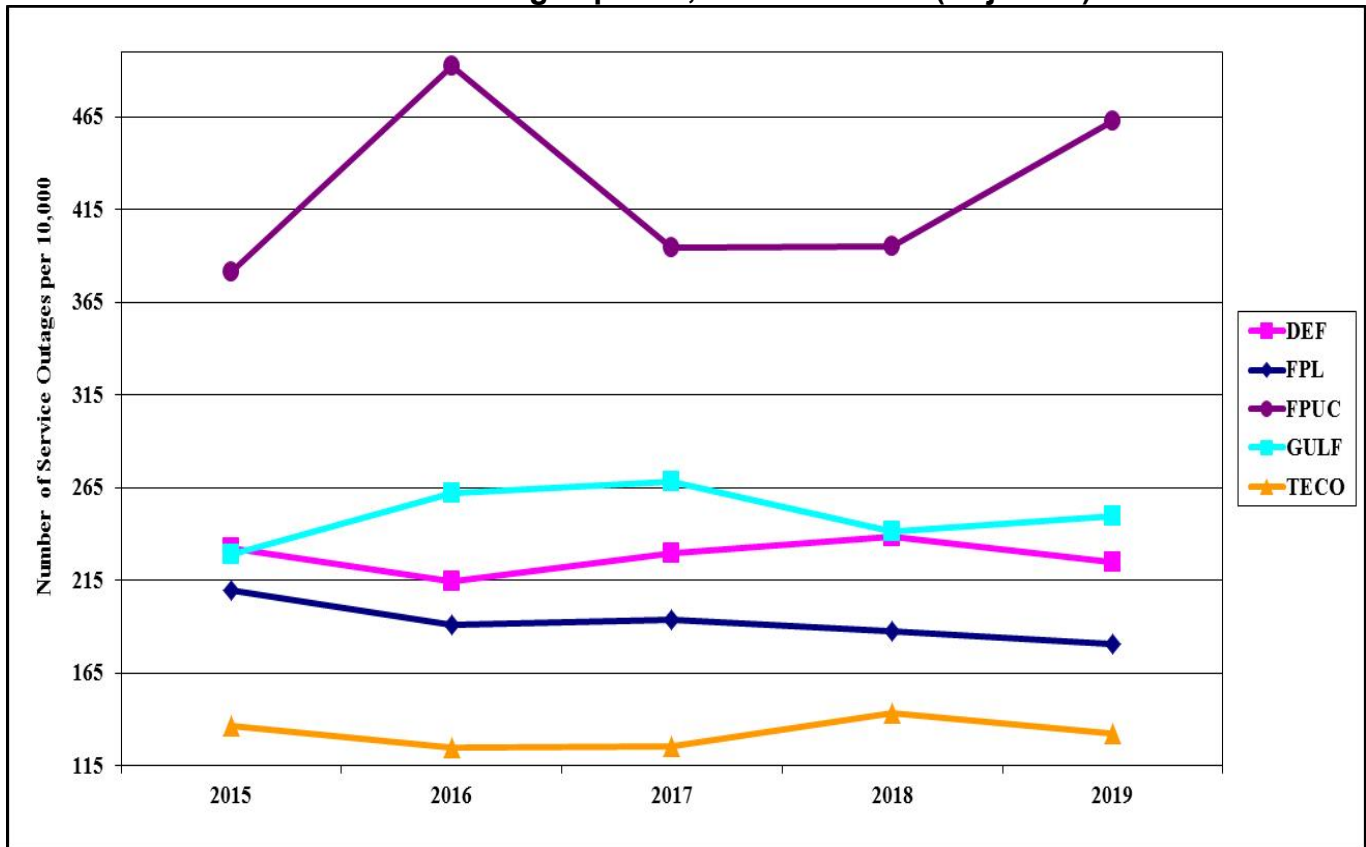
Figure 4-6
Number of Outages per 10,000 Customers (Adjusted)

Figure 4-6 shows the number of outages per 10,000 customers on an adjusted basis for the five IOUs over the last five years. The graph displays each utility's adjusted data concerning the number of outage events and the total number of customers on an annual basis. The number of FPL outages decreased from 93,306 in 2018 to 91,979 in 2019, and the number of outages per 10,000 customers is trending downward for the five-year period. TECO's results are trending upward for the five-year period. DEF's number of outages decreased for 2019 and the results are relatively flat for the five-year period. Gulf's number of outages increased for 2019, and is trending upward for the five-year period. FPUC's results increased for 2015 to 2016, decreased for 2016 to 2017, decreased for 2017 to 2018 and increased for 2018 to 2019. Due to its small customer base, FPUC's number of outages per 10,000 customers may be more volatile.

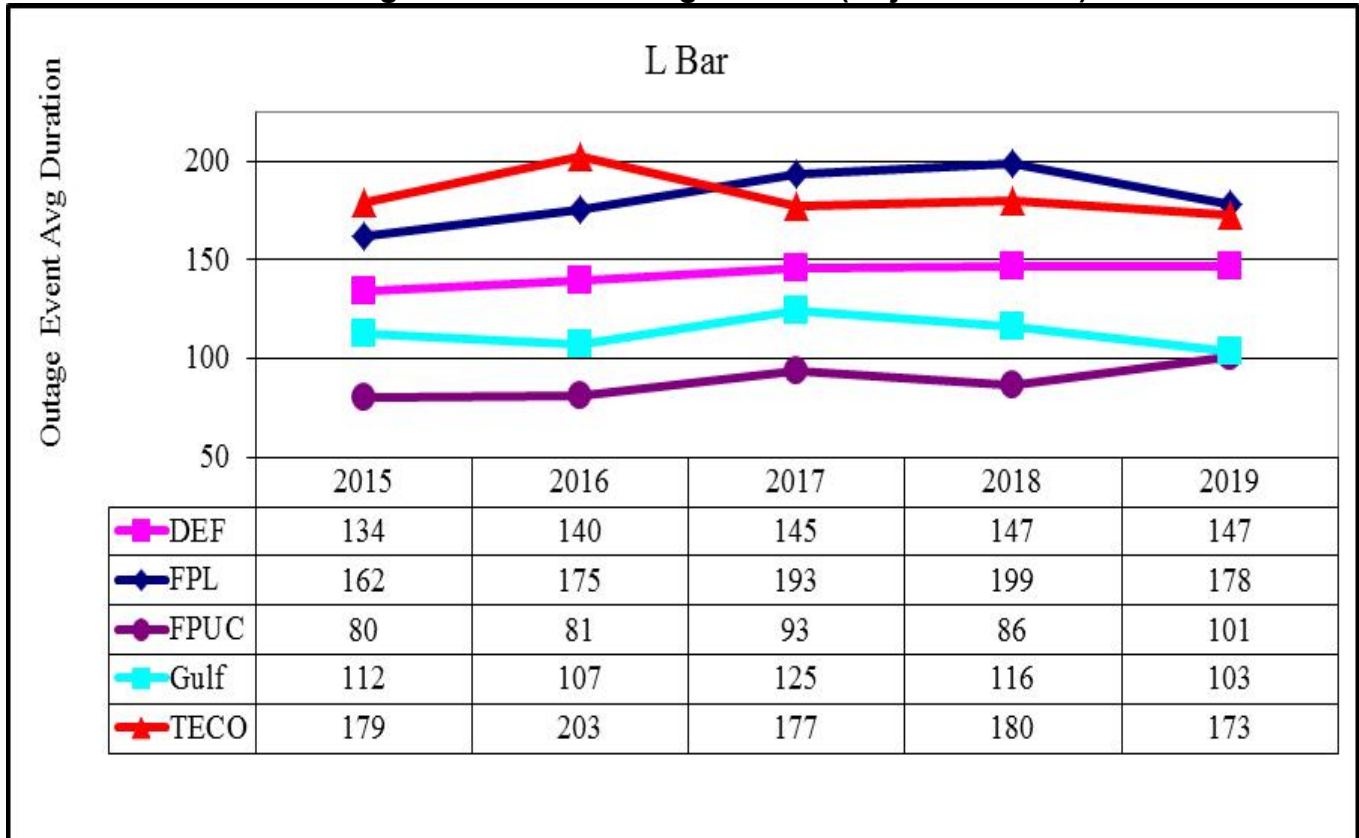
Figure 4-7
Average Duration of Outage Events (Adjusted L-Bar)

Figure 4-7 represents the average duration of outage events (Adjusted L-Bar) for each IOU. From the data shown, it appears that the utilities have been consistent with their restoral times for the five-year period of 2015 to 2019, even with increases from 2018 to 2019.

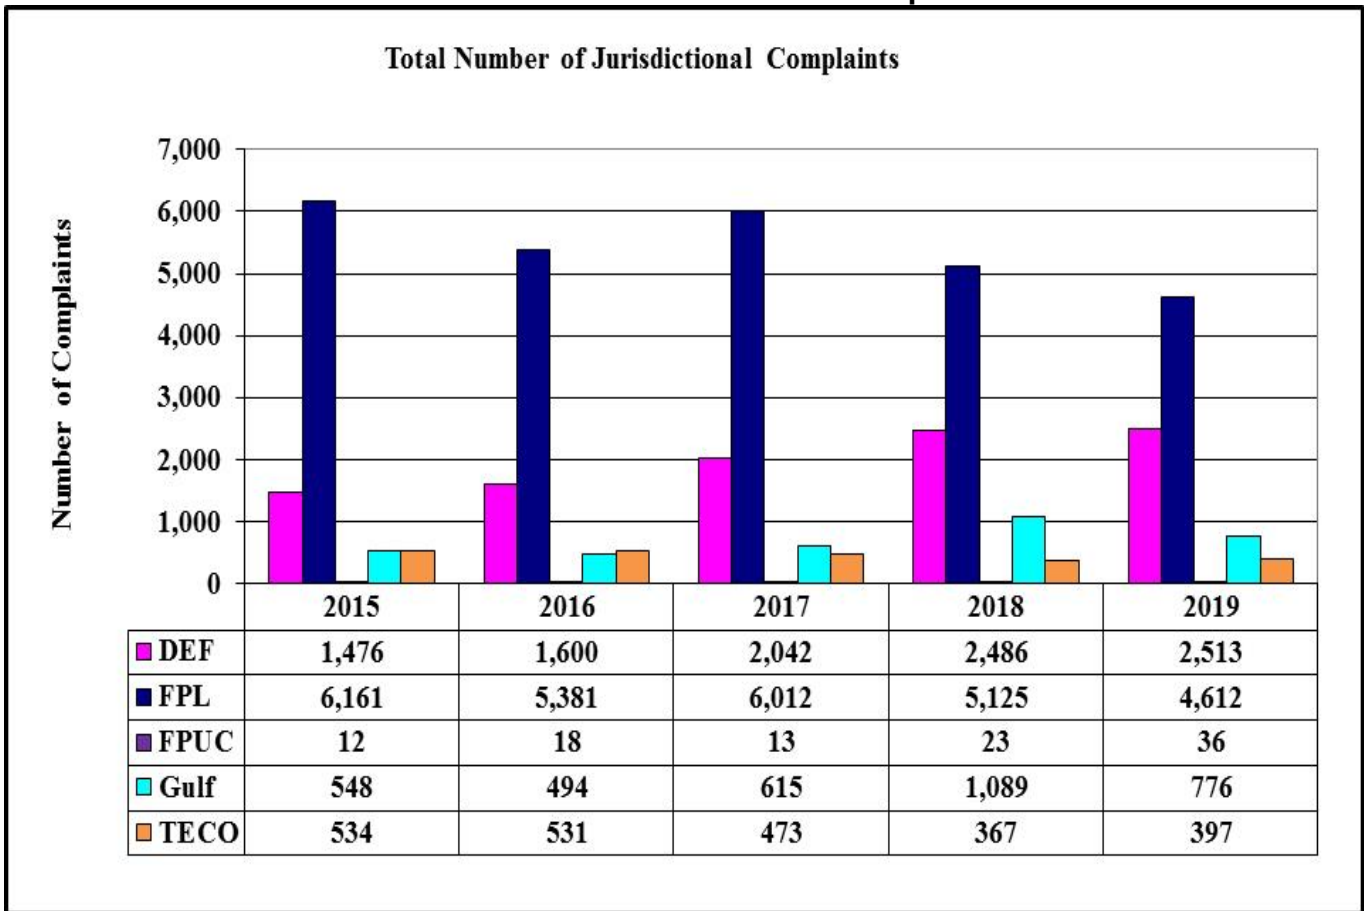
Figure 4-8
Total Number of Jurisdictional Complaints

Figure 4-8 shows the total number of jurisdictional complaints¹⁶ for each IOU. In comparing the number of complaints by the different companies, the total number of customers should be considered. FPL has the higher number of complaints, but FPL also has more customers than the other companies.

Figures 4-8, 4-9, 4-10, and 4-11 represent consumer complaint data that was extracted from the Commission’s Consumer Activity Tracking System (CATS). Each consumer complaint received by the Commission is assigned a code after the complaint is resolved. Reliability related complaints have 10 specific category types and typically pertain to “Trees,” “Safety,” “Repairs,” “Frequent Outages,” and “Momentary Service Interruptions.”

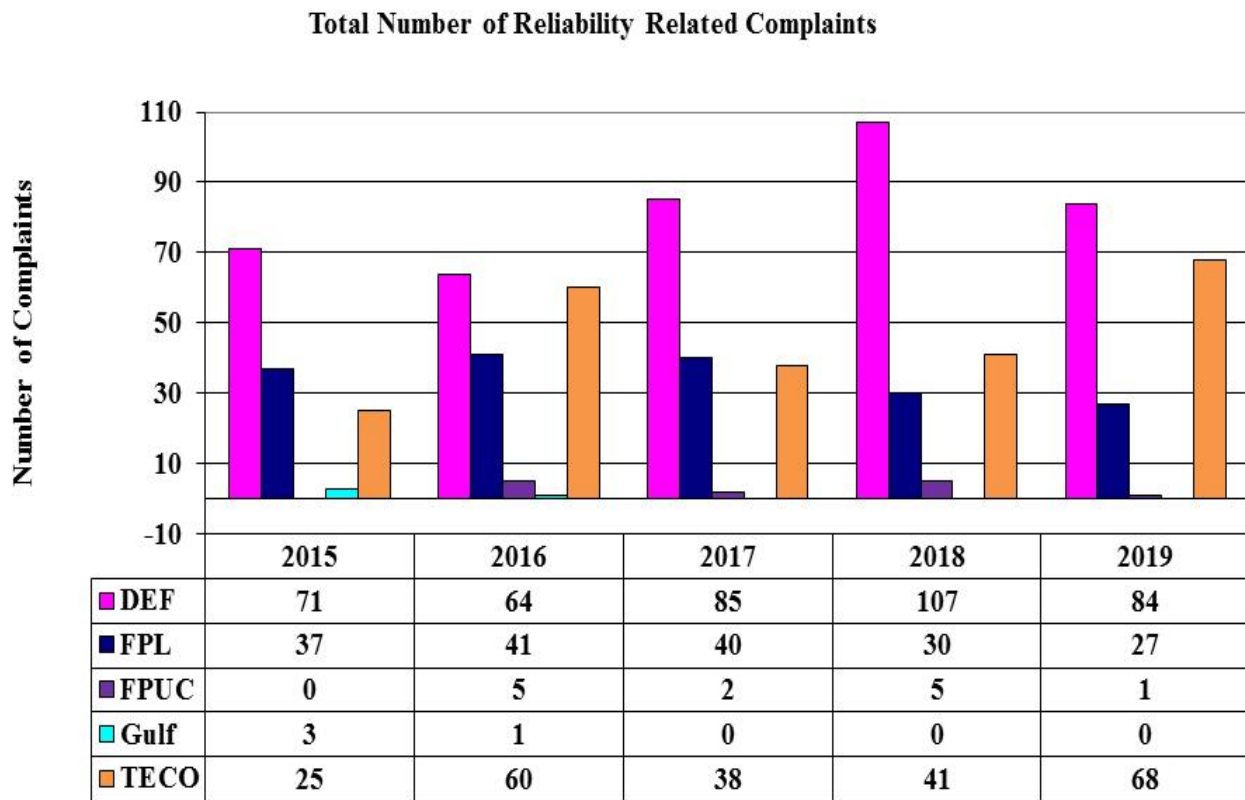
Figure 4-9
Total Number of Reliability Related Complaints

Figure 4-9 charts the total number of reliability related complaints for the IOUs. DEF is showing the largest amount of reliability complaints for the five-year period of 2015 to 2019 with FPUC and Gulf showing the least amount. FPL, FPUC, and Gulf are trending downward in the number of reliability complaints, while DEF and TECO are trending upward.

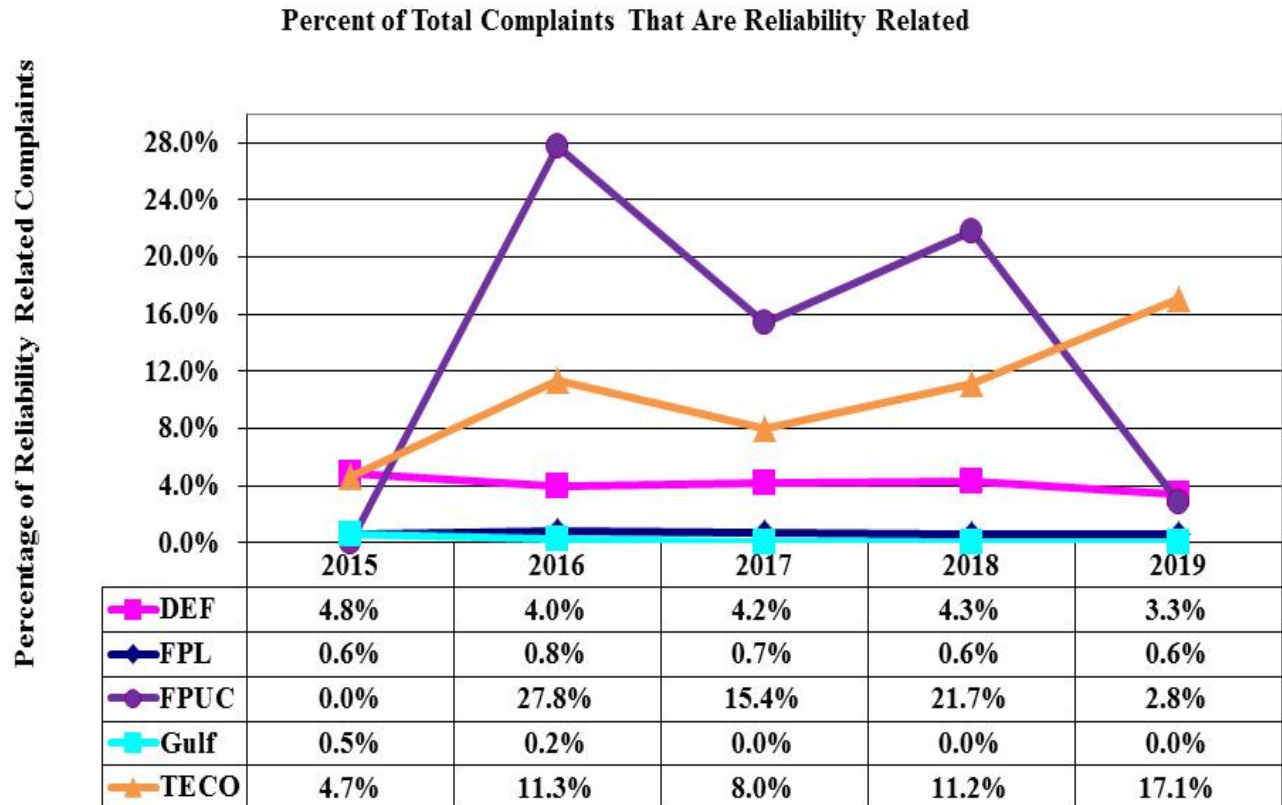
Figure 4-10
Percent of Complaints that are Reliability Related

Figure 4-10 shows the percentage of reliability related customer complaints in relation to the total number of complaints for each IOU. DEF, FPL and Gulf appear to be trending downward as FPUC and TECO are trending upward. The percentages of FPUC complaints compared to the other companies appears high, however FPUC has fewer customers and fewer complaints in total.

Complaints related to FPL’s reliability did not change from 2018 to 2019, and stayed at 0.6 percent. FPL’s reliability related complaints appear to be trending downward as shown in **Figure 4-10**.

There were no complaints reported to the Commission against Gulf that were reliability related in 2019. Gulf's percentage of total complaints for the five-year period of 2015 to 2019 has remained relatively flat. Overall, as shown in **Figure 4-10**, Gulf has the lowest percentage of total complaints related to reliability.

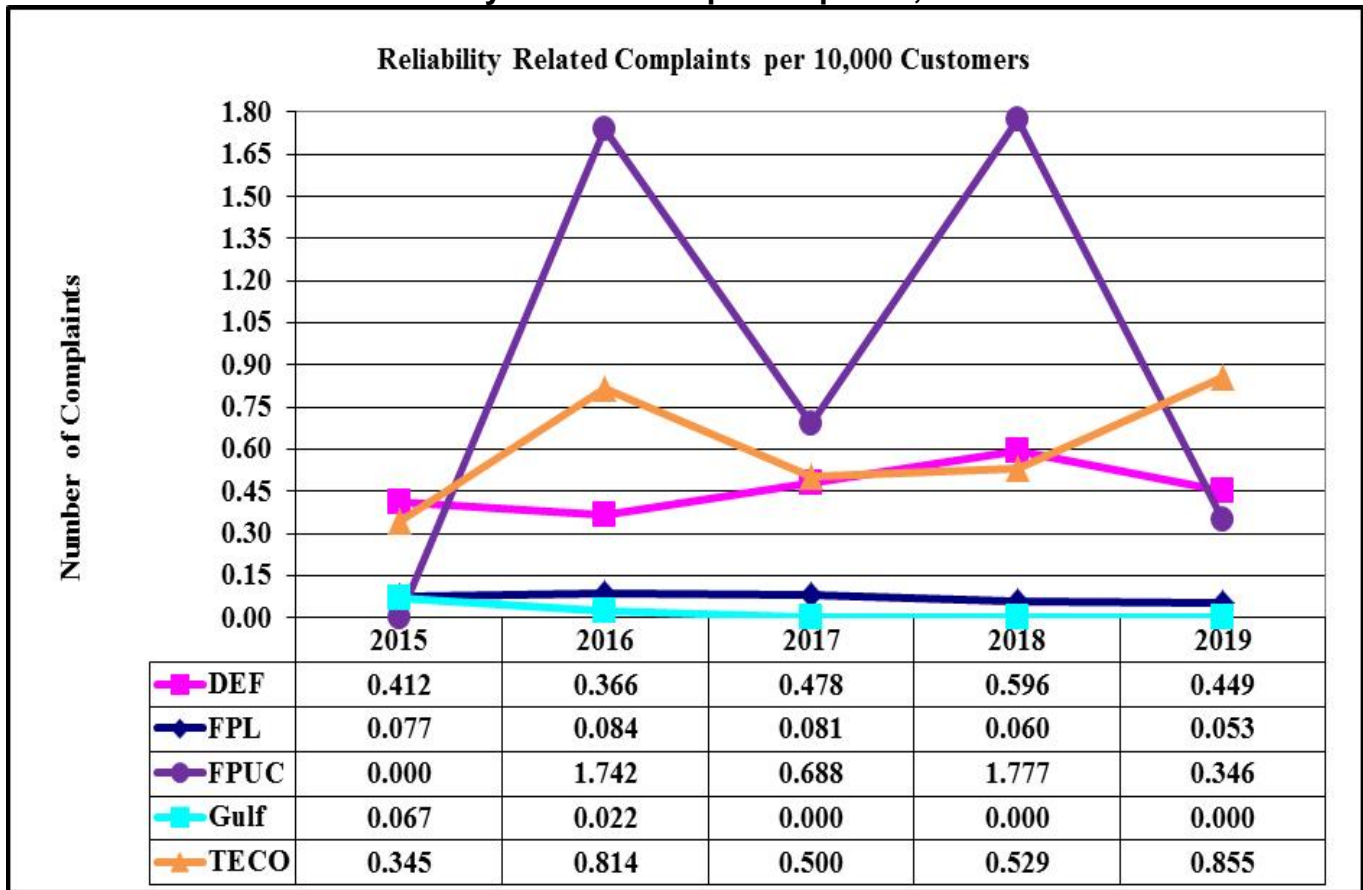
Figure 4-11
Service Reliability Related Complaints per 10,000 Customers

Figure 4-11 charts the volume of reliability related complaints per 10,000 customers for the IOUs. The volume of service reliability complaints is normalized to a 10,000-customer base for comparative purposes. This is calculated for each IOU by dividing the total number of reliability complaints reported to the Commission by the total number of the utility's customers. This fraction is then multiplied by 10,000 for graphing purposes.

All the IOUs have less than one reliability complaint per 10,000 customers since 2015 except FPUC. For the five-year period, Gulf and FPL remain relatively flat. DEF, FPUC, and TECO are trending upward for the five-year period. The volatility of FPUC's results can be attributed to its small customer base, which typically averages 28,500 customers.
