*Review of
Florida's
Investor-Owned
Electric Utilities*

Service Reliability Reports

State of Florida
Florida Public Service Commission
Division of Engineering

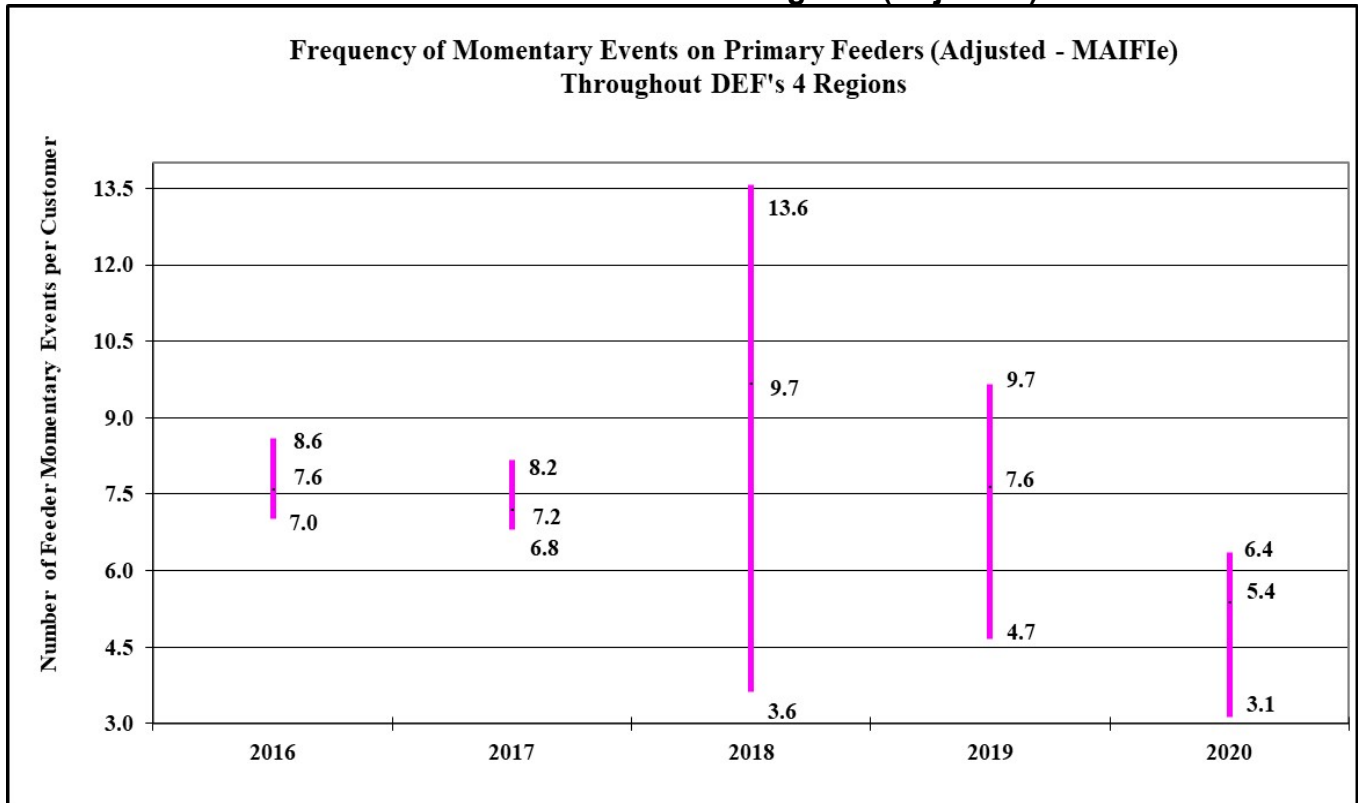
Figure 2-5
MAIFle across DEF's Four Regions (Adjusted)

Figure 2-5 illustrates the frequency of momentary events on primary circuits for DEF's customers recorded across its system. These momentary events often affect a small group of customers. A review of the supporting data suggests that the MAIFle results between 2016 and 2020 appear to be trending downward showing improvement and there was a decrease in the average MAIFle of 29 percent from 2019 to 2020. All four regions appear to fluctuate between having the best (lowest) results to having the worst (highest) results. From 2019 to 2020, both the lowest and highest MAIFle decreased by 34 percent.

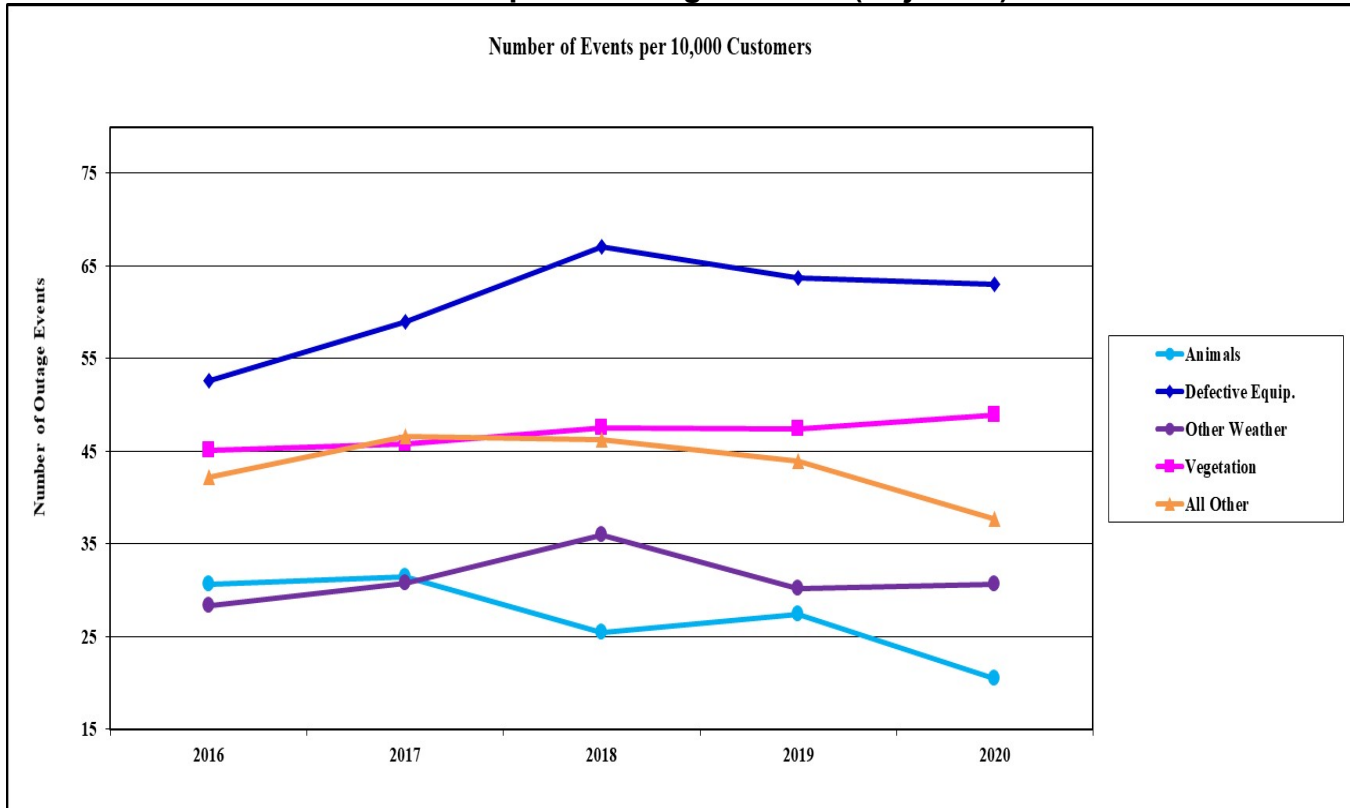
Figure 2-8
DEF's Top Five Outage Causes (Adjusted)

Figure 2-8 shows the top five causes of outage events on DEF's distribution system normalized to a 10,000-customer base. The figure is based on DEF's adjusted data and represents approximately 95 percent of the top 10 causes of outage events that occurred during 2020. For the five-year period, the top five causes of outage events were "Defective Equipment" (30 percent), "Vegetation" (23 percent), "Other Causes" (18 percent), "Other Weather" (15 percent), and "Animals" (10 percent) on a cumulative basis. The outage events caused by "Other Causes," and "Animals" are trending downward. The "Other Causes" category had a 13 percent decrease and "Animals" category had a 24 percent decrease in 2020. DEF reported that it prioritizes the reliability improvements action plan by balancing historical and current year performance. In addition, current year performance is monitored monthly to identify emergent and seasonal issues including load balancing for cold weather and the need for foot patrols of devices experiencing multiple interruptions.

DEF will continue several programs that help mitigate outages. The Self-Optimizing Grid Team program will help reduce the impact of all types of outages. The Targeted Underground program will reduce the impact of "Vegetation," "Other Weather," and "Animals" related outages. The Transformer Retrofit Program will reduce the risk of "Defective Equipment" and "Animals" related outages. The Deteriorated Conductor Program will help mitigate the outages caused by "Defective Equipment," "Vegetation," "Animals," and "Other Weather." In addition, DEF is also implementing its Fuse Replacement Program, which will reduce the impact from "Other Weather," "Vegetation," and "Animals" related outages. To help mitigate outages from "Defective Equipment," DEF explained that it will continue to invest in proactive system maintenance activities; such as, pole replacements, pad-mounted transformer replacements, and underground cable replacements.

In Figure 2-8, DEF’s Top Five Outage Categories, the category “Defective Equipment” is in the top spot representing 30 percent of the total number of outages. The subsequent categories were “Vegetation” (23 percent) and “Other Causes” (18 percent), followed by “Other Weather” (15 percent) and “Animals” (10 percent). The “Animals” and “Other Causes” outage categories are trending downward for the five-year period of 2016 to 2020 as the “Animals” category had a 24 percent decrease in 2020 and the “Other Causes” category had an 13 percent decrease. The “Defective Equipment” category had an increase between 2019 and 2020 and continued to trend upward for the five-year period. The “Vegetation” and “Other Weather” categories had increases in 2020 and are trending upward for the five-year period.

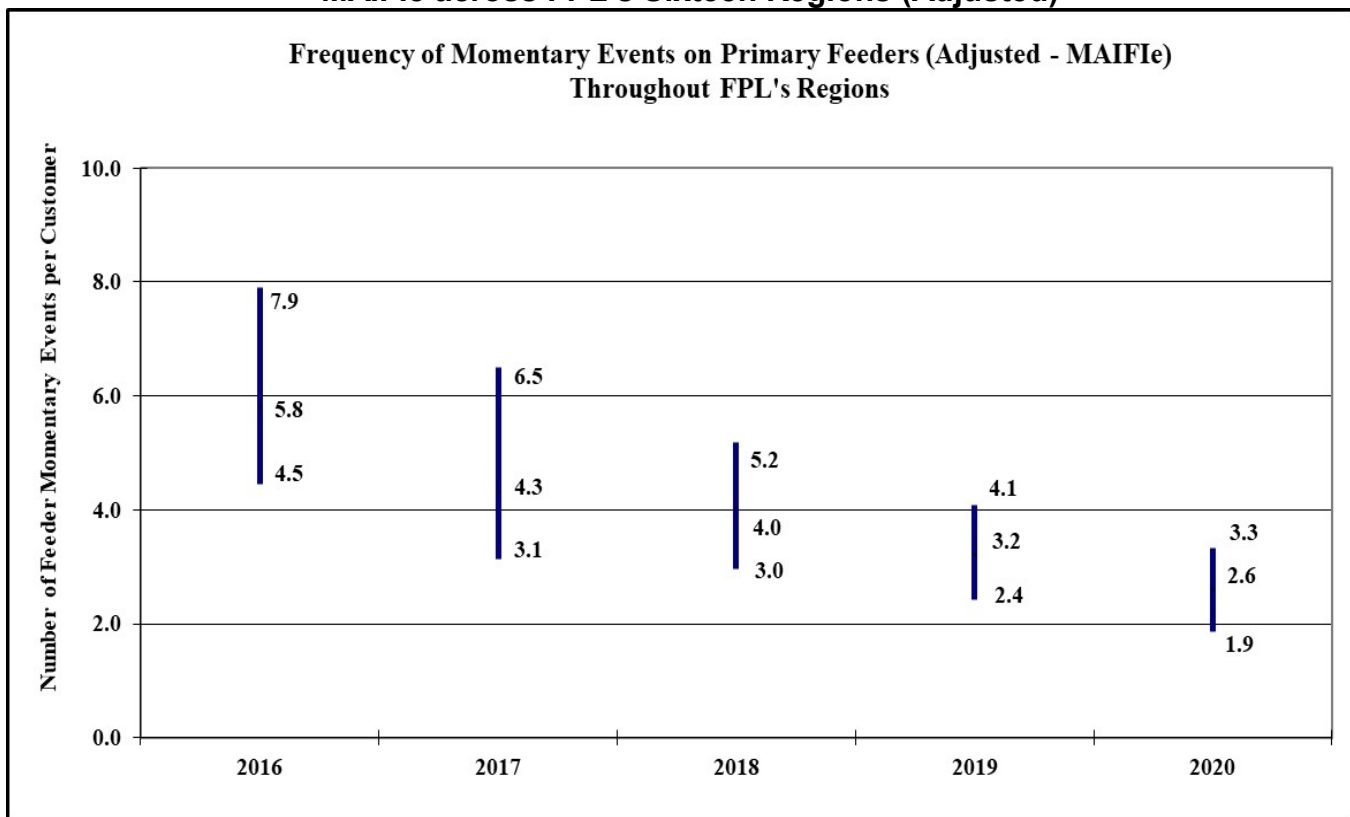
Figure 2-13
MAIFle across FPL's Sixteen Regions (Adjusted)

Figure 2-13 is the highest, average, and lowest adjusted MAIFle recorded across FPL's system. FPL's Wingate, Toledo Blade, West Palm, and **Boca Raton** service areas have experienced the least reliable MAIFle results of the 16 service areas of FPL since **2016**. The Pompano, Central Dade, and Manasota service areas had the fewest momentary events since **2016**. The results have been trending downward (improving) over the last five years. There is a **19** percent decrease in the average MAIFle results from **2019** to **2020**. As a note, FPL calculates MAIFle differently. Specifically, if a feeder begins in one region and crosses another region, all customers on that feeder are impacted by the MAIFle event and are counted in the starting region. Therefore, the number of customers per region will be different.

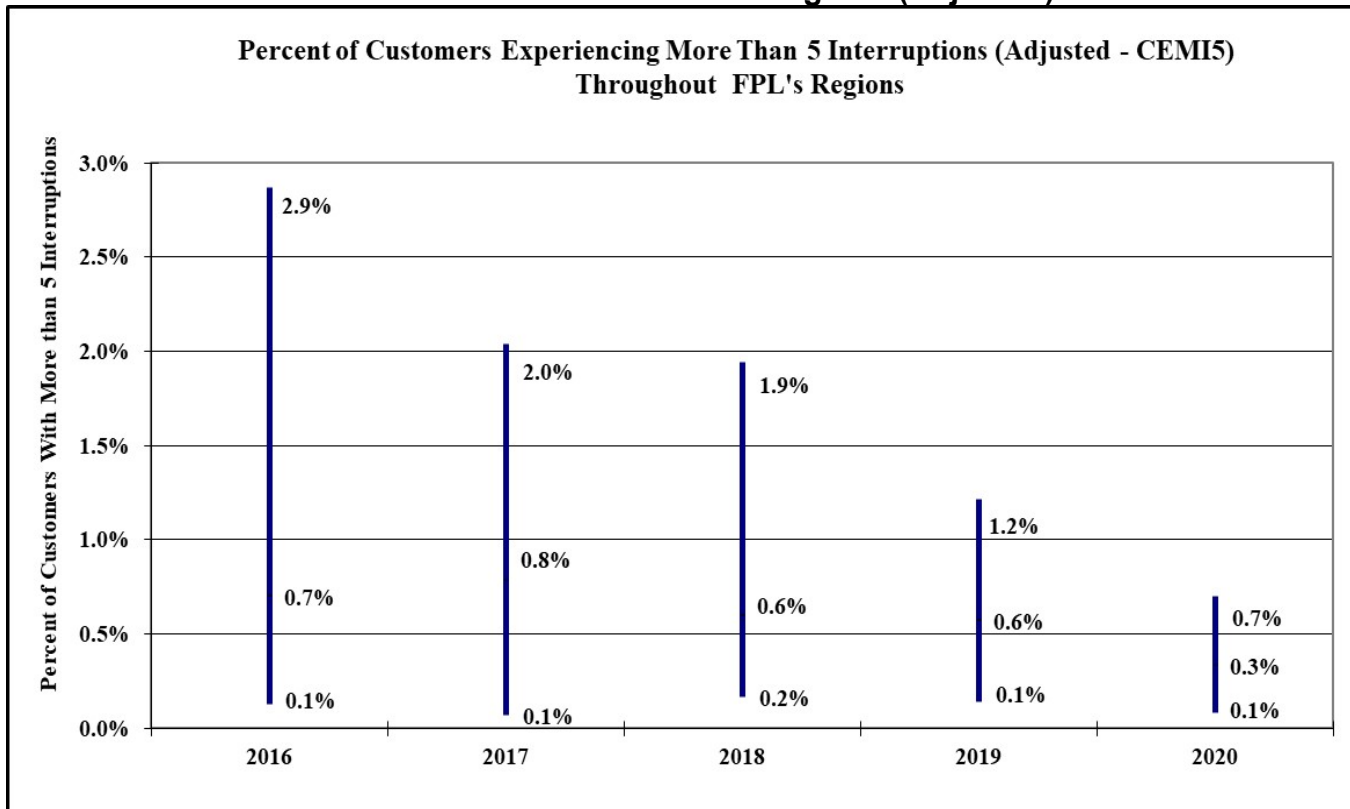
Figure 2-14
CEMI5 across FPL's Sixteen Regions (Adjusted)

Figure 2-14 shows the highest, average, and lowest adjusted CEMI5. FPL's customers with more than five interruptions per year appear to be slightly trending downward. The service areas experiencing the highest CEMI5 over the five-year period appear to fluctuate among West Dade, Treasure Coast, West Palm, Toledo Blade and North Florida. Pompano, South Broward (Gulf Stream), Central Dade, and North Broward are reported as having the lowest percentages in the last five years. The average CEMI5 result for 2020 was 0.3 percent, which is 50 percent lower than 0.6 percent in 2019.

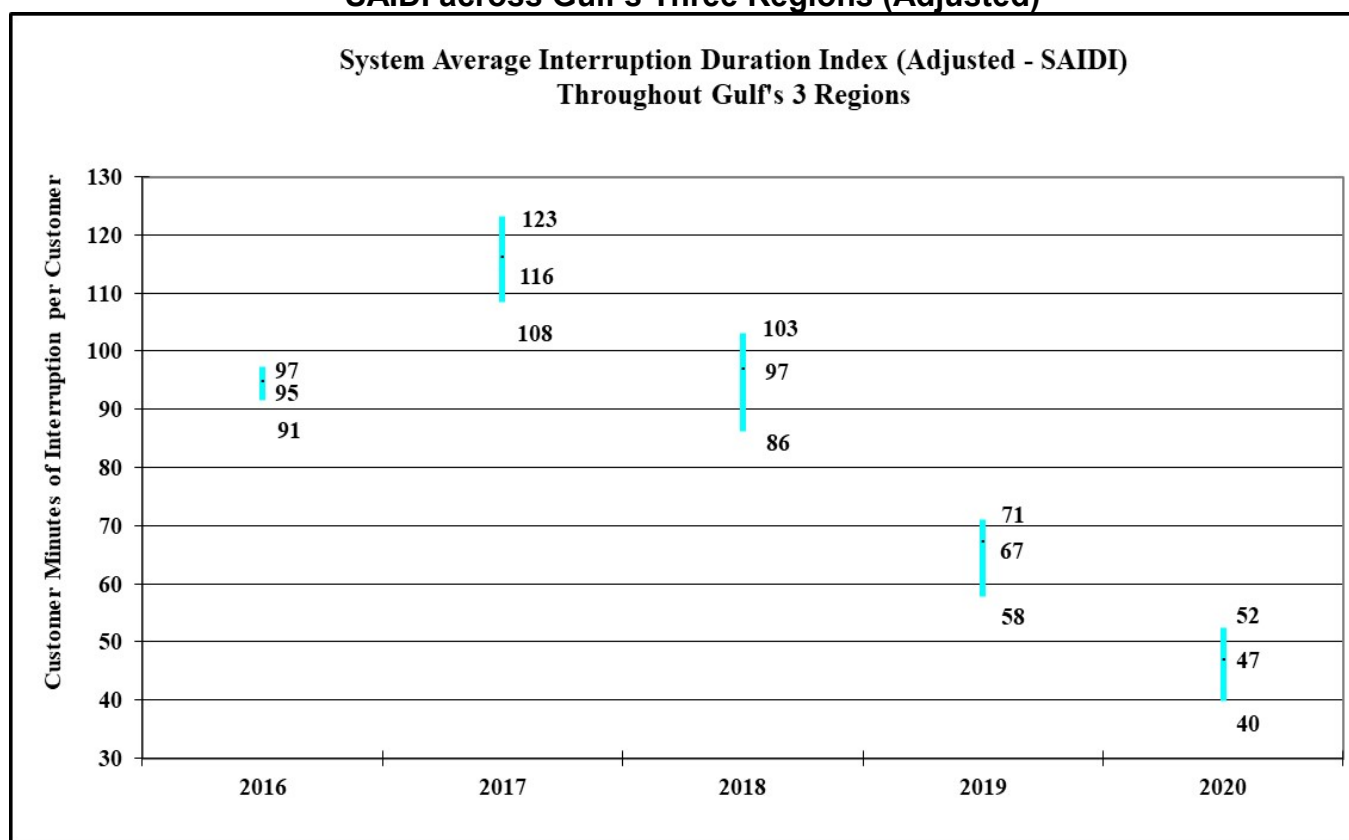
Figure 2-22
SAIDI across Gulf's Three Regions (Adjusted)

Figure 2-22 illustrates Gulf's SAIDI minutes, or the interruption duration minutes on a system basis. The chart depicts a 30 percent decrease in the average SAIDI in Gulf's combined regions when compared to the 2019 results. Gulf's 2020 average performance was 47 minutes compared to 67 minutes in 2019. The highest SAIDI value for 2020 was the Panama City region as the Fort Walton region had the best or lowest SAIDI value. The maximum, minimum, and average SAIDI indices are trending downward.

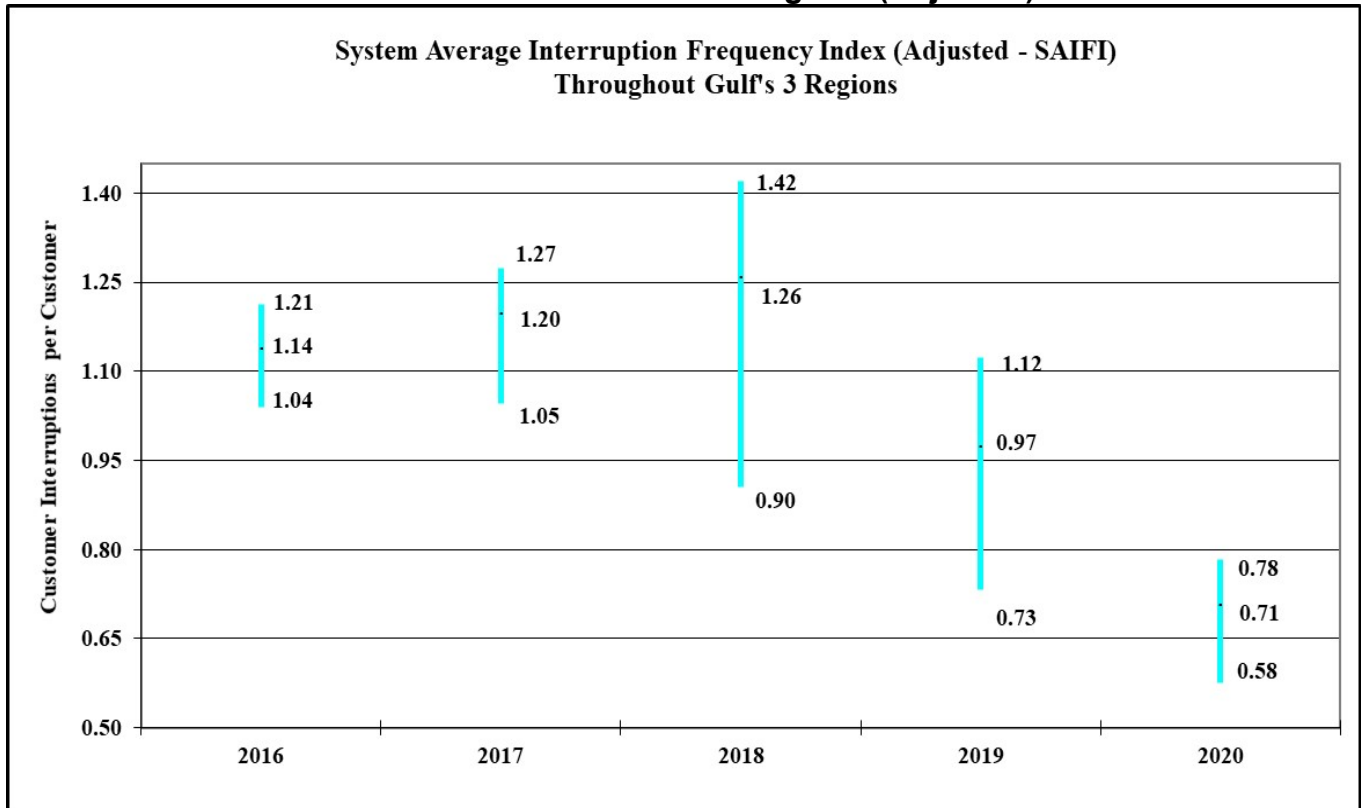
Figure 2-23
SAIFI across Gulf's Three Regions (Adjusted)

Figure 2-23 illustrates that Gulf's SAIFI had a 27 percent decrease in 2020 when compared to 2019. The highest SAIFI value for the past five years has fluctuated between the Panama City and Pensacola regions. The lowest values appear to be in the Fort Walton region. The maximum, average, and minimum SAIFI values appear to be trending downward.

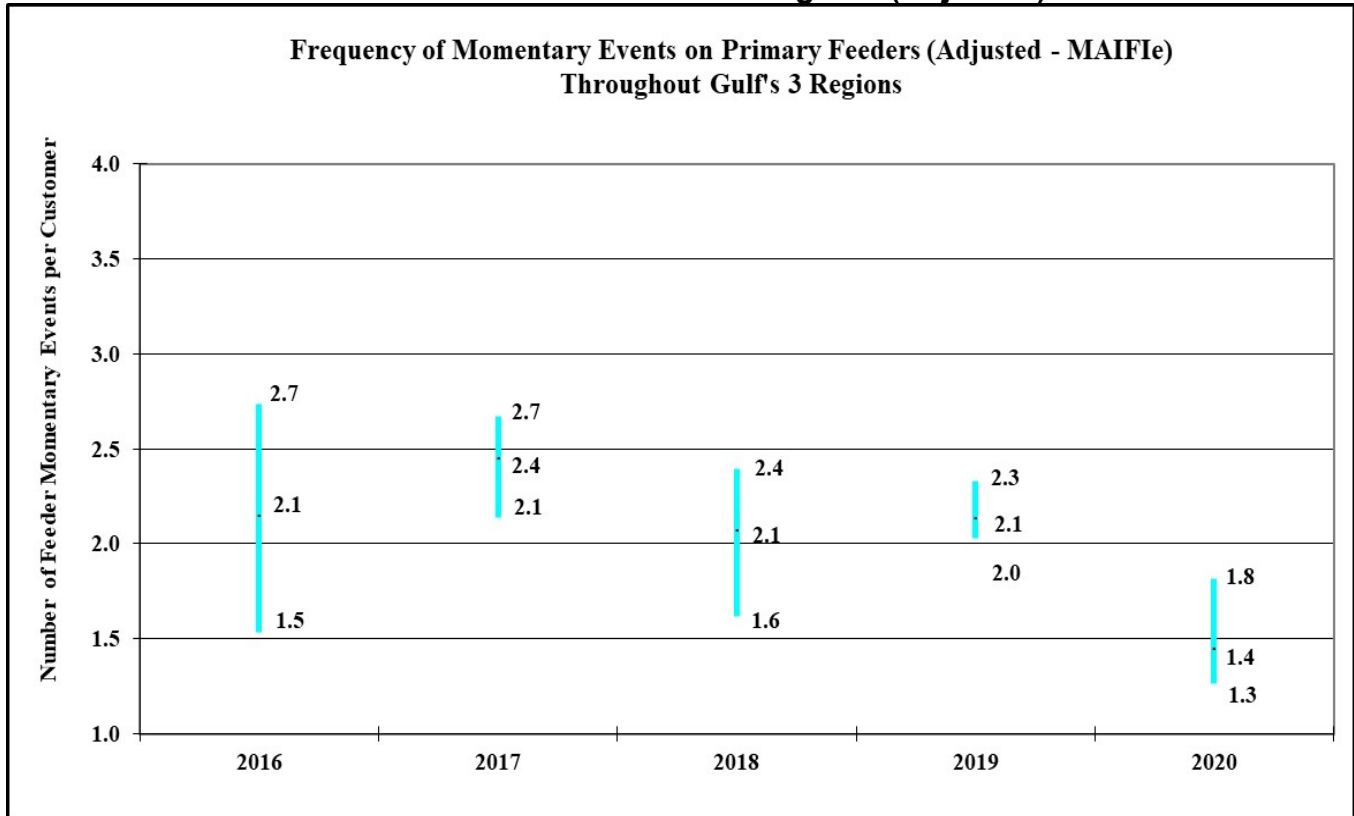
Figure 2-26
MAIFle across Gulf's Three Regions (Adjusted)

Figure 2-26 is the adjusted MAIFle recorded across Gulf's system. The adjusted MAIFle results by region show that the **Pensacola** region had the lowest frequency of momentary events on primary feeders. The **Panama City** region had the highest MAIFle index in **2020**. The average MAIFle had a 33 percent decrease of 1.4 events in 2020 compared to 2.1 events in 2019. The data suggest that the highest, average, and lowest MAIFle are all continuing to trend downward, suggesting improvement.

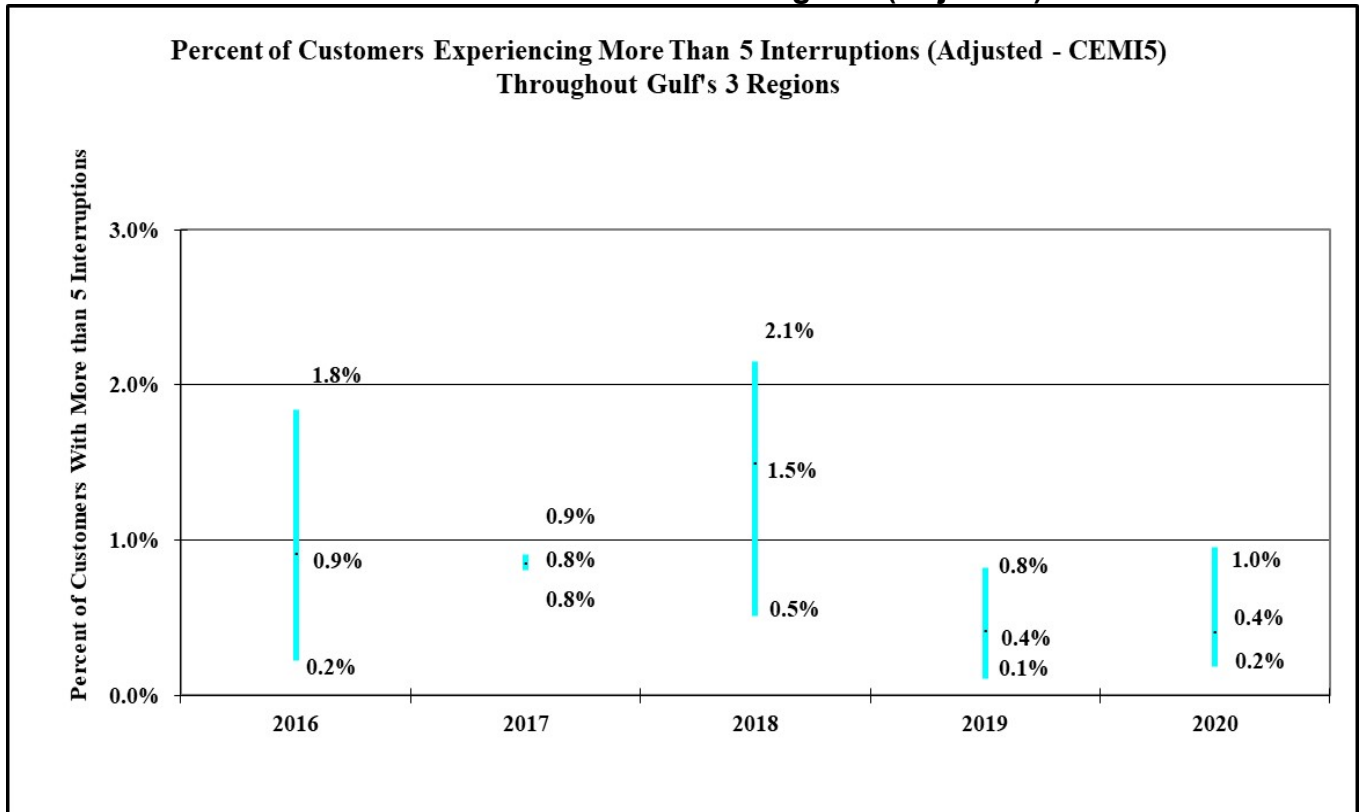
Figure 2-27
CEMI5 across Gulf's Three Regions (Adjusted)

Figure 2-27 shows the highest, average, and lowest adjusted CEMI5 across Gulf's Pensacola, Fort Walton, and Panama City regions. Gulf's 2020 results illustrate no change in the average CEMI5 percentage when compared to 2019, staying at 0.4 percent. The maximum, average, and minimum CEMI5 appears to be trending downward over the five-year period of 2016 to 2020.

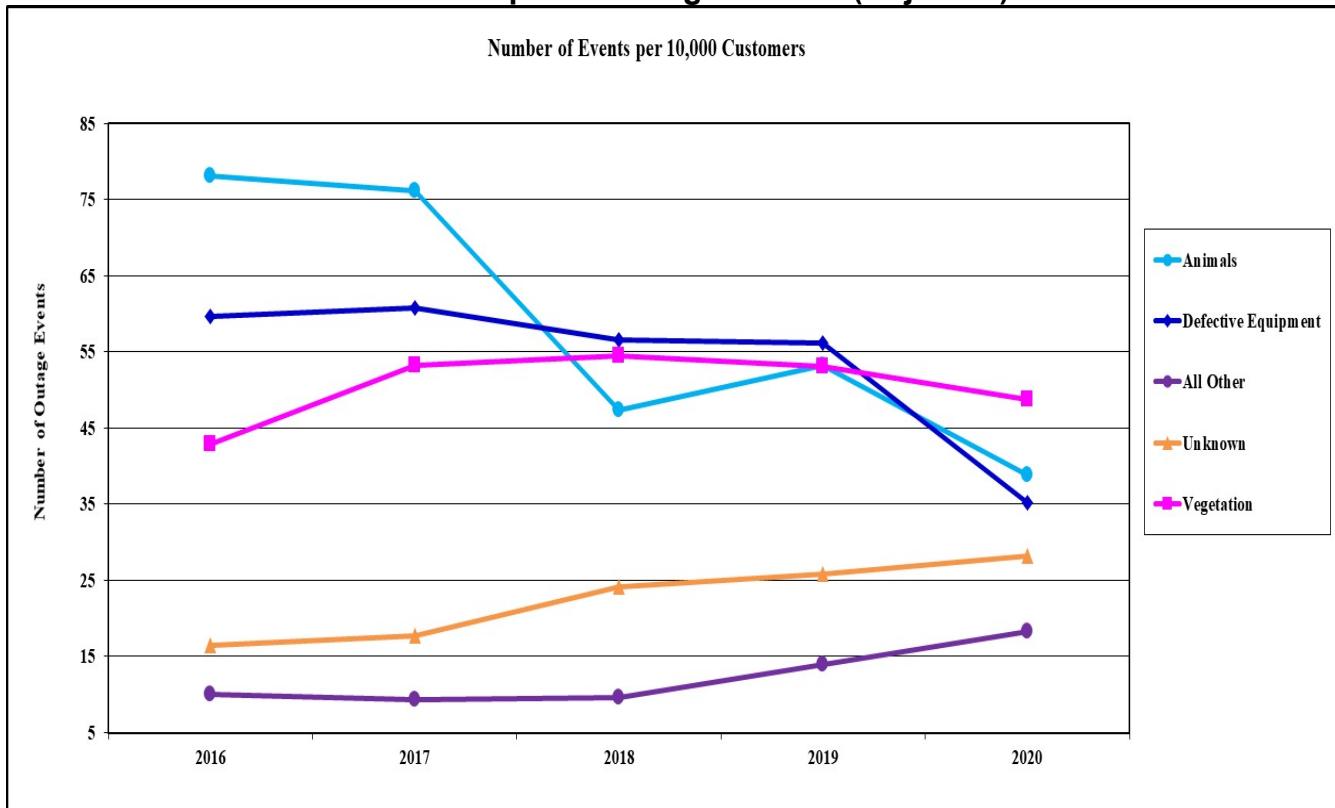
Figure 2-29
Gulf's Top Five Outage Causes (Adjusted)

Figure 2-29 shows the top five causes of outage events on Gulf’s distribution system normalized to a 10,000-customer base. The figure is based on Gulf’s adjusted data of the top 10 causes of outage events and represents 84 percent of the total adjusted outage events that occurred during 2019. The top five causes of outage events were “Vegetation” (24 percent), “Animals” (19 percent), “Defective Equipment” (18 percent), “Unknown Causes” (14 percent), and “Other Causes” (9 percent). The percentage of outages due to “Vegetation” was the highest cause of outages. The number of outage events due to “Vegetation” is trending upward even though there was a 7 percent decrease in 2020. The number of outage events due to “Unknown Causes” and “Other Causes” are also trending upward. The number of outages due to “Animals” and “Defective Equipment” are trending downward.

Gulf annually evaluates its current reliability remediation programs. Gulf is proposing 11 different reliability programs aimed at reducing customer interruptions caused by “Vegetation,” “Defective Equipment,” “Animals,” and “Unknown Causes.” These programs include, adding automated equipment to reduce temporary faults and outages, and replacing and modernizing aging equipment.

Gulf’s top five causes of outages were “Vegetation” (24 percent), “Animals” (19 percent), “Defective Equipment” (18 percent), “Unknown Causes” (14 percent), and “All Other” (9 percent). As shown in Figure 2-29, the number of outages decreased for “Vegetation,” “Animals,” and “Defective Equipment” in 2020 when compared to 2019.

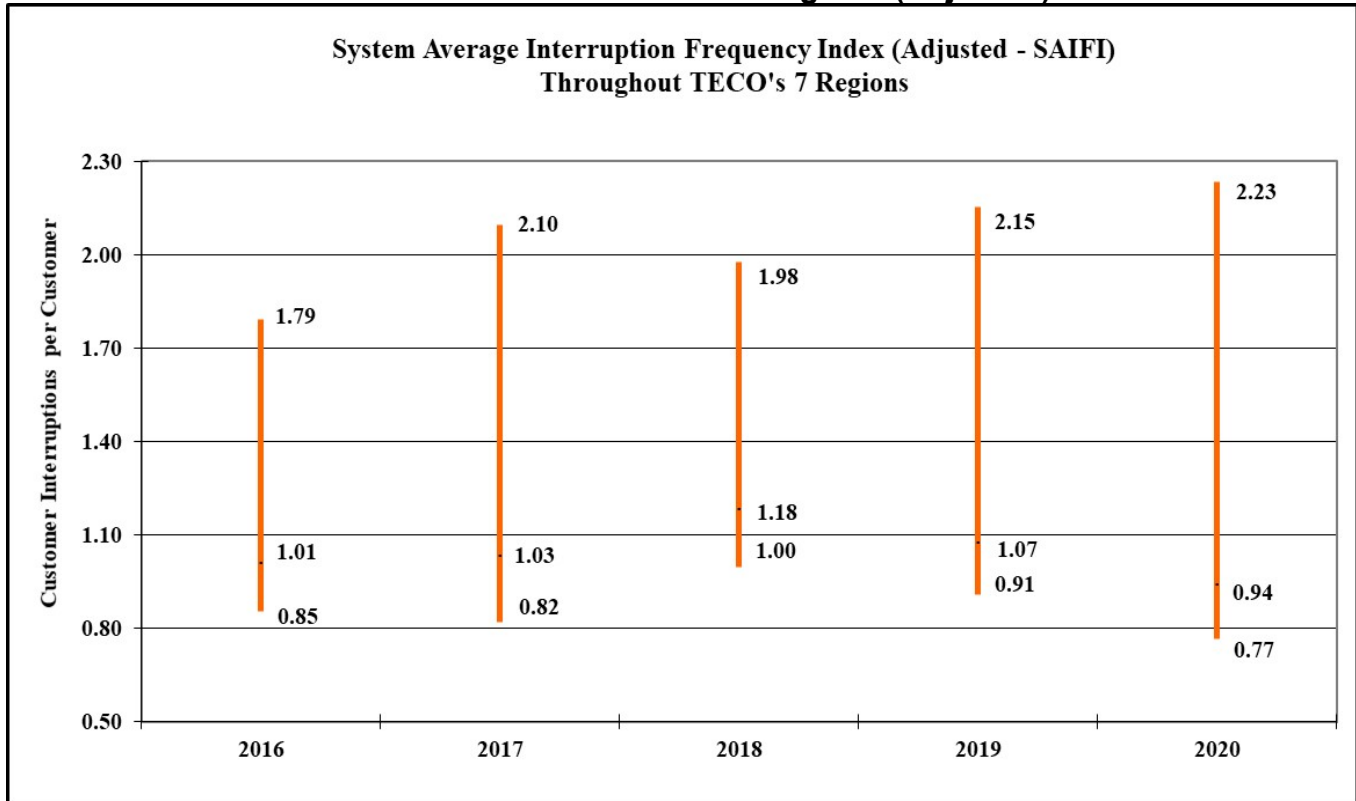
Figure 2-31
SAIFI across TECO's Seven Regions (Adjusted)

Figures 2-31 illustrates TECO's adjusted frequency of interruptions per customer reported by the system. TECO's data represent a 12 percent decrease in the SAIFI average from 1.07 interruptions in 2019 to 0.94 interruptions in 2020. TECO's Dade City region continues to have the highest frequency of service interruptions when compared to TECO's other regions. The maximum SAIFI is trending upward as the average SAIFI is trending downward. The minimum SAIFI appears to remain flat.
