***Review of  
Florida's  
Investor-Owned  
Electric Utilities***

***2 0 1 5  
Service Reliability Reports***

**State of Florida  
Florida Public Service Commission  
Division of Engineering**

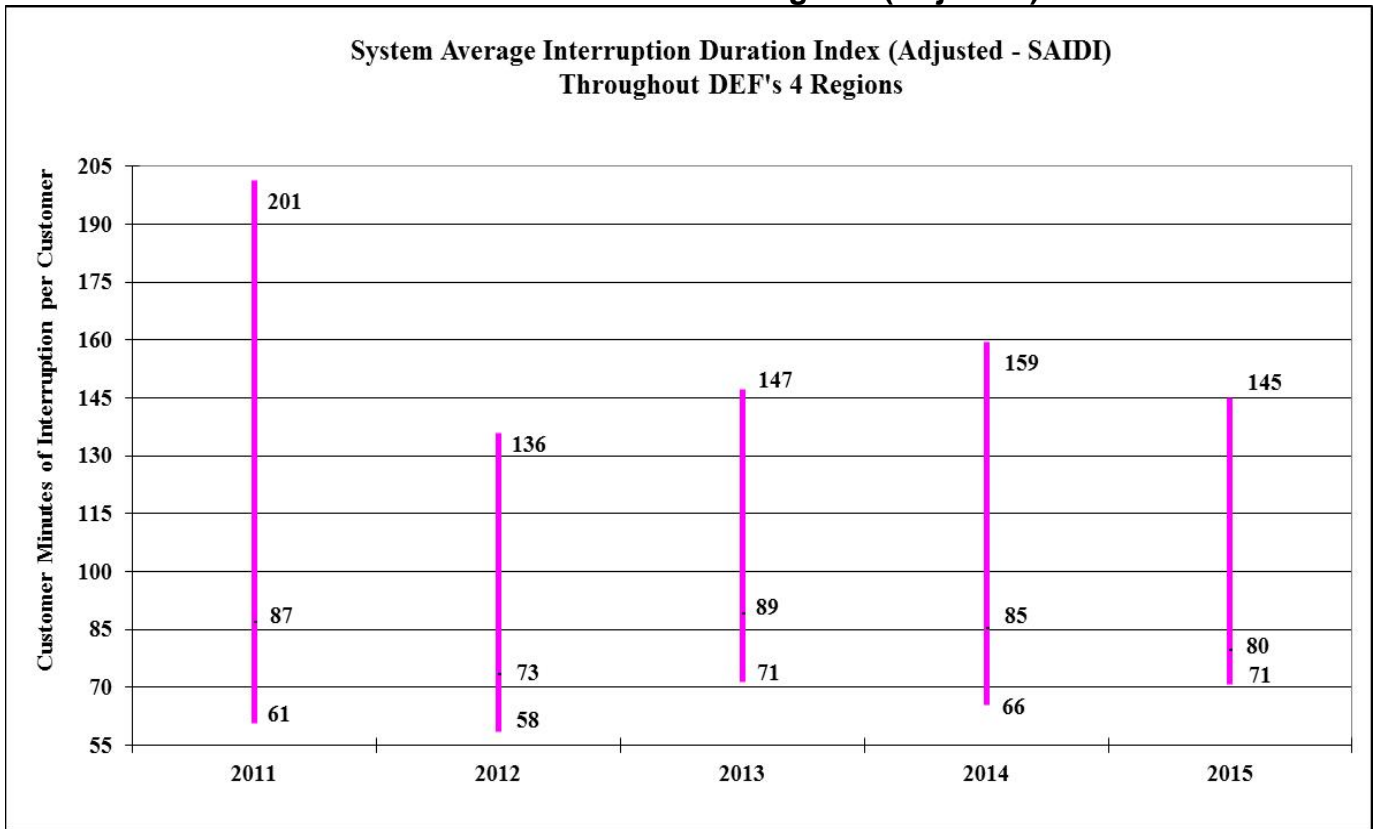
**Figure 3-1.  
SAIDI across DEF's Four Regions (Adjusted)**

**Figure 3-1** charts the adjusted SAIDI recorded across DEF's system and depicts an increase in the lowest value and decreases in the average and highest values for 2015. DEF reported that in 2015, the flooding of the Anclote River, which caused the activation of the Pasco County Emergency Operations Center, account for 1.1 customer minutes of interruptions per customers. This event was the only weather excluded event in 2015. DEF notes that 2015 was an extremely active storm season with multiple thunderstorms causing higher outage volumes in the North and South Coastal regions and two abnormally long feeder cable outages in the South Coastal region.

DEF's service territory is comprised of four regions: North Coastal, South Coastal, North Central, and South Central. **Figure 3-1** illustrates that the North Coastal region continues to report the poorest SAIDI over the last five years, fluctuating between 136 minutes and 201 minutes. While the South Coastal and South Central regions have the best or lowest SAIDI for the same period. The North Coastal region is rural and has more square miles when compared to the other regions. This region is also served by predominantly long circuits with approximately 7,700 miles of overhead and underground main circuits. DEF explained that these factors result in higher exposure to outage causes and higher reliability indices.

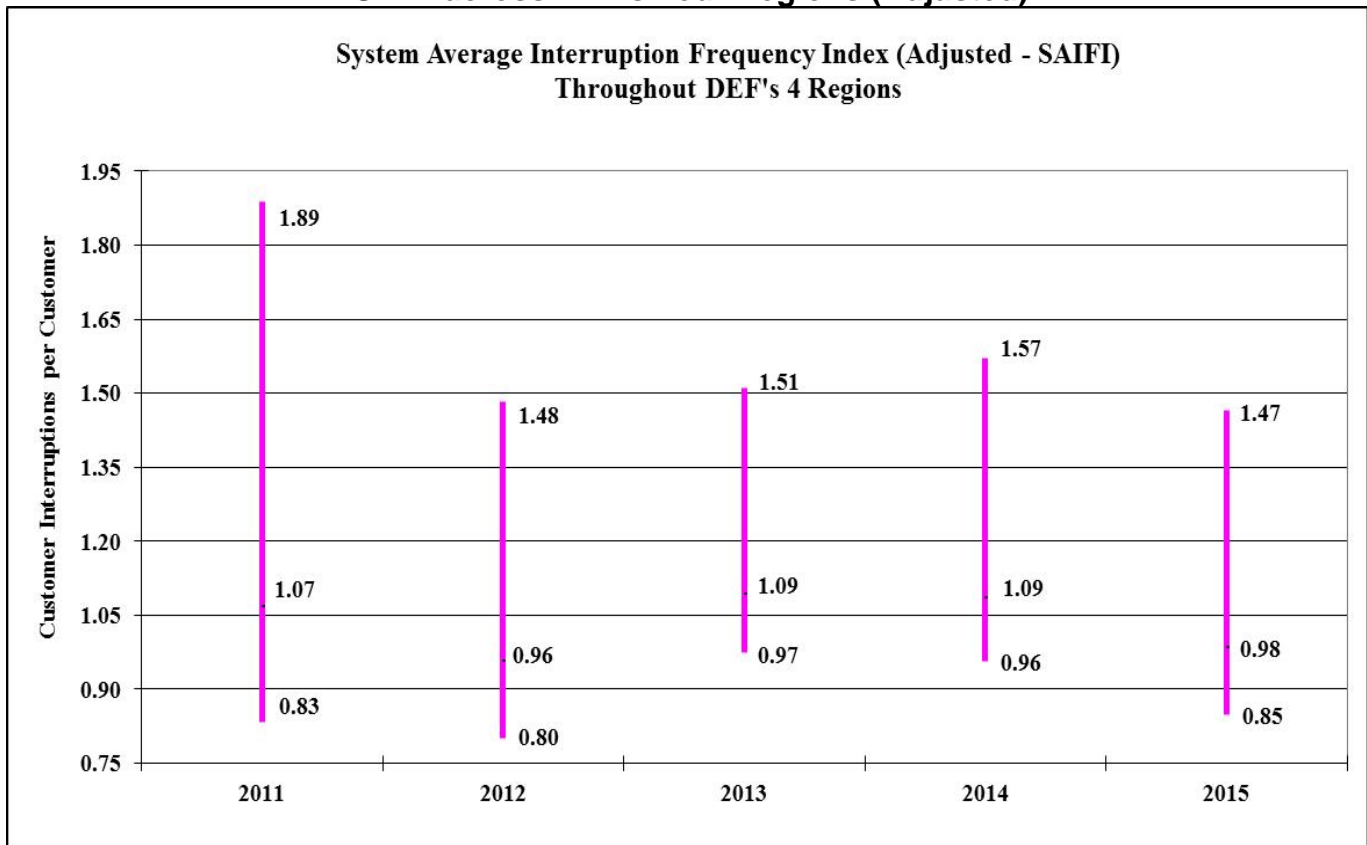
**Figure 3-2.  
SAIFI across DEF's Four Regions (Adjusted)**

**Figure 3-2** shows the adjusted SAIFI across DEF's system. The maximum and average SAIFI indexes are trending downward as the minimum SAIFI is trending slightly upward. There were decreases of 6 percent for the maximum value, 10 percent for the average value, and 11 percent for the minimum value, in 2015. The North Central region had the lowest number of interruptions, while the North Coastal region continues to have the highest number of interruptions.

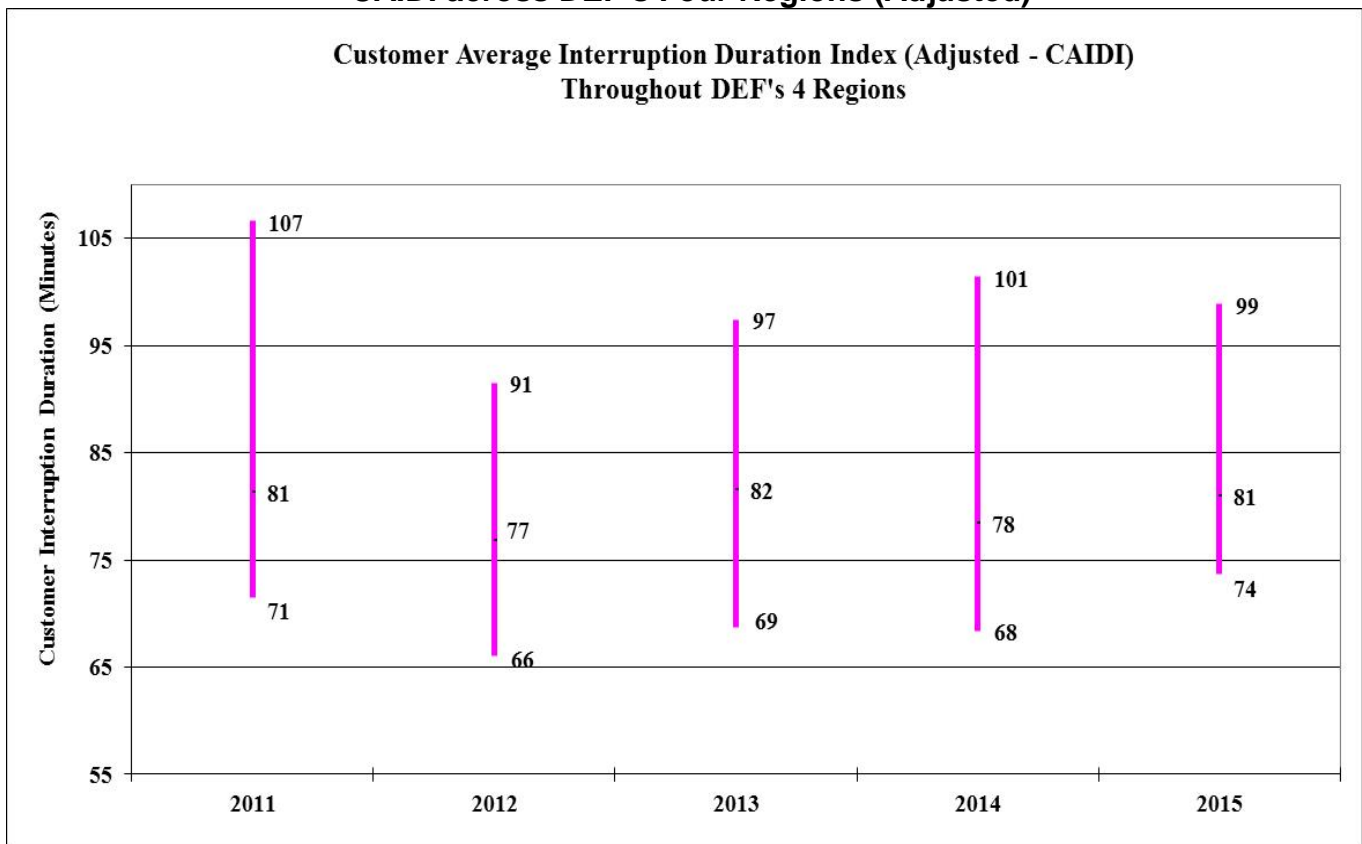
**Figure 3-3.**  
**CAIDI across DEF's Four Regions (Adjusted)**

**Figure 3-3** illustrates the CAIDI, or the average number of minutes a customer is without power when a service interruption occurs, for DEF's four regions. DEF's adjusted CAIDI is remaining relatively flat for a five-year period from 81 minutes in 2011 to 81 minutes in 2015 even though there was a 4 percent increase from 78 minutes in 2014 to 81 minutes in 2015. The North Coastal region has continued to have the highest CAIDI level for the past five years with the maximum CAIDI trending downward. The South Coastal region has maintained the lowest CAIDI level during the same period with the minimum CAIDI trending upward.

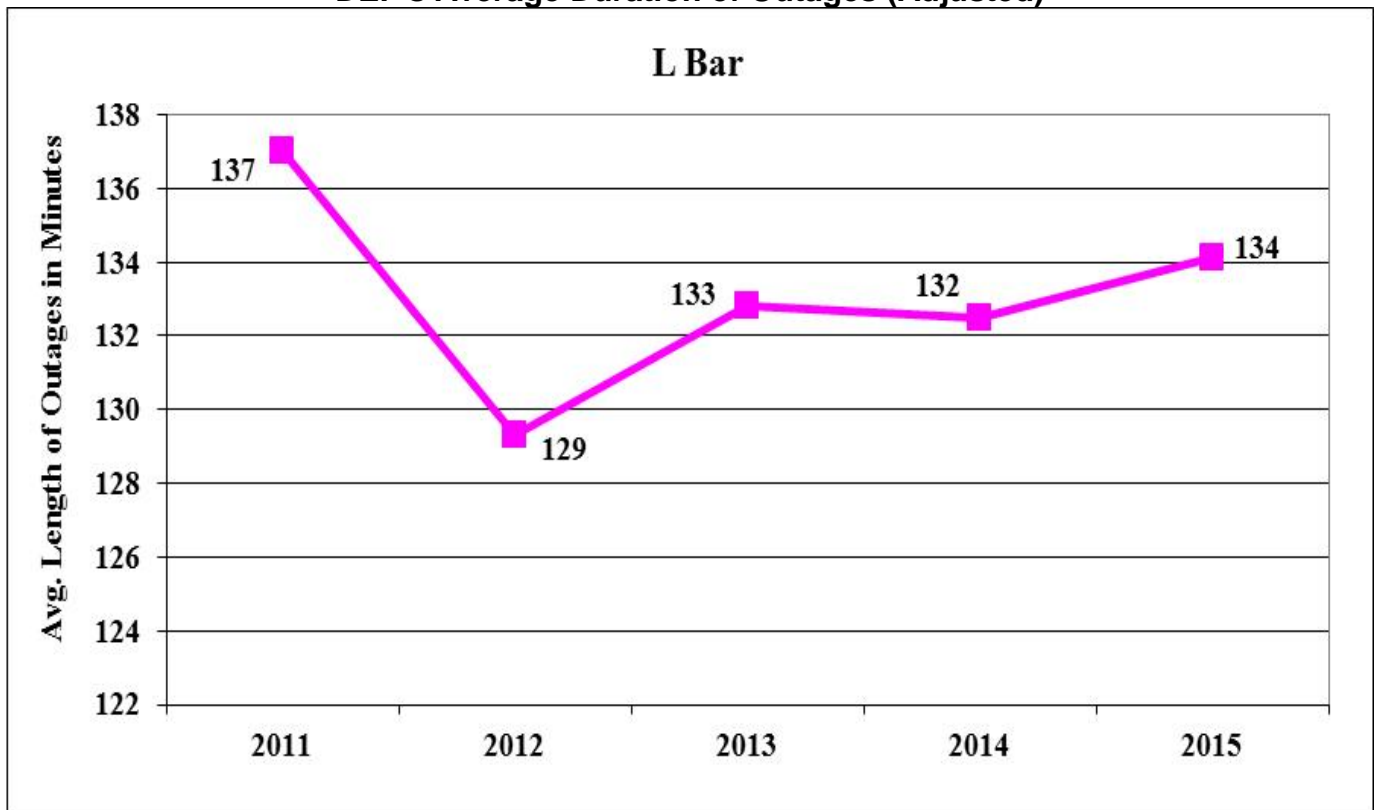
**Figure 3-4.**  
**DEF's Average Duration of Outages (Adjusted)**

**Figure 3-4** is the average length of time DEF spends restoring customers affected by outage events, excluding hurricanes and certain other outage events. This is displayed by the index L-Bar in the graph below. The data demonstrates an overall 2.2 percent decrease of outage durations since 2011, and a 1.5 percent increase from 2014 to 2015. DEF's overall L-Bar index is trending slightly downward, indicating that DEF is spending a shorter time restoring service from outage events.

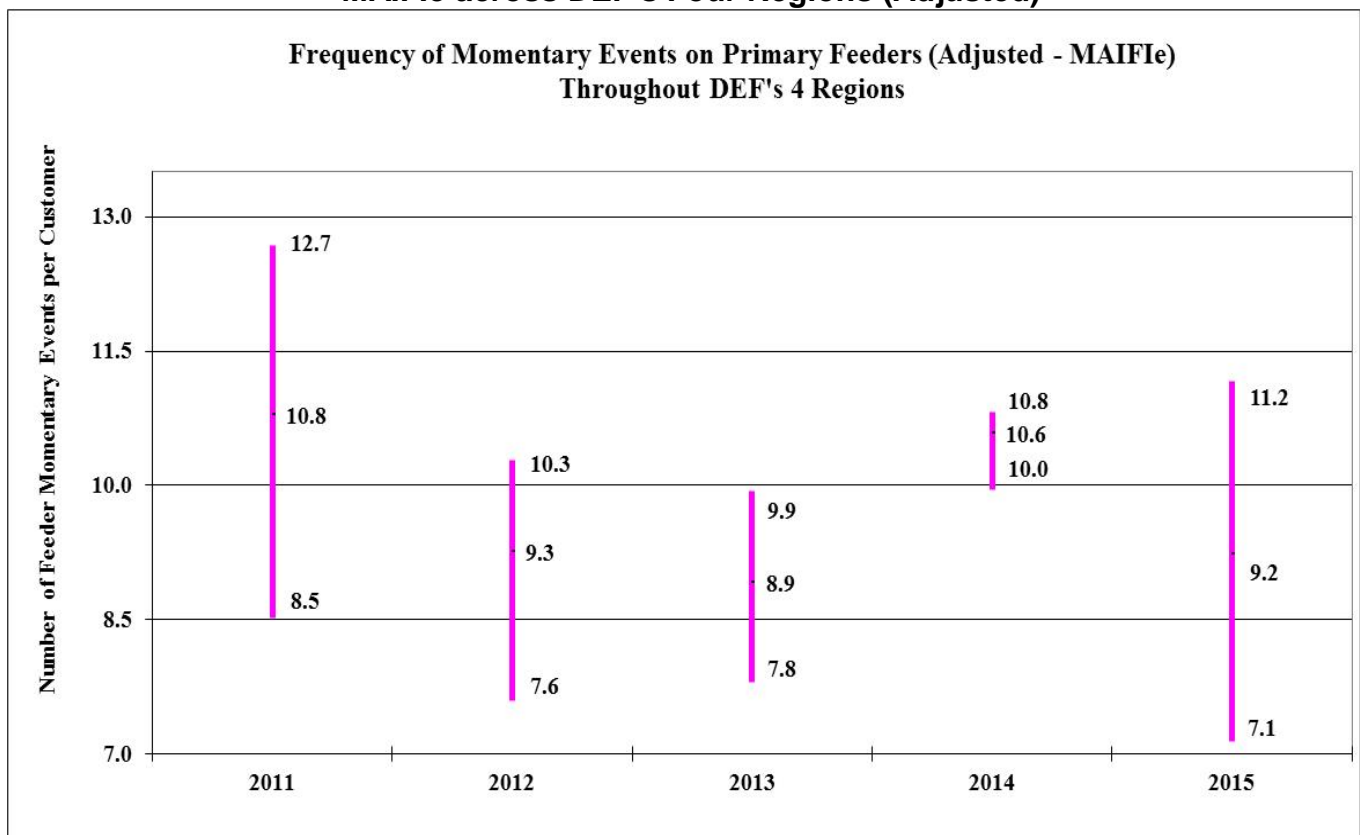
**Figure 3-5.  
MAIFle across DEF's Four Regions (Adjusted)**

**Figure 3-5** illustrates the frequency of momentary events on primary circuits for DEF's customers recorded across its system. These momentary events often affect a small group of customers. A review of the supporting data suggests that the MAIFle results between 2011 and 2015 appear to be trending downward showing improvement and there was a decrease in the average MAIFle of 13 percent from 2014 to 2015. The North Coastal and South Central regions appear to have the best (lowest) results for the last five years. There was a 29 percent decrease for the lowest MAIFle from 2014 to 2015. The South Coastal and North Central regions appear to have the worst (highest) results for the last five years. There was a 4 percent increase from 2014 to 2015.

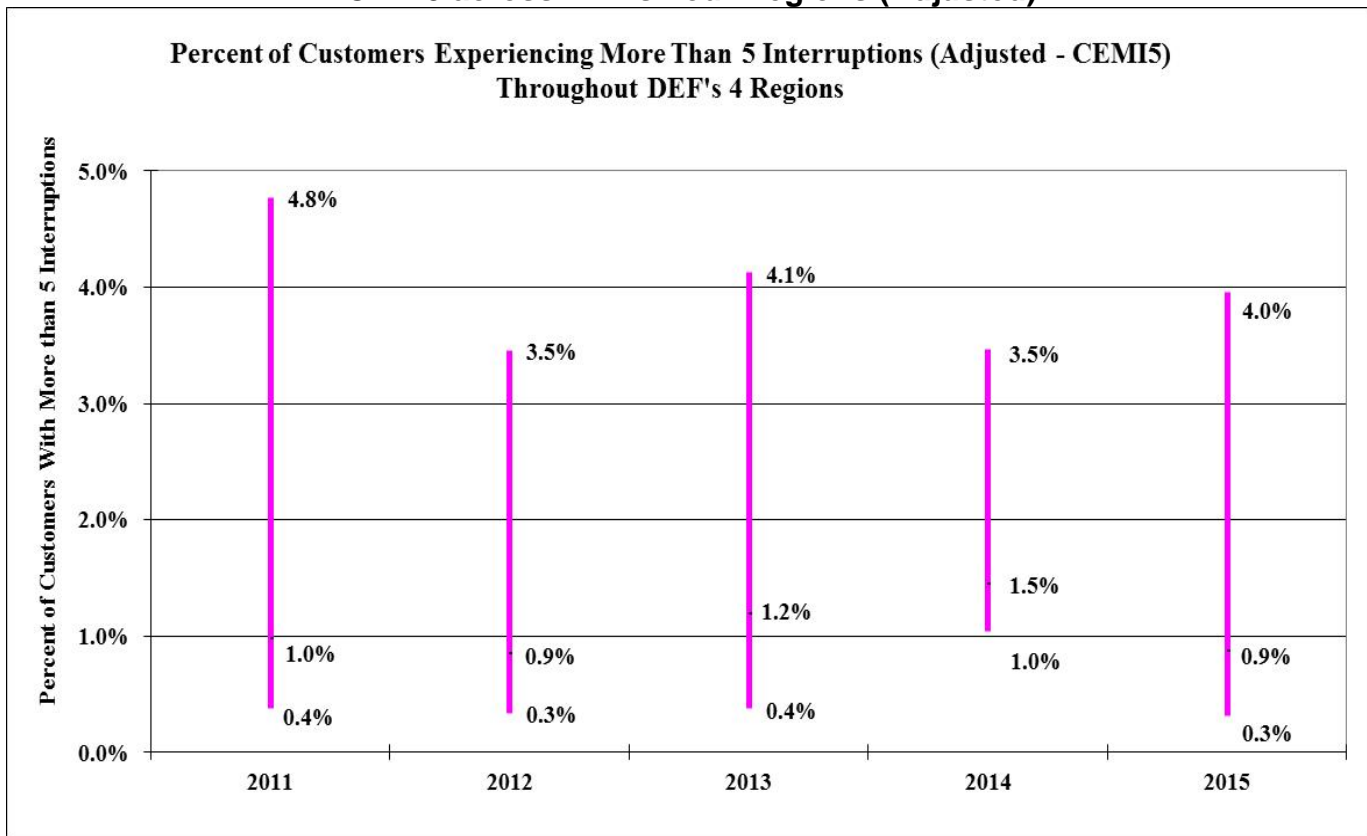
**Figure 3-6.  
CEMI5 across DEF’s Four Regions (Adjusted)**

**Figure 3-6** charts the percentage of DEF’s customers experiencing more than five interruptions over the last five years. DEF reported a decrease in the average CEMI5 performance from 1.5 percent in 2014 to 0.9 percent in 2015; however the average CEMI5 is trending upward over the past five years. The North Central region has the lowest reported percentage for all of DEF’s regions and the North Coastal region continues to have the highest reported percentage.

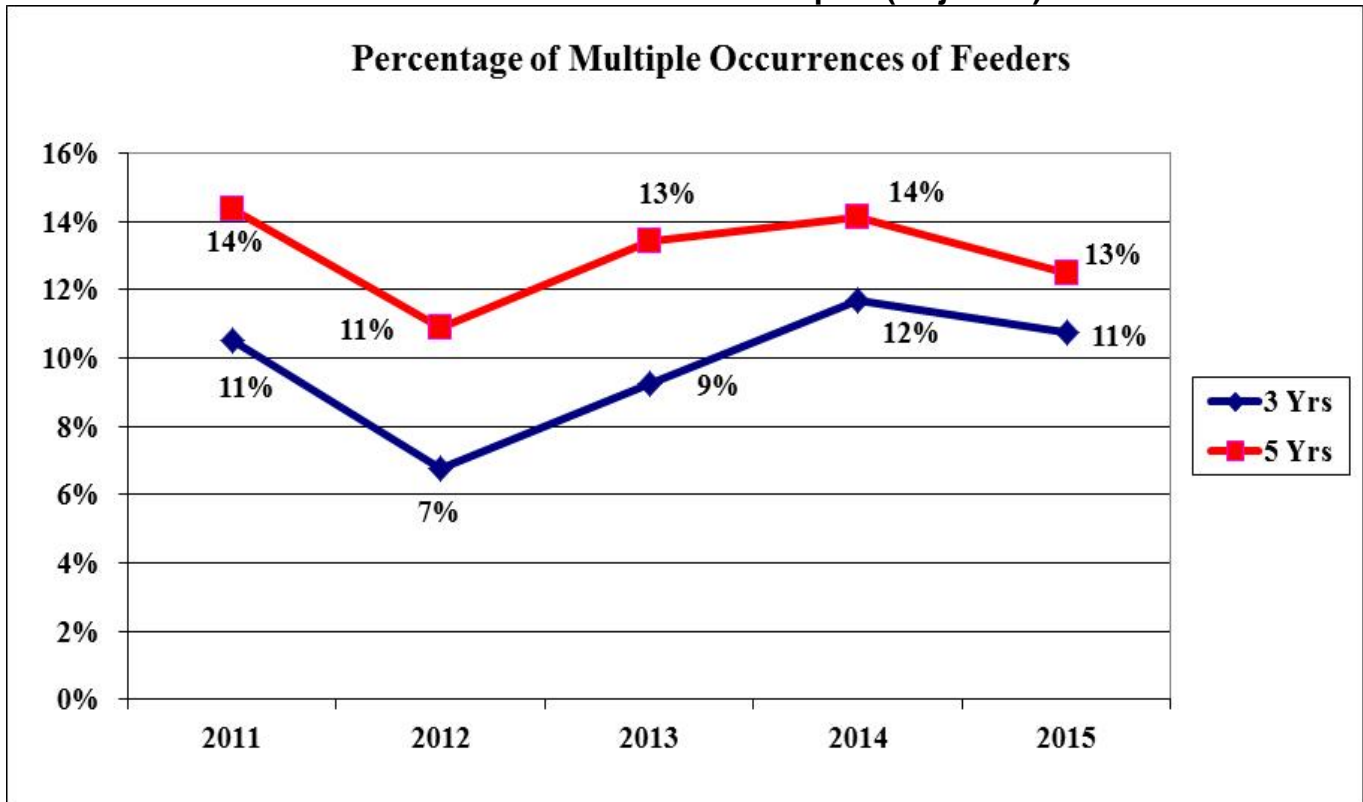
**Figure 3-7.**  
**DEF's Three Percent Feeder Report (Adjusted)**

**Figure 3-7** shows the fraction of multiple occurrences of feeders using a three-year and five-year basis. During the period of 2011 to 2015, the five-year fraction of multiple occurrences is relatively flat as the three-year fraction of multiple occurrences is trending upward. The Three Percent Feeder Report lists the top three percent of feeders with the most feeder outage events. The fraction of multiple occurrences is calculated from the number of recurrences divided by the number of feeders reported.

Another feeder has been on the Three Percent Feeder Report for three years. DEF performed an infrared scan in June 2015 and no issues were found. DEF will perform another infrared scan in 2016. In addition, DEF trimmed 55.4 miles of the feeder laterals, which was completed in January 2016. There were five outages in 2015 related to this feeder. Storms caused two of the outages, wind cause one outage, a connector failure cause one outage, and the cause of the last outage was unknown.

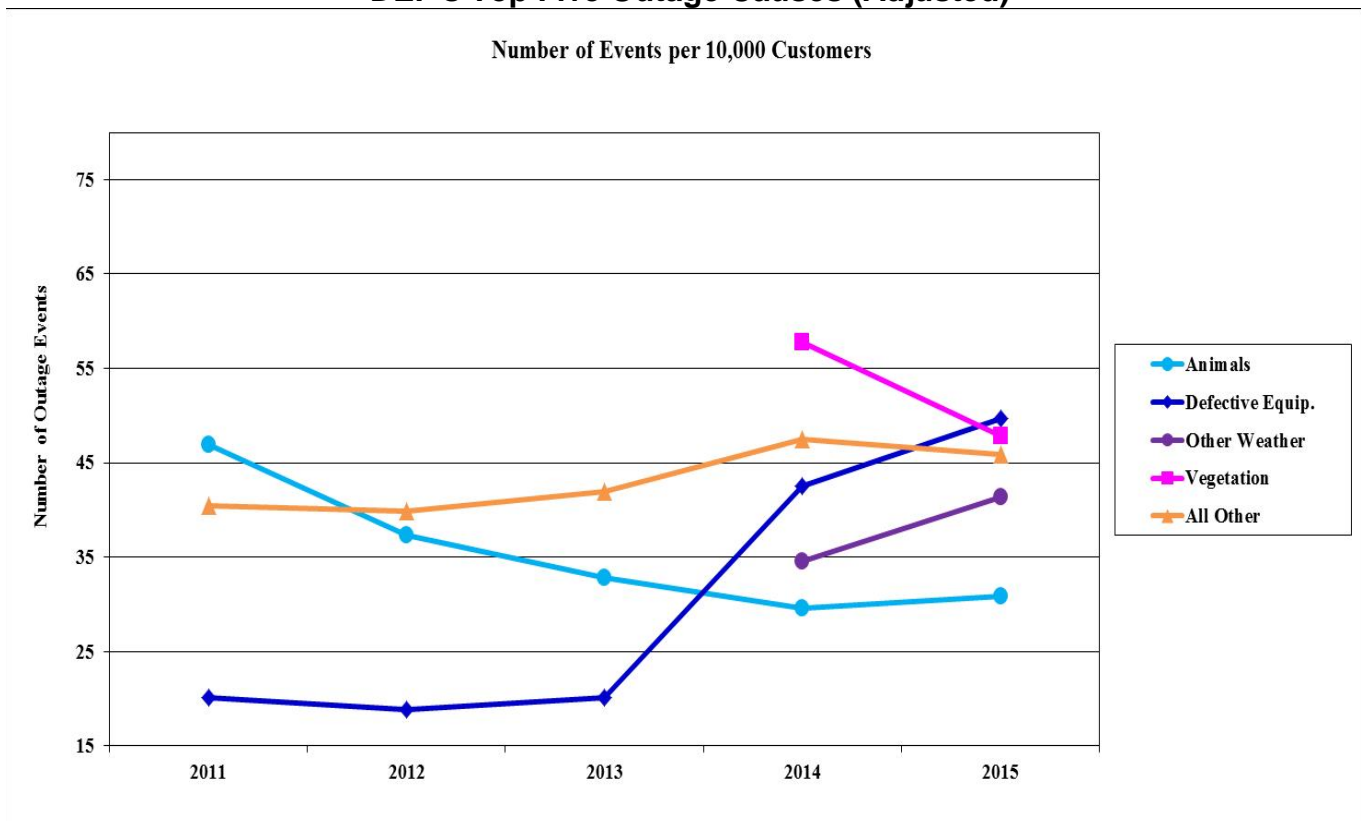
**Figure 3-8.  
DEF’s Top Five Outage Causes (Adjusted)**

**Figure 3-8** shows the top five causes of outage events on DEF’s distribution system normalized to a 10,000-customer base. The figure is based on DEF’s adjusted data and represents approximately 93 percent of the top 10 causes of outage events that occurred during 2015. For the five-year period, the top five causes of outage events were Defective Equipment (21 percent), Vegetation (21 percent), All Other (20 percent), Other Weather (18 percent), and Animals (13 percent) on a cumulative basis. Commission staff requested that, beginning with 2014 data, all IOU’s use the same outage categories for comparison purposes. As such, the Vegetation, Defective Equipment, and Other Weather now include outage categories that in the past were separately identified. The outage events caused by Vegetation and Animals are trending downward even though the Animals category had an 8 percent increase in 2015. DEF reported that it prioritizes the reliability improvements action plan by balancing historical and current year performance. In addition, current year performance is monitored monthly to identify emergent and seasonal issues including load balancing for cold weather and the need for foot patrols of devices experiencing multiple interruptions.

To address outages related to Defective Equipment, DEF’s Outage Follow Up process, operational threshold reviews, and annual asset programs are all targeted at reducing CMI in this area. DEF explained that the Defective Equipment category was merged with the Connector Failure, Corrosion, and Equipment Misapplication causes codes, which caused the increase of outages for 2014 and 2015 when compared to 2013.

In **Figure 3-8**, DEF's Top Five Outage Categories, the category Defective Equipment is in the top spot representing 21 percent of the top 10-outage categories. The next two highest categories were Vegetation (21 percent) and All Other (20 percent). Other Weather (18 percent) and Animals (13 percent) are the next two causes of outages. Commission staff requested that, beginning with 2014 data, all IOU's use the same outage categories for comparison purposes. As such, the Vegetation, Defective Equipment, and Other Weather now include outage categories that in the past were separately identified. The Vegetation and Animals outage categories are trending downward for the five-year period of 2011 to 2015 even though the Animals category had an 8 percent increase in 2015 and the Vegetation category had an 14 percent decrease. The Defective Equipment, All Other and Other Weather categories all had increases between 2014 and 2015 and all are trending upward for the same five-year period.

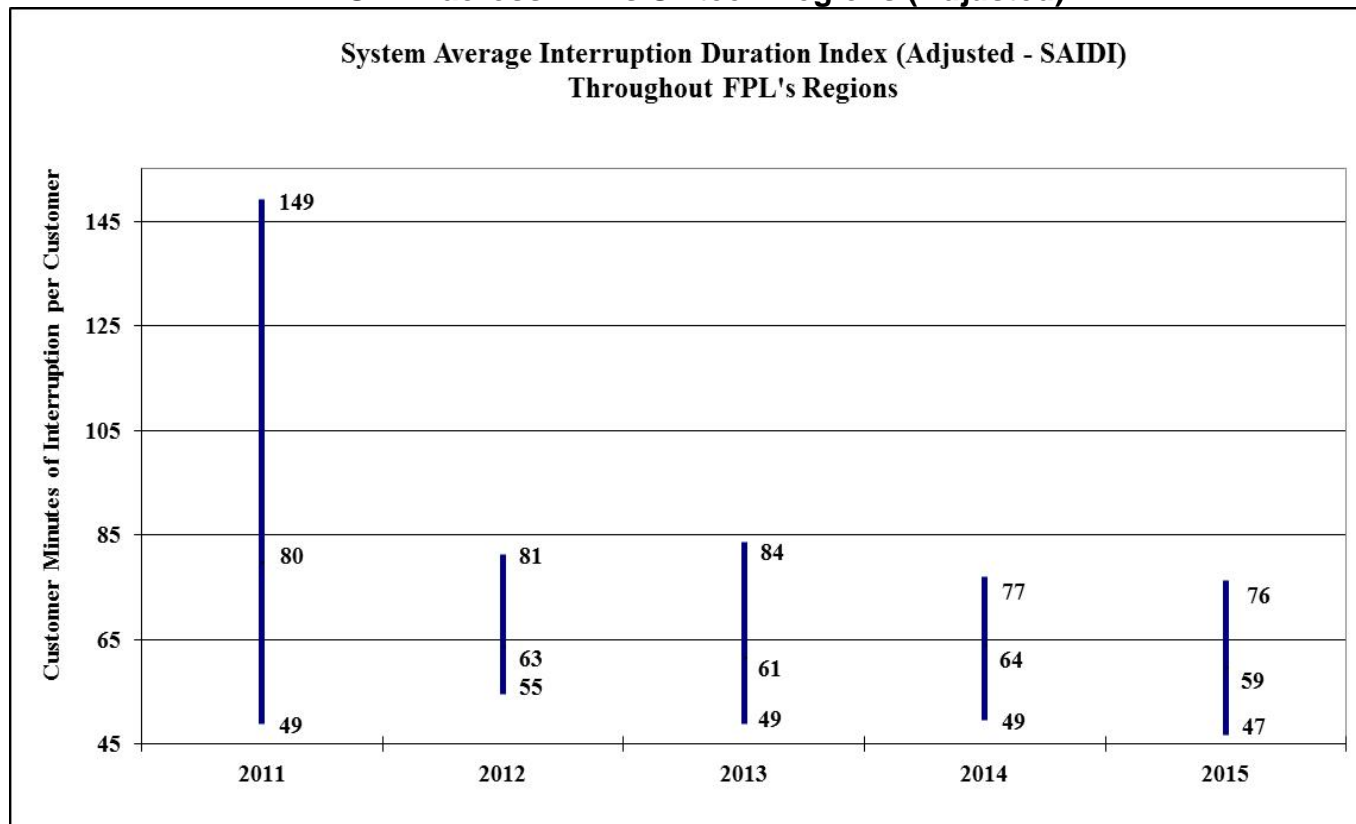
**Figure 3-9.**  
**SAIDI across FPL's Sixteen Regions (Adjusted)**

**Figure 3-9** shows the highest, average, and lowest adjusted SAIDI recorded across FPL's system that encompasses four management regions with 16 service areas. The highest and lowest SAIDI values are the values reported for a particular service area. FPL had an overall decrease of five minutes (8 percent) to its average SAIDI results for 2015 compared to 2014. The average SAIDI appears to be trending downward over the five-year period of 2011 to 2015. The Central Dade region has the best SAIDI results for two out of the five years.

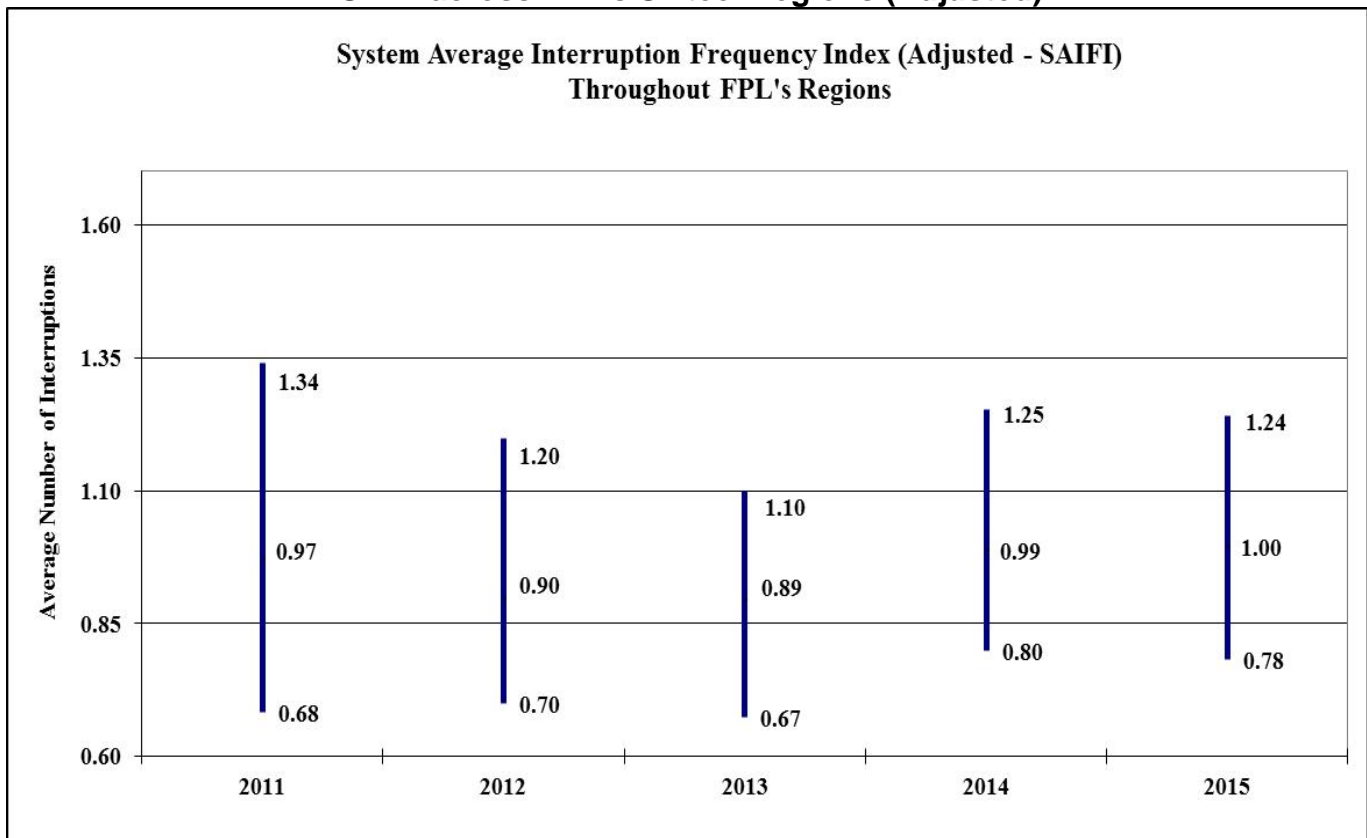
**Figure 3-10.  
SAIFI across FPL's Sixteen regions (Adjusted)**

**Figure 3-10** is a chart of the highest, average, and lowest adjusted SAIFI across FPL's system. FPL had an increase in the system average results to 1.00 outages in 2015, compared to 0.99 outages in 2014, which is a 1 percent increase. FPL reported a decrease in the highest SAIFI of 1.24 interruptions in 2015 compared to 1.25 interruptions in 2014. The region reporting the lowest adjusted SAIFI for 2015 was Central Dade, again, at 0.78 interruptions compared to 0.80 interruptions in 2014. The average and lowest SAIFI appear to be trending upward as the highest SAIFI appear to be trending downward. The 2015 average SAIFI results are the highest (worst) for the five-year period of 2011 to 2015.

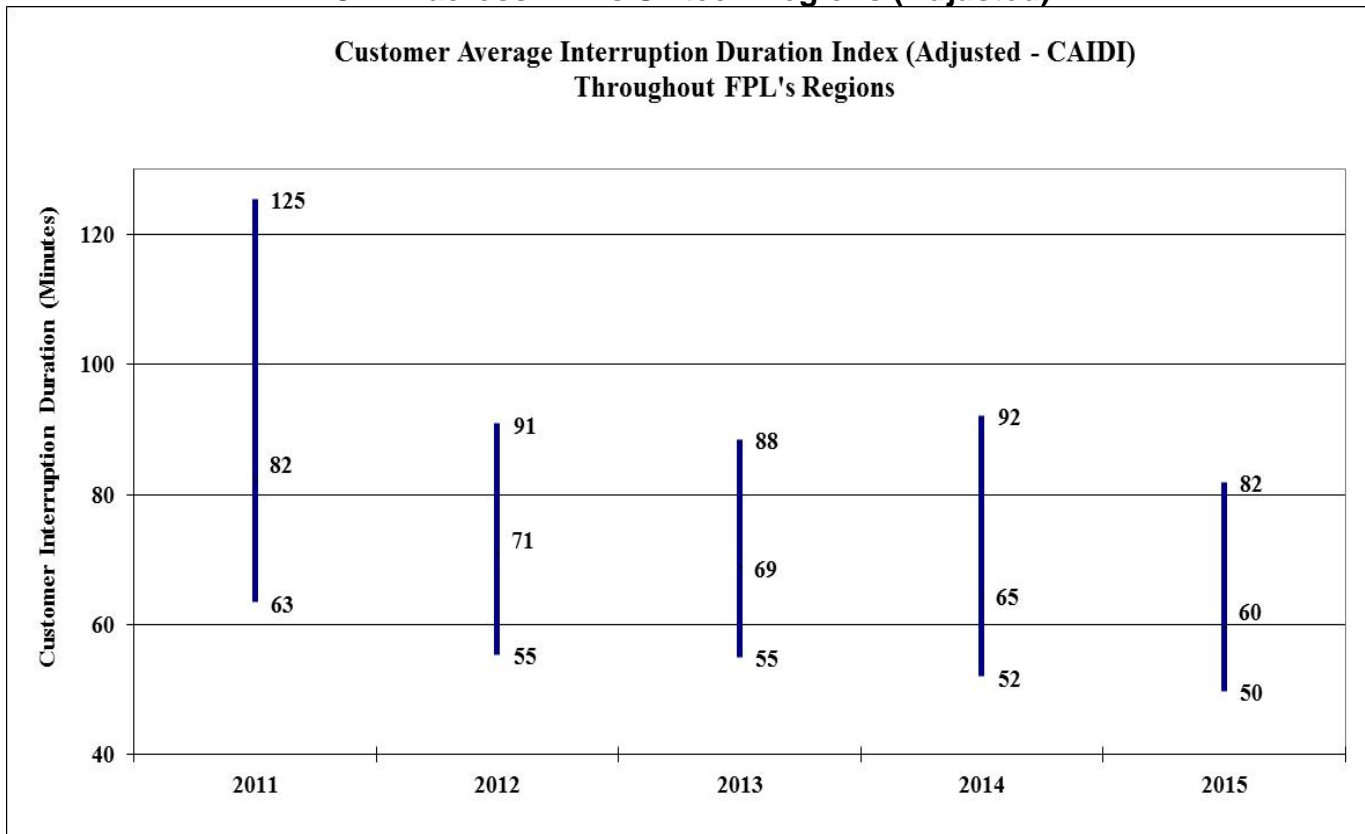
**Figure 3-11.  
CAIDI across FPL’s Sixteen Regions (Adjusted)**

**Figure 3-11** is a chart of FPL’s highest, average, and lowest CAIDI expressed in minutes. FPL’s adjusted average CAIDI has dropped approximately 8 percent from 65 minutes in 2014, to 60 minutes in 2015. The average duration of CAIDI is trending downward. For 2015, the Boca Raton service area once again reported the lowest duration of CAIDI at 50 minutes, which is a decrease from 52 minutes in 2014. The highest duration of CAIDI was 82 minutes for the North Dade service area for 2015, which is 11 percent lower than the highest CAIDI minutes in 2014.

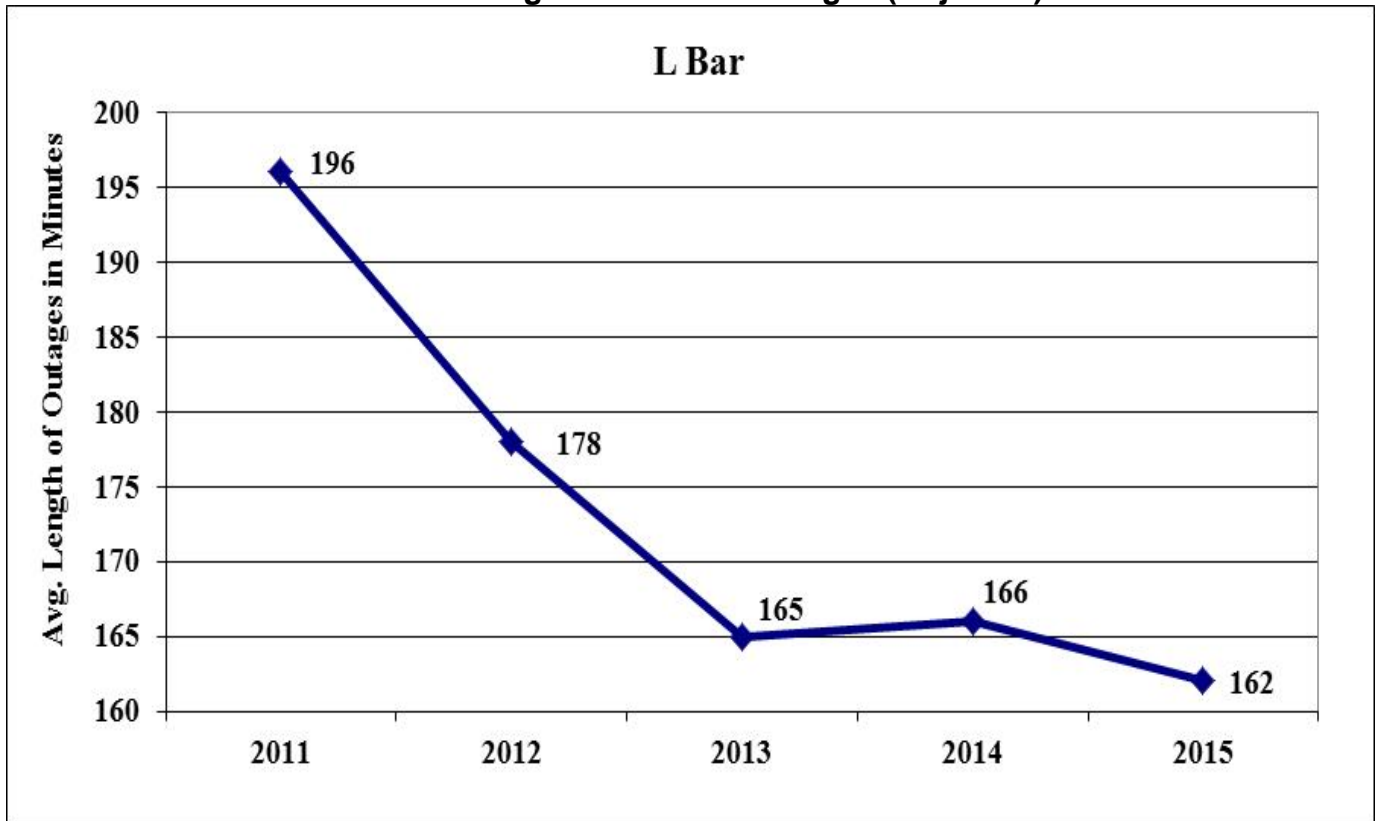
**Figure 3-12.**  
**FPL's Average Duration of Outages (Adjusted)**

**Figure 3-12** depicts the average length of time that FPL spends recovering from outage events, excluding hurricanes and other extreme outage events and is the index known as L-Bar (Average Service Restoration Time). FPL had a 2.4 percent decrease in L-Bar from 166 minutes in 2014, to 162 minutes in 2015. There is a 17 percent overall decrease since 2011, indicating FPL is spending less time restoring service.

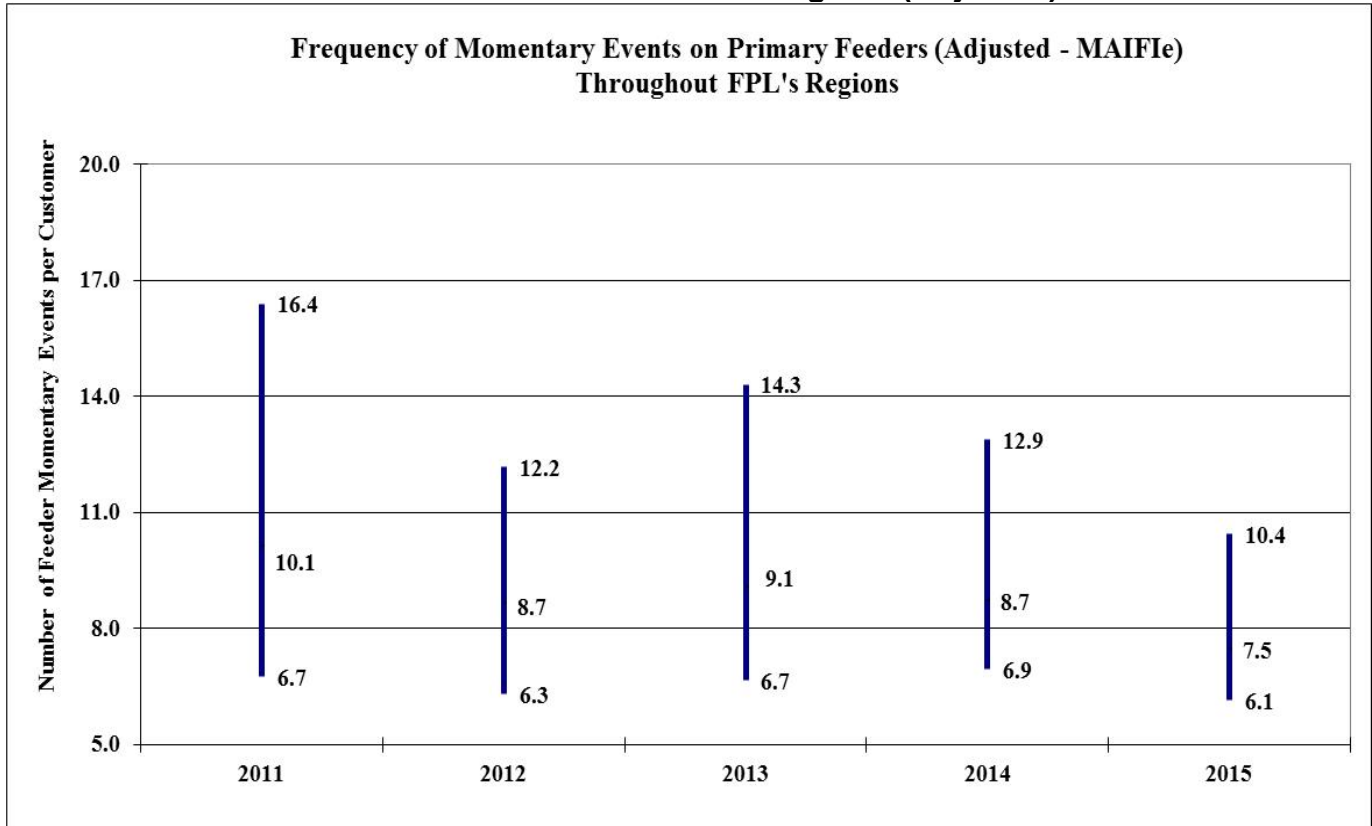
**Figure 3-13.  
MAIFle across FPL’s Sixteen Regions (Adjusted)**

**Figure 3-13** is the highest, average, and lowest adjusted MAIFle recorded across FPL’s system. FPL’s Treasure Coast, North Florida, and Wingate service areas have experienced the least reliable MAIFle results of the 16 service areas of FPL since 2011. The Pompano, Central Dade, Naples, and Manasota service areas had the fewest momentary events since 2011. The results have been trending downward (improving) over the last five years. There is a 14 percent decrease in the average MAIFle results from 2014 to 2015.

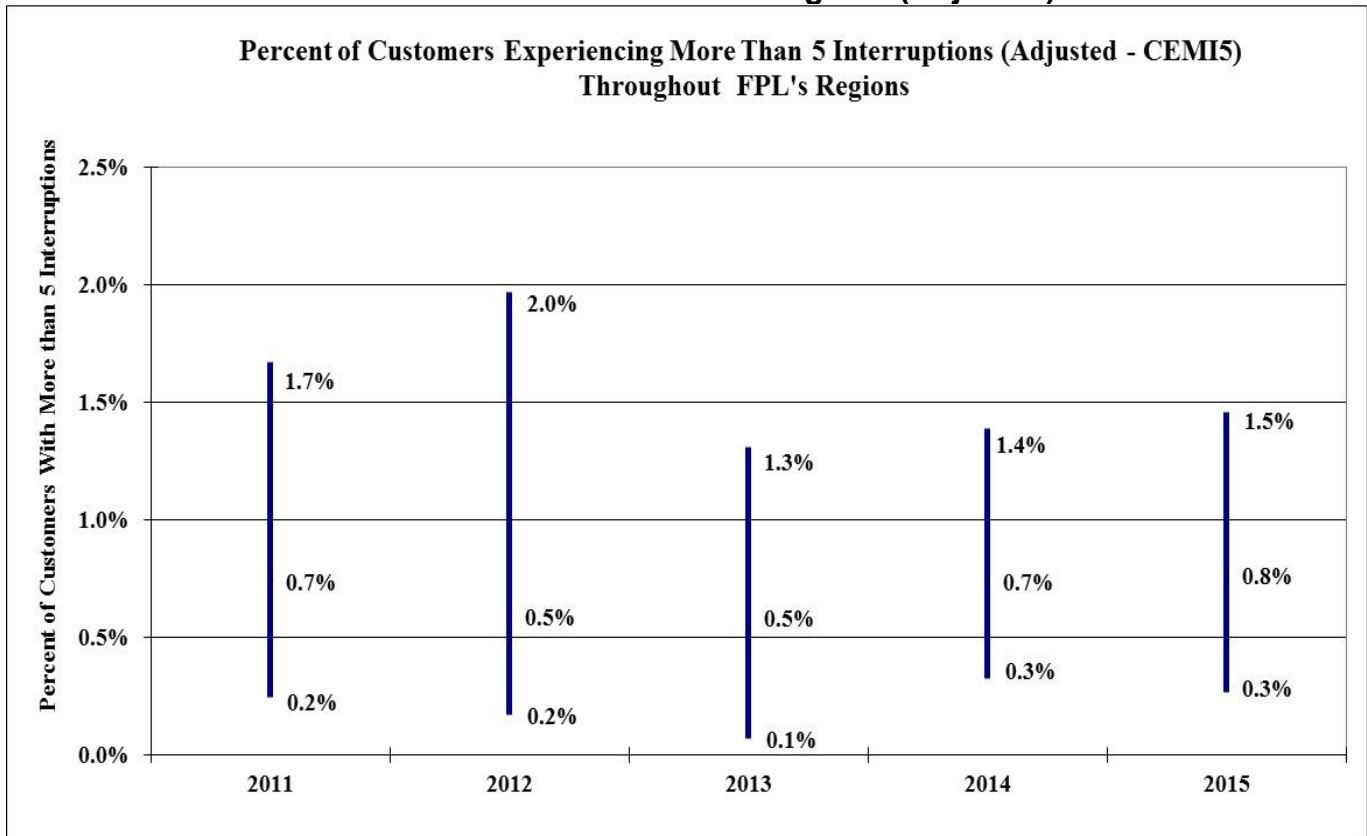
**Figure 3-14.  
CEMI5 across FPL's Sixteen Regions (Adjusted)**

**Figure 3-14** shows the highest, average, and lowest adjusted CEMI5. FPL's customers with more than five interruptions per year appear to be slightly increasing and trending upward. The service areas experiencing the highest CEMI5 over the five-year period appear to fluctuate among North Florida, West Dade, Boca Raton, and West Palm. Pompano, Central Dade, and Brevard are reported as having the lowest percentages in the last five years. The average CEMI5 result for 2015 was 0.8 percent compared to 0.7 percent in 2014.

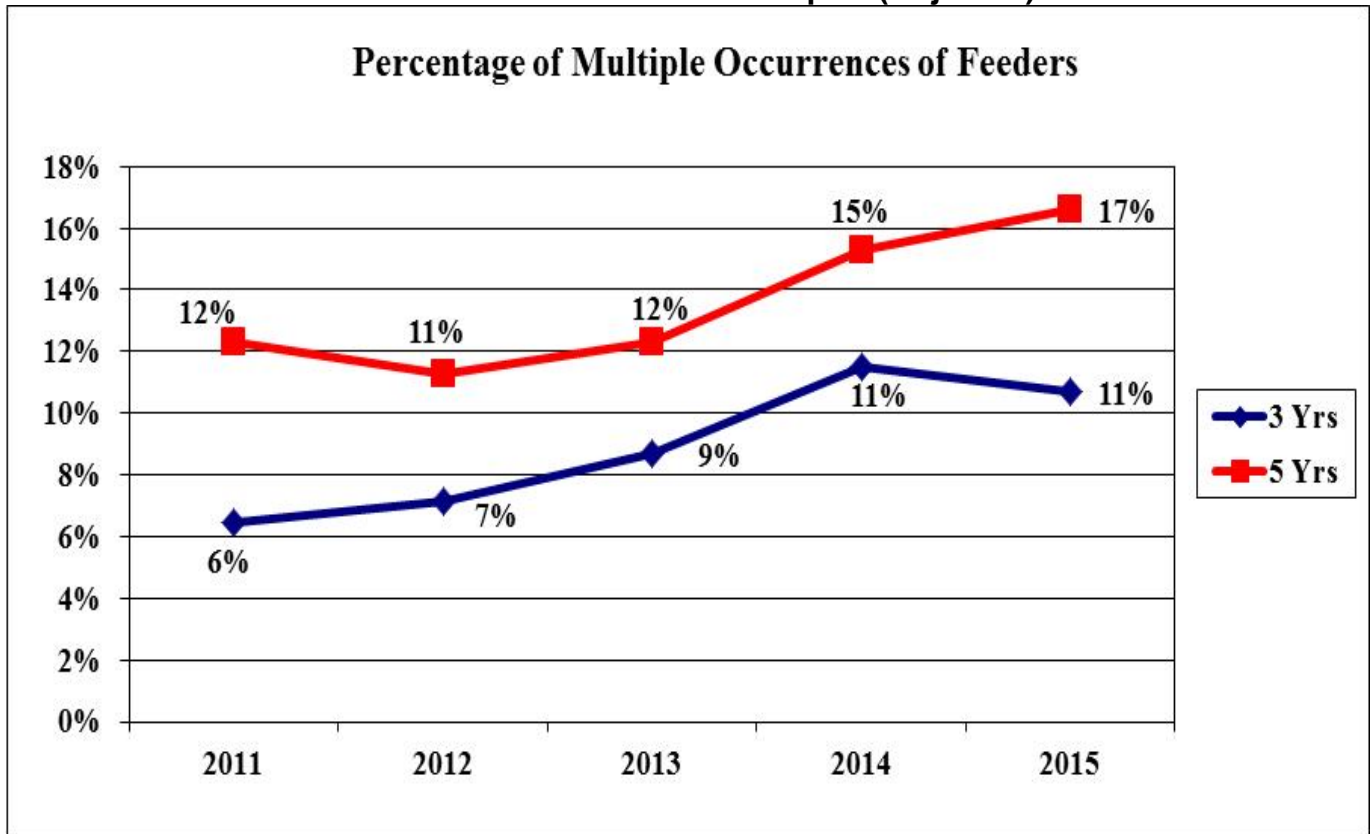
**Figure 3-15.**  
**FPL's Three Percent Feeder report (Adjusted)**

**Figure 3-15** is a graphical representation of the percentage of multiple occurrences of FPL's feeders and is derived from The Three Percent Feeder Report, which is a listing of the top three percent of problem feeders reported by the utility. The fraction of multiple occurrences is calculated from the number of recurrences divided by the number of feeders reported. The three-year percentage had no change with 11 percent in 2014 and 11 percent in 2015. The five-year percentage increased from 15 percent in 2014 to 17 percent in 2015. Both the five-year percentage and the three-year percentage appear to be trending upward.

FPL also reported that two of these feeders were storm hardened in late 2015.

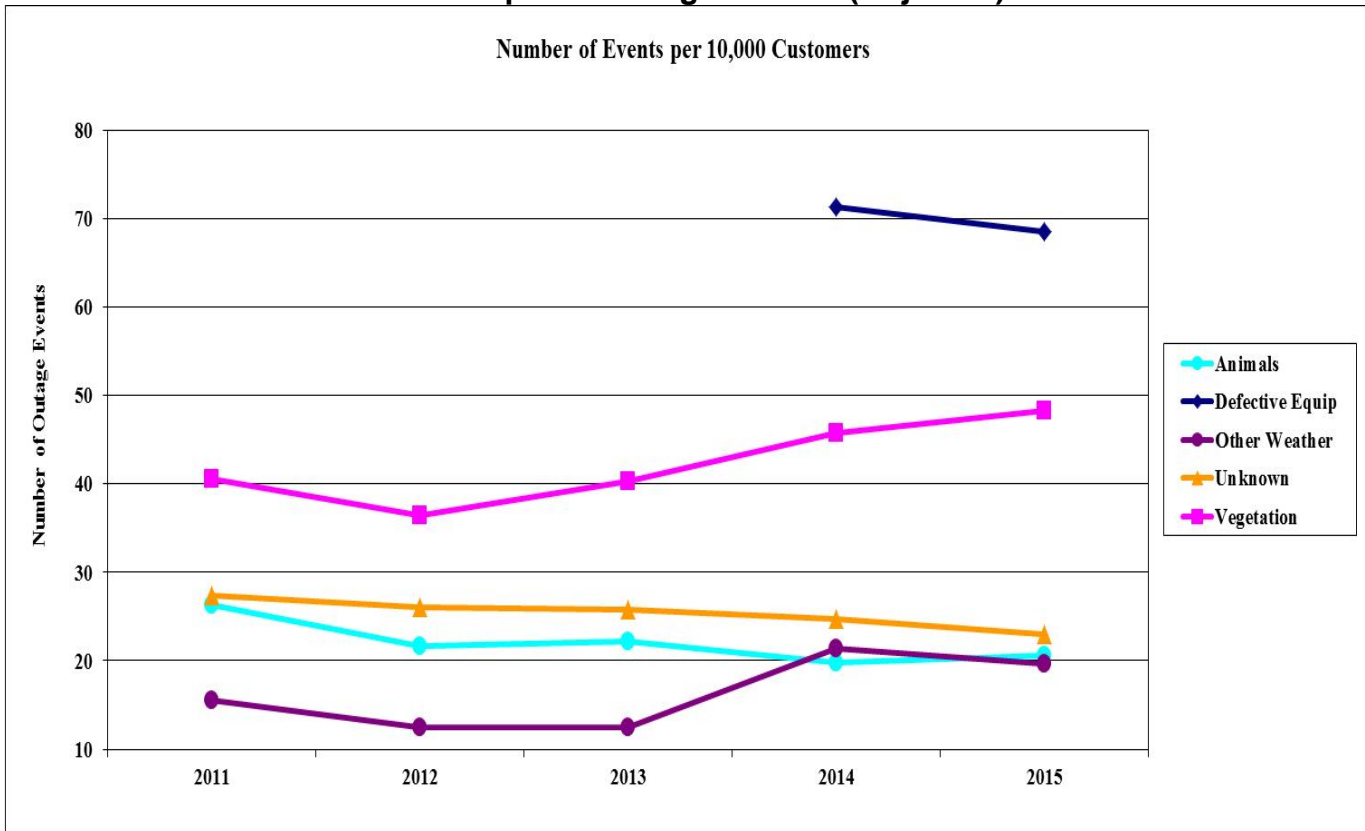
**Figure 3-16.  
FPL's Top Five Outage Causes (Adjusted)**

**Figure 3-16** depicts the top five causes of outage events on FPL’s distribution system normalized to a 10,000-customer base. The graph is based on FPL’s adjusted data of the top 10 causes of outage events. For the five-year period, the five top causes of outage events included Defective Equipment (33 percent), Vegetation (23 percent), Unknown (11 percent), Animals (10 percent), and Other Weather (9 percent) on a cumulative basis. The data shows an increasing trend in outage events caused by Vegetation and Other Weather. The number of outages increased for the Vegetation category and decreased for the Other Weather category from 2014 to 2015. The outage events due to Animals and Unknown are trending downward. The Defective Equipment category dominates the highest percentage of outage causes throughout the FPL regions. Starting in 2014, Defective Equipment includes Equipment Failure, Equipment Connect and Dig-in, which were all separate categories, in prior years.

Annually, FPL evaluates its current reliability remediation programs and verifies the program’s need and/or existence. In addition, FPL proposes new reliability remediation programs to improve its reliability performance concentrating on the highest cause codes and those cause codes that have shown trends needing attention. FPL has 17 reliability programs listed for its 2016 budget. The programs include: priority feeder inspection, distribution automation (installing and maintaining automated feeder switches, automated lateral switches and fault current indicators), and replacing oil circuit reclosers with electronic reclosers. Six programs are designed to help improve the Vegetation cause code, which had an increase in 2015. Along with those six programs, FPL has several other initiatives to address vegetation issues, including FPL’s “Right Tree, Right Place” and Palm Management programs. Four programs are intended to help improve the Animal cause code, which also had an increase in 2015.

Defective Equipment (33 percent) and Vegetation (23 percent) outages were the leading causes of the number of outage events per customer for 2015. Starting in 2014, Defective Equipment includes Equipment Failure, Equipment Connect and Dig-in, which were all separate categories, in prior years. Outages caused by vegetation are addressed through FPL's Vegetation Management Program. The next three outage causes are Unknown (11 percent), Animals (10 percent) and Other Weather (9 percent). Analysis of **Figure 3-16** shows an increasing trend in the number of outage events attributed to Vegetation, causing the number of outages to increase by 8 percent from 2014 to 2015. The analysis shows a decreasing trend in the number of outage events caused by Defective Equipment, causing the number of outages to decrease by 1 percent from 2014 to 2015 and a decreasing trend of outage events by Unknown, causing a decrease of 4 percent from 2014 to 2015. The analysis shows that the trend for the Animals category is trending downward even though there was an increase in outages of 6 percent and the Other Weather category is trending upward even though there was a decrease in outages of 5 percent.
