***Review of  
Florida's  
Investor-Owned  
Electric Utilities***

***2 0 1 5  
Service Reliability Reports***

**State of Florida  
Florida Public Service Commission  
Division of Engineering**

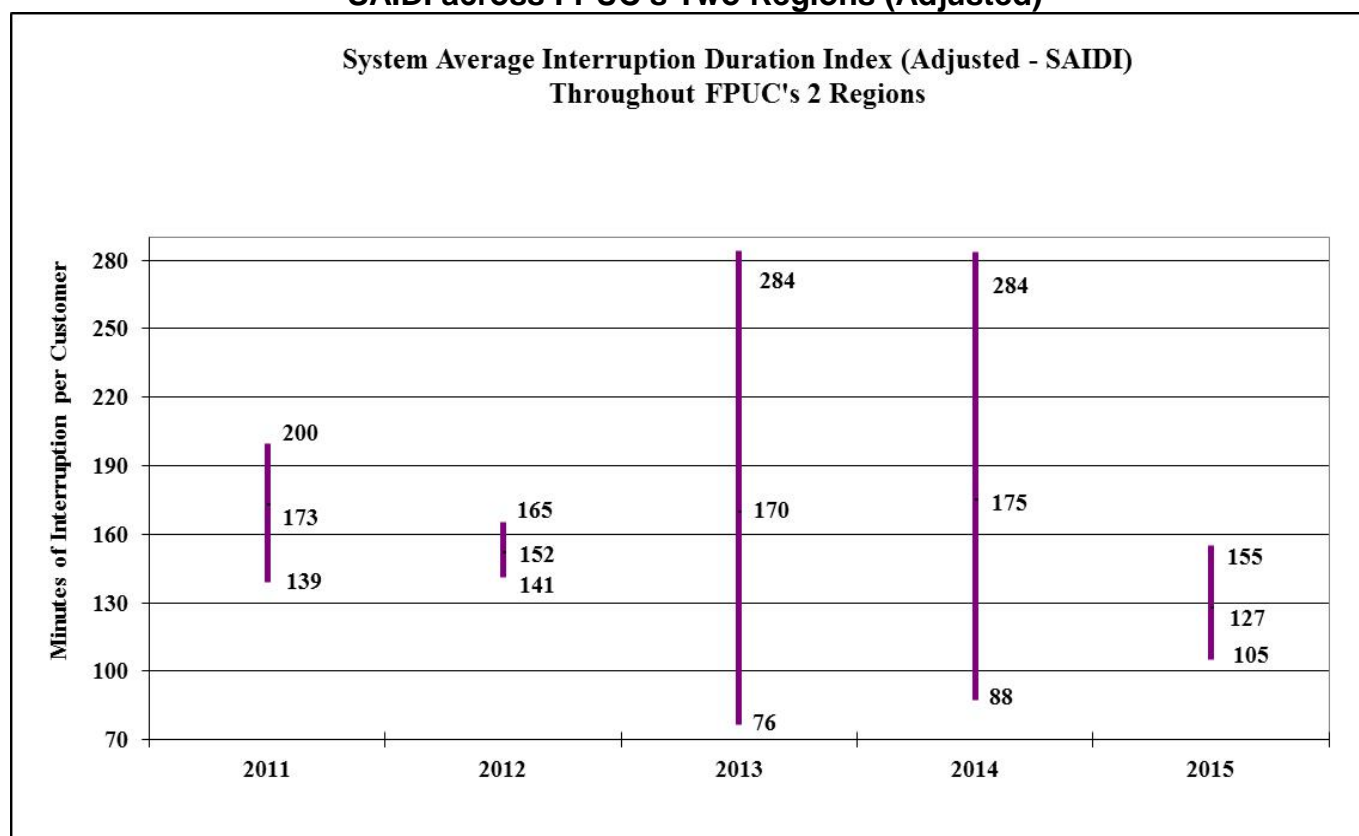
**Figure 3-17.**  
**SAIDI across FPUC's Two Regions (Adjusted)**

**Figure 3-17** shows the highest, average, and lowest adjusted SAIDI values recorded by FPUC's system. The data shows the average SAIDI index is trending downward for the five-year period of 2011 to 2015 and there was a 27 percent decrease from 2014 to 2015. FPUC's 2015 Reliability Report notes that the reliability indicators continue to be heavily influenced by the weather and the small size of the territories.

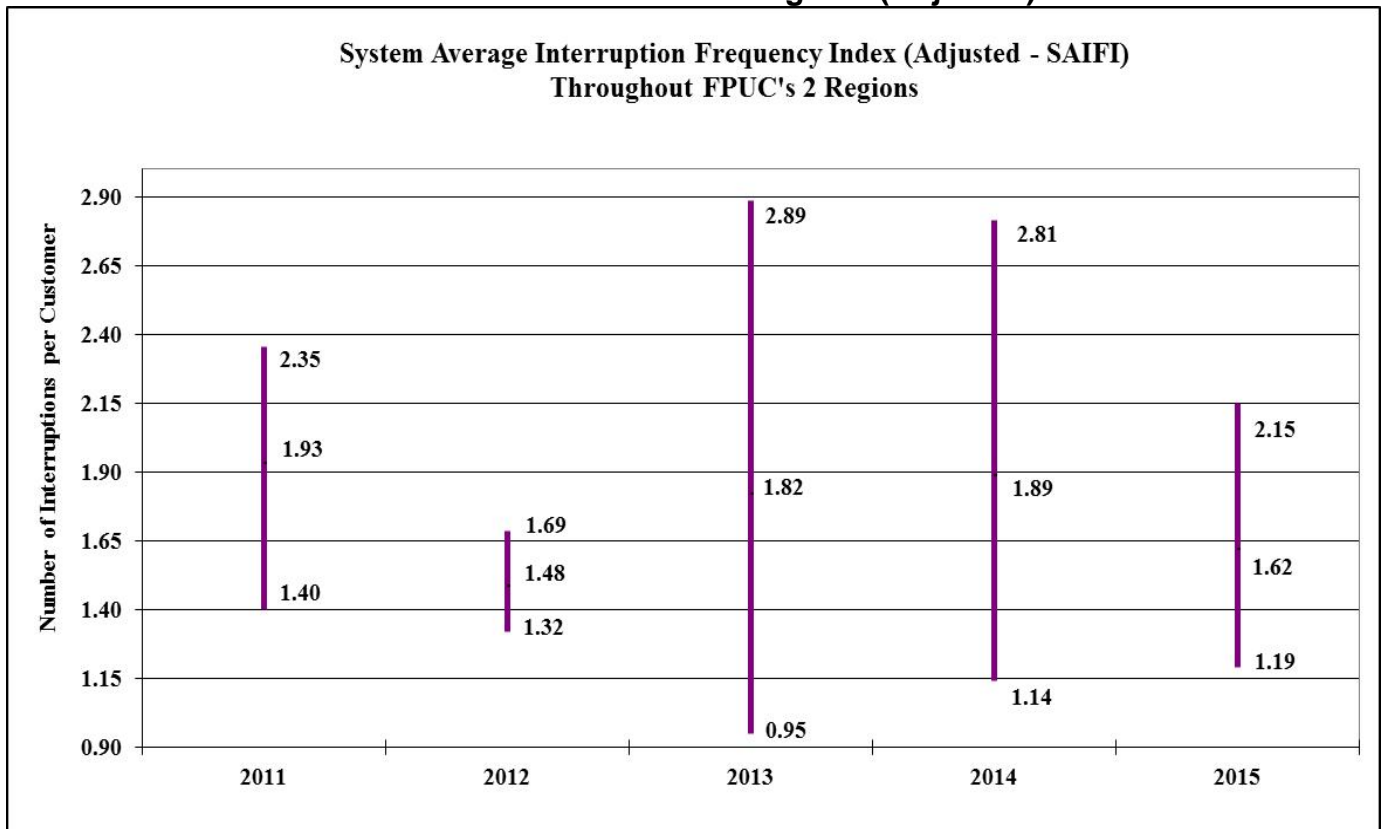
**Figure 3-18.  
SAIFI across FPUC's Two Regions (Adjusted)**

**Figure 3-18** shows the adjusted SAIFI across FPUC's two divisions. The data depicts a 14 percent decrease in the 2015 average SAIFI reliability index from 2014. The data for the minimum and average SAIFI values are trending downward over the five-year period of 2011 to 2015 as the trend line for the maximum SAIFI value is trending upward for the same period.

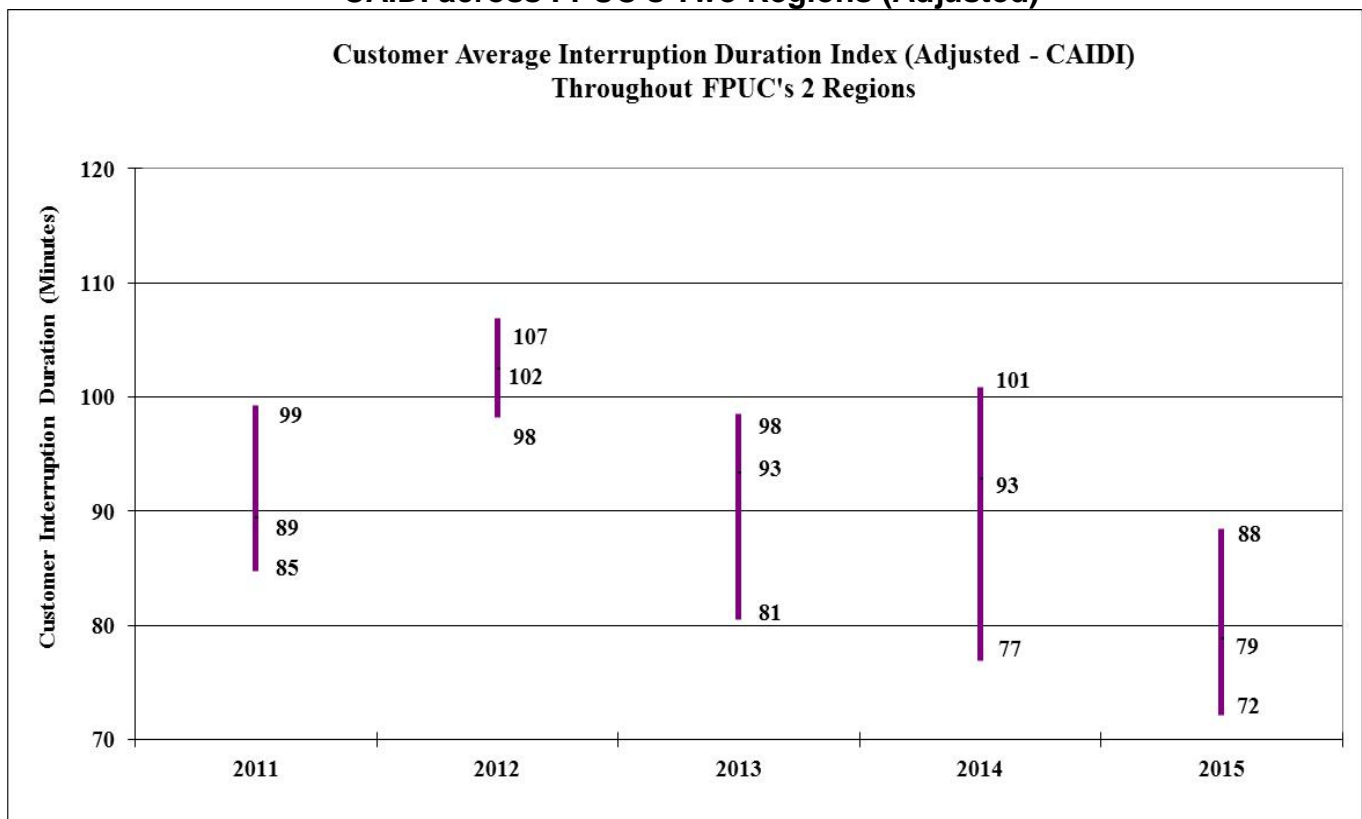
**Figure 3-19.  
CAIDI across FPUC's Two Regions (Adjusted)**

**Figure 3-19** shows the highest, average, and lowest adjusted CAIDI values across FPUC's system. FPUC's data shows the average CAIDI value decreased by 15 percent for 2015 (79 minutes) when compared to 2014 (93 minutes). For the past five years, the maximum, the minimum, and the average CAIDI values are trending downward.

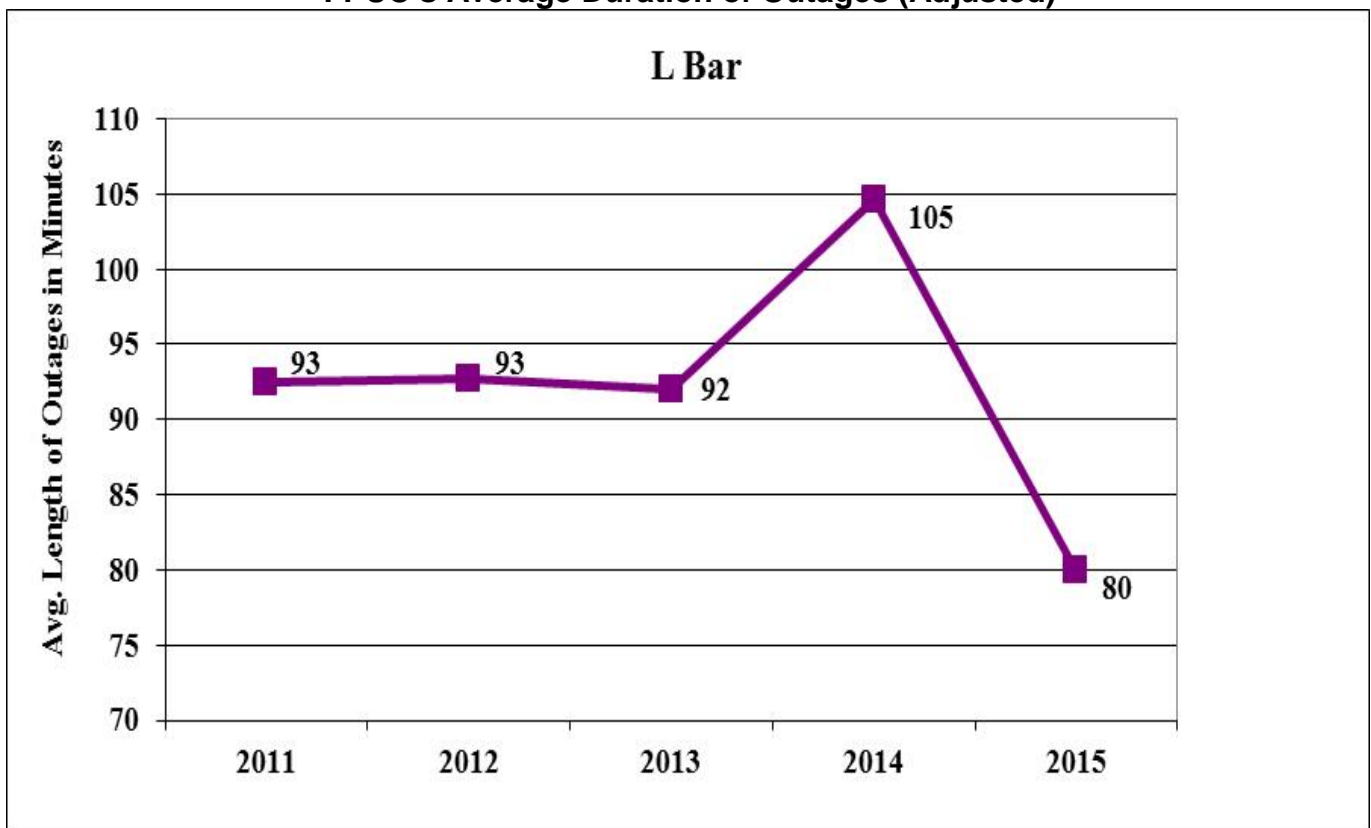
**Figure 3-20.**  
**FPUC's Average Duration of Outages (Adjusted)**

**Figure 3-20** is the average length of time FPUC spends recovering from outage events (adjusted L-Bar). There was a 24 percent decrease in the L-Bar value from 2014 to 2015. The data for the five-year period of 2011 to 2015 suggests that the L-Bar index is trending downward indicating FPUC is taking less time to restore service after an outage event.

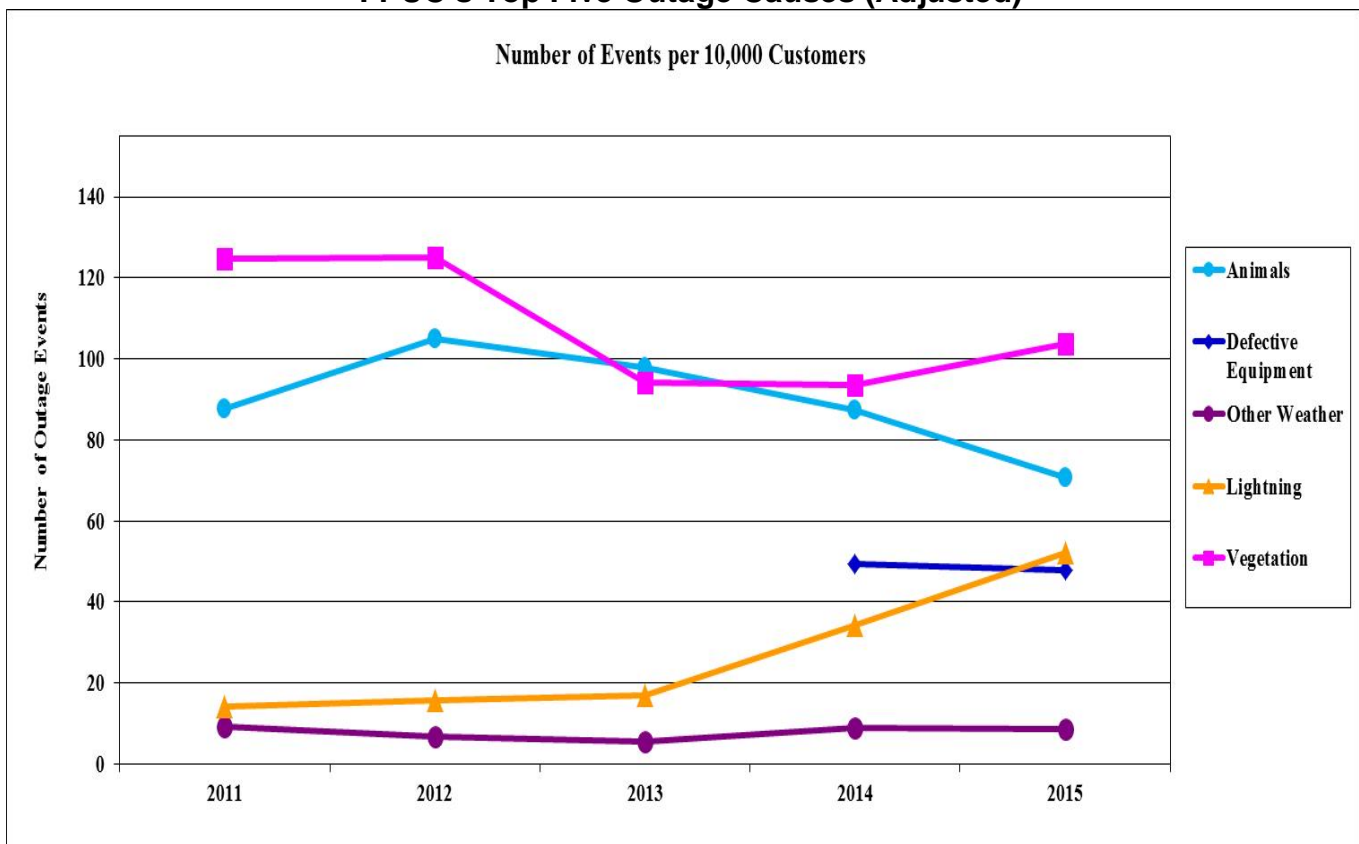
**Figure 3-21.  
FPUC's Top Five Outage Causes (Adjusted)**

**Figure 3-21** shows the top five causes of outage events on FPUC's distribution system normalized to a 10,000-customer base. The figure is based on FPUC's adjusted data of the top 10 causes of outages. For 2015, the top five causes of outage events were Vegetation (27 percent), Animals (19 percent), Other Weather (16 percent), Lightning (14 percent), and Defective Equipment (13 percent). These five factors represent 89 percent of the total adjusted outage causes in 2015. The cause by Lightning is trending upward and increased 44 percent from 2014 to 2015. The causes by Defective Equipment, Animals, and Vegetation are trending downward. Defective Equipment and Vegetation increased 12 percent and 24 percent from 2014 to 2015, respectively. The Animals category decreased 5 percent during the same time period. The Other Weather category caused outages has remained relatively flat over the five-year period of 2011 to 2015, even though there was a 46 percent decrease from 2014 to 2015. Beginning with 2014, the Defective Equipment category now includes outage categories that in the past were separately identified.

FPUC's top five causes of outages included Vegetation, Animals, Other Weather, Lightning, and Defective Equipment events. Vegetation (27 percent) related outages were the number one cause of outages in 2015 as shown in **Figure 3-21** followed by Animals (19 percent), Other Weather (16 percent), Lightning (14 percent), and Defective Equipment (13 percent). Animal and Other

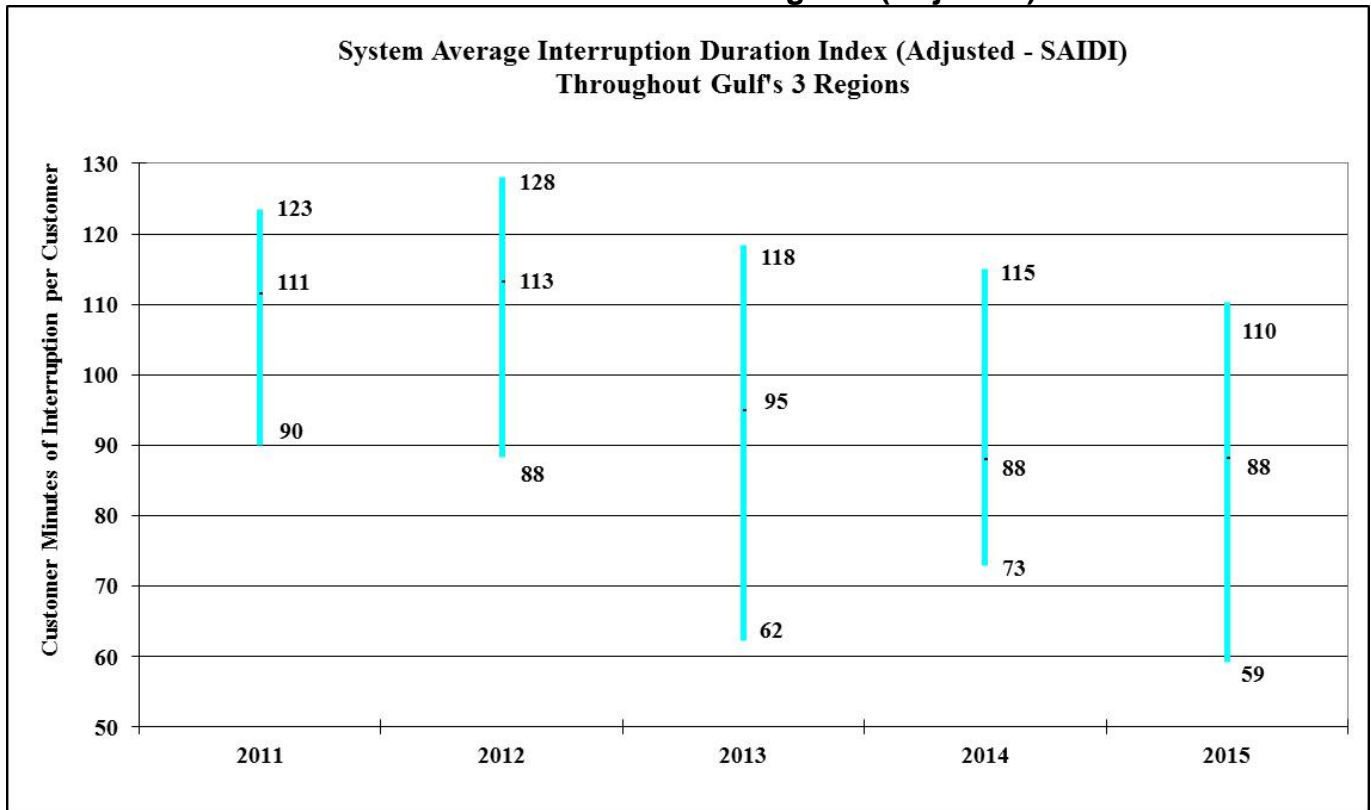
**Figure 3-22.  
SAIDI across Gulf's Three Regions (Adjusted)**

**Figure 3-22** illustrates Gulf's SAIDI minutes, or the interruption duration minutes on a system basis. The chart depicts no change in the average SAIDI in Gulf's combined regions when compared to the 2014 results. Gulf's 2015 average performance was 88 minutes as were the 2014 SAIDI results. The highest SAIDI value for the past five years has fluctuated between the three regions as the Central and Eastern districts have the best or lowest SAIDI values. The maximum, minimum, and average SAIDI indices are continuing to trend downward, showing improvements.

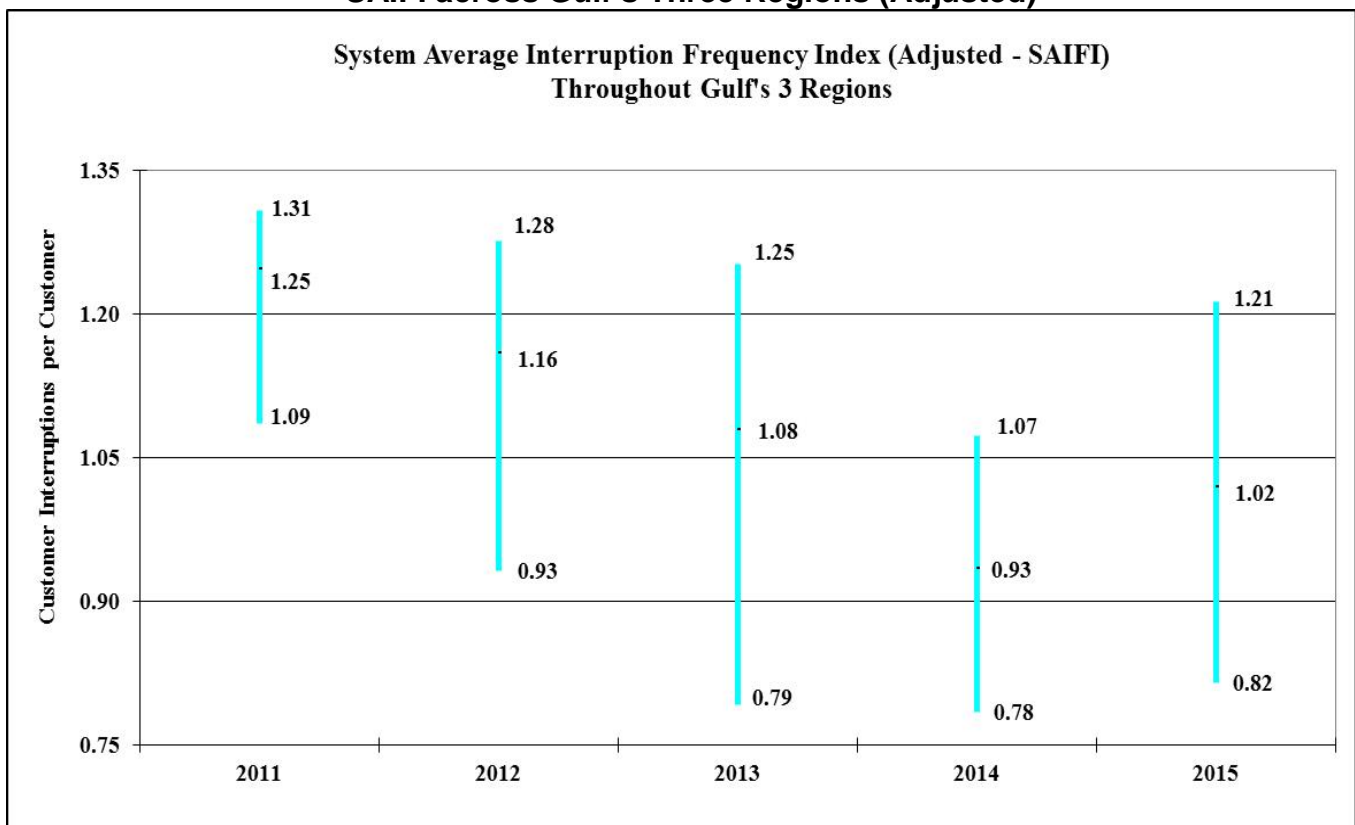
**Figure 3-23.  
SAIFI across Gulf's Three Regions (Adjusted)**

**Figure 3-23** illustrates that Gulf's SAIFI had a 9 percent increase in 2015 when compared to 2014. The highest SAIFI value for the past five years has fluctuated between the three regions. The lowest values appear to fluctuate between the Central region and the Eastern region. The maximum, minimum, and average SAIFI values still appear to be trending downward.

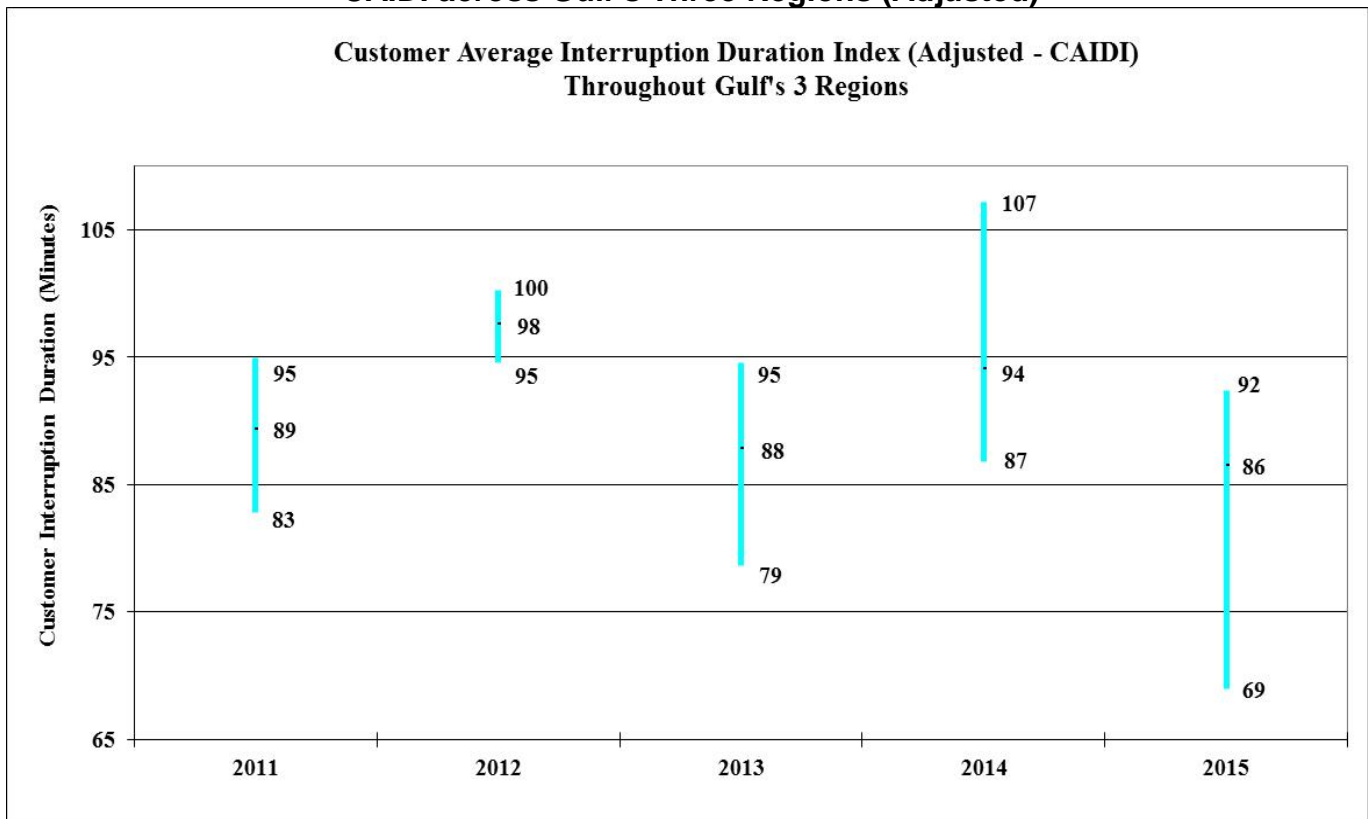
**Figure 3-24.  
CAIDI across Gulf's Three Regions (Adjusted)**

**Figure 3-24** is Gulf's adjusted CAIDI. For 2015, the average CAIDI is 86 minutes and represents a 9 percent decrease from the 2014 value of 94 minutes. In 2015, the Central region had the highest CAIDI value, as the Eastern region had the lowest CAIDI. Staff notes that the average and the minimum CAIDI values are trending upward as the maximum CAIDI value is remaining relatively flat.

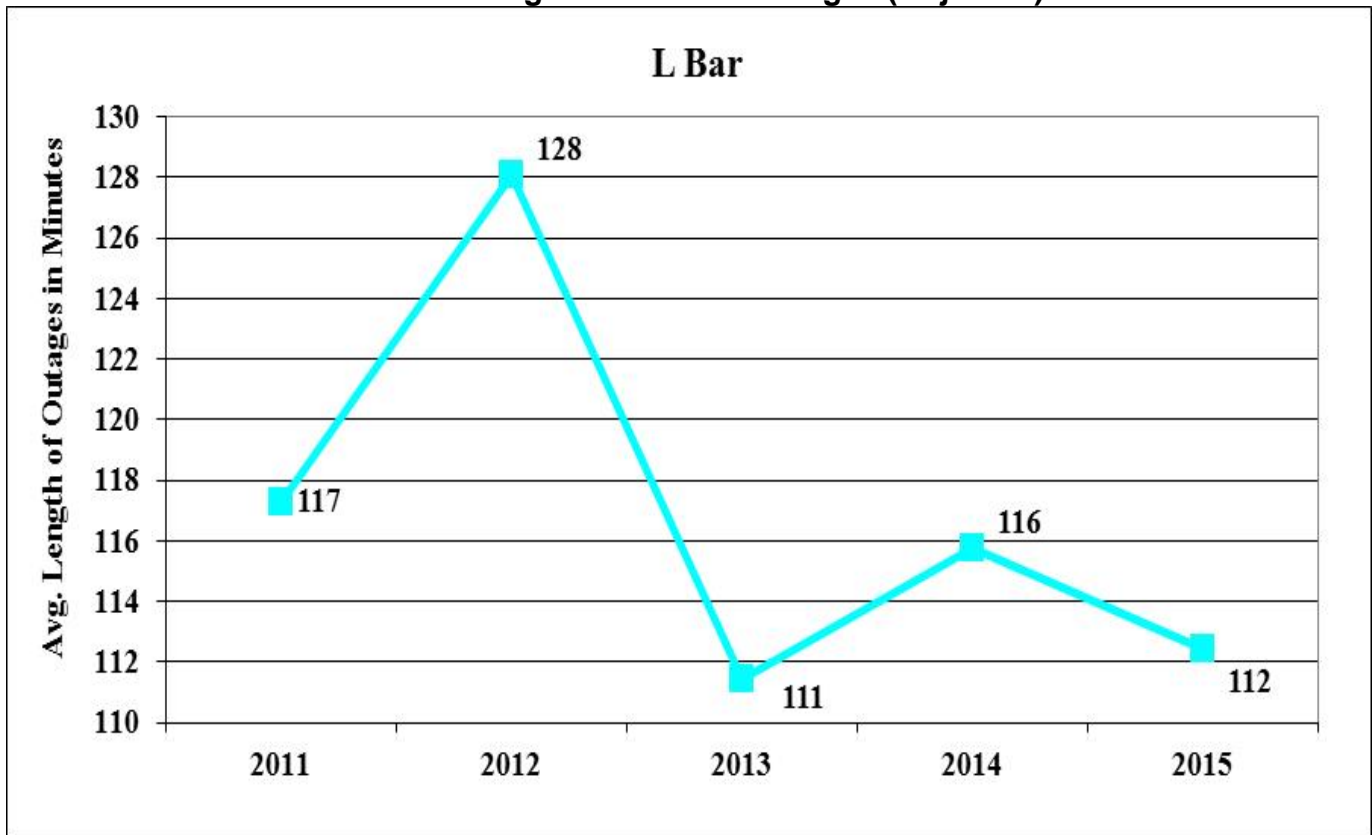
**Figure 3-25.**  
**Gulf's Average Duration of Outages (Adjusted)**

**Figure 3-25** illustrates Gulf's L-Bar or the average length of time Gulf spends recovering from outage events, excluding hurricanes and other allowable excluded outage events. Gulf's L-Bar showed a 3 percent decrease from 2014 to 2015. The data for the five-year period of 2011 to 2015 still shows a downward trend.

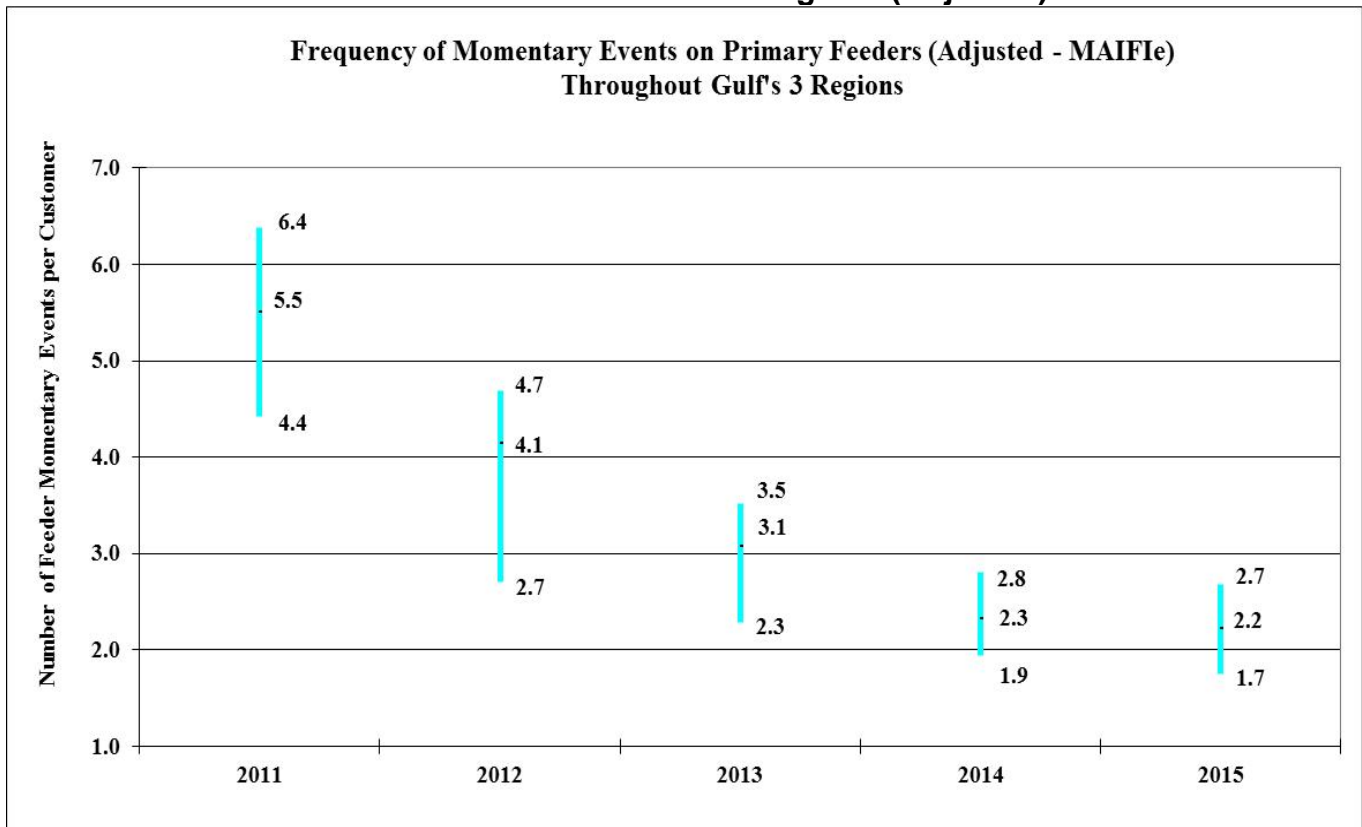
**Figure 3-26.  
MAIFle across Gulf’s Three Regions (Adjusted)**

**Figure 3-26** is the adjusted MAIFle recorded across Gulf’s system. The adjusted MAIFle results by region show that the Eastern region once again had the lowest frequency of momentary events on primary feeders. The Western region has the highest MAIFle index in 2015, with a 4 percent improvement when compared to 2014. The data suggest that the highest, average, and lowest MAIFle are all continuing to trend downward, suggesting improvement.

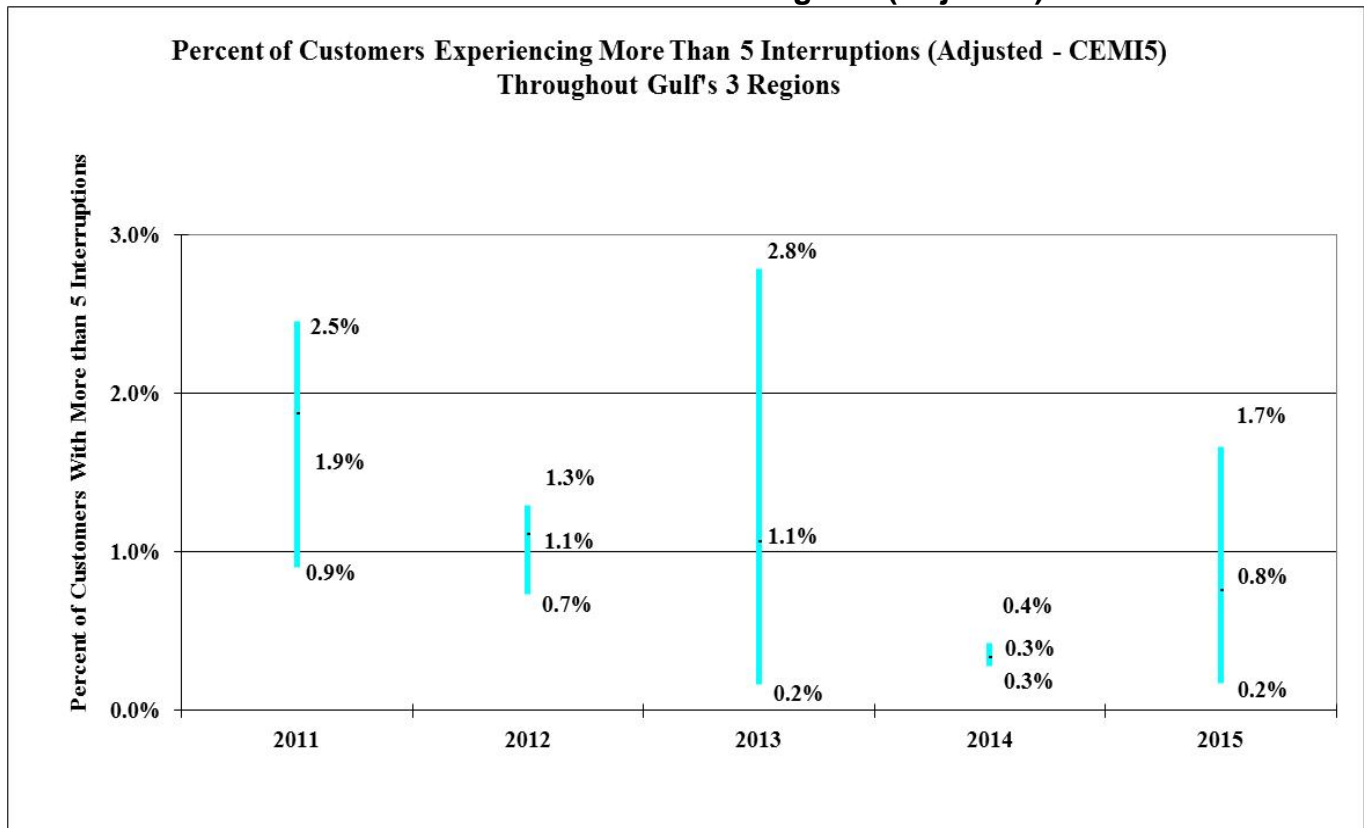
**Figure 3-27.  
CEMI5 across Gulf’s Three Regions (Adjusted)**

**Figure 3-27** shows the highest, average, and lowest adjusted CEMI5 across Gulf’s Western, Central, and Eastern regions. Gulf’s 2015 results illustrate a 63 percent increase in the average CEMI5 percentage when compared to 2014. The average, lowest, and highest CEMI5 appears to still be trending downward over the five-year period of 2011 to 2015, suggesting that the percentage of Gulf’s customers experiencing more than five interruptions is decreasing and improving.

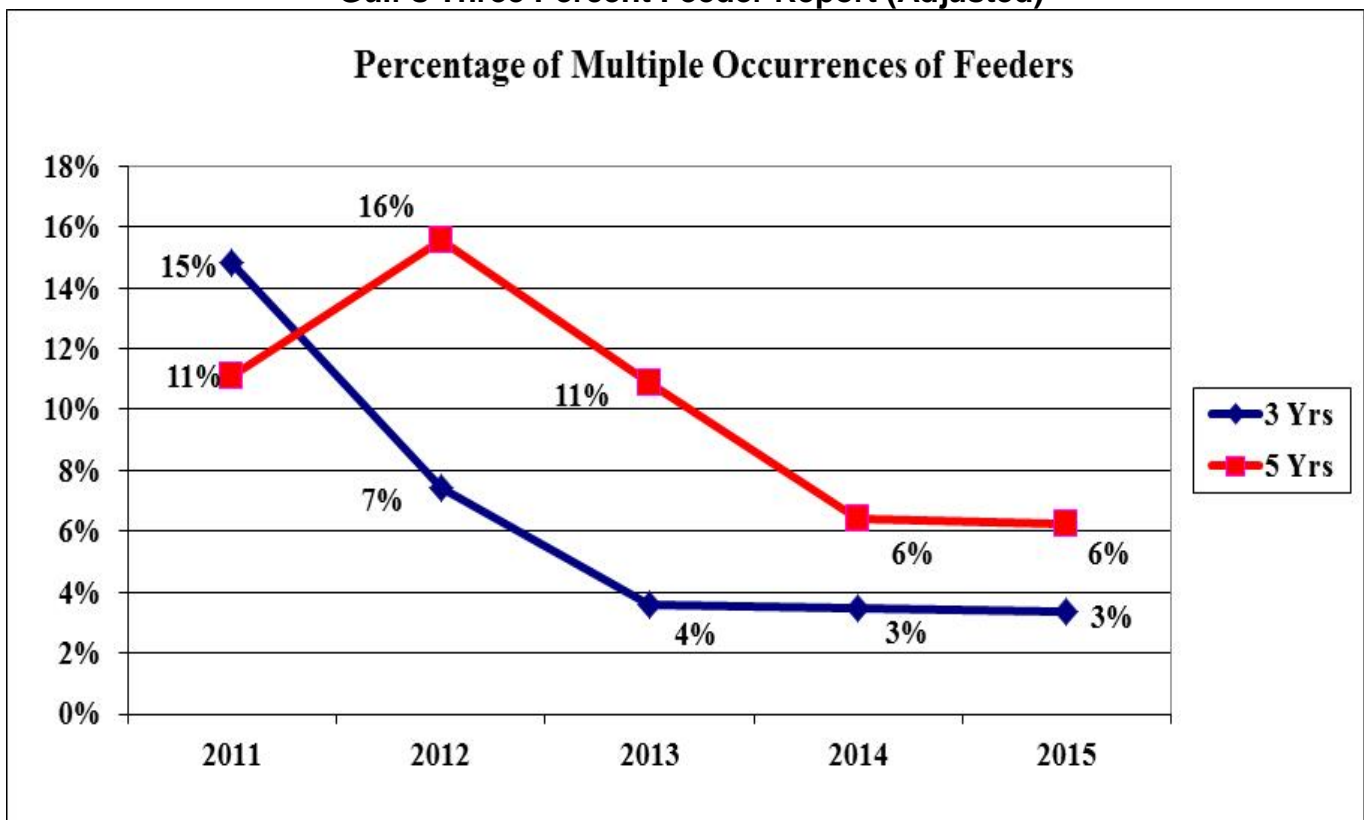
**Figure 3-28.**  
**Gulf's Three Percent Feeder Report (Adjusted)**

**Figure 3-28** shows the multiple occurrences of feeders using the utility's Three Percent Feeder Report and is analyzed on a three- and five-year basis. The Three Percent Feeder Report is a listing of the top three percent of feeders that have the most feeder outage events. The supporting data illustrates that the five-year multiple occurrences did not change from 2014 to 2015 along with the three-year multiple occurrences. The five-year period of 2011 to 2015 indicates overall that the five-year index is trending downward, as is the three-year multiple occurrences index.

Staff notes there was one feeder on the Three Percent Feeder Report with the last two years consecutively. Gulf reported that feeder 5542 experienced four outages in 2015. Three outages were created by Gulf's control center to create a safe work environment and all three outages lasted less than six minutes. The fourth outage was due to the severe weather event on April 25, 2015, when a switch was damaged by lightning. The customers lost power for approximately 124 minutes. Additional review of the feeder will be conducted to determine if there are any specific improvements that can be performed to improve performance of the feeders including installing smart devices that will enable operators to de-energize smaller sections of the feeder.

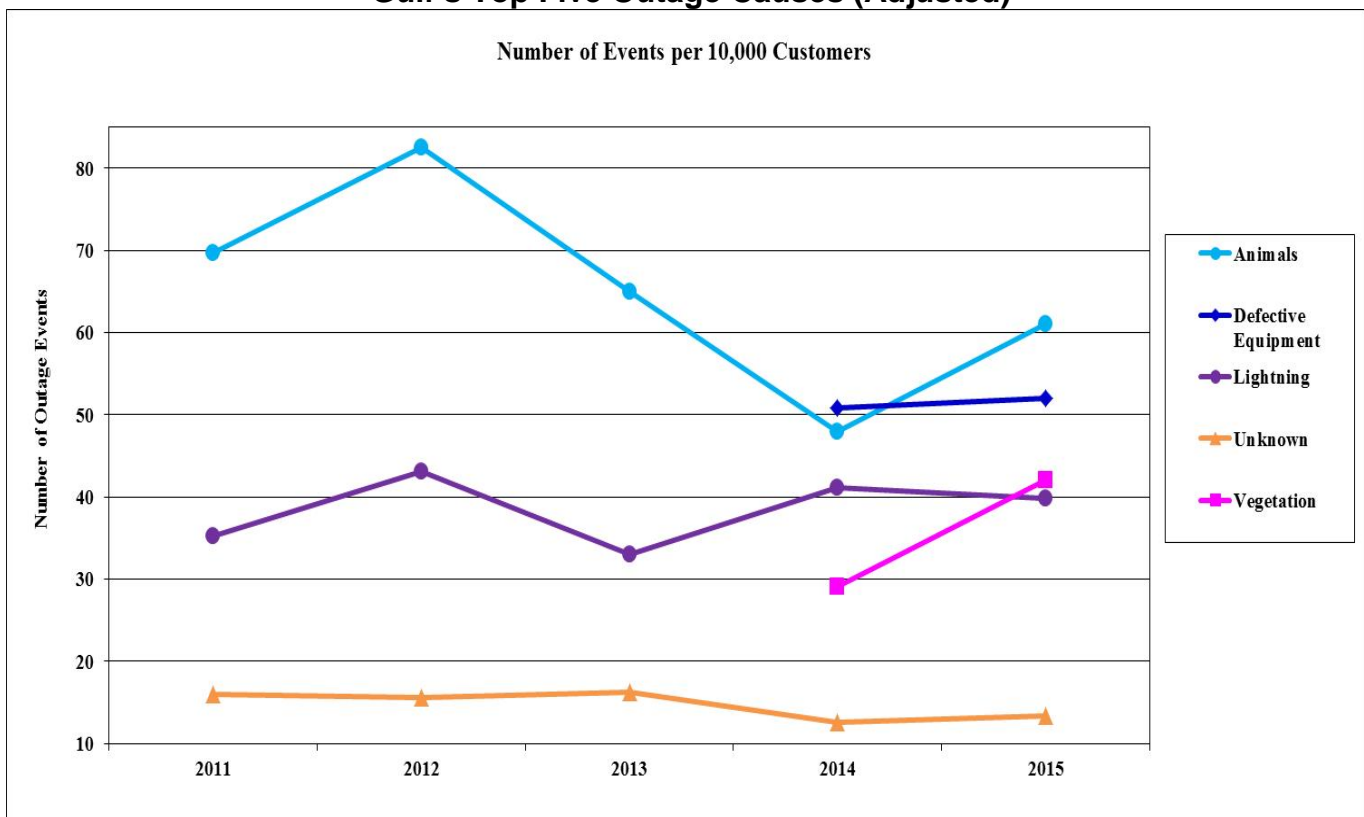
**Figure 3-29.**  
**Gulf’s Top Five Outage Causes (Adjusted)**

**Figure 3-29** is a graph of the top five causes of outage events on Gulf’s distribution system normalized to a 10,000-customer base. The figure is based on Gulf’s adjusted data of the top 10 causes of outage events and represents 91 percent of the total adjusted outage events that occurred during 2015. The top five causes of outage events were Animals (27 percent), Defective Equipment (23 percent), Vegetation (18 percent), Lightning (17 percent), and Unknown Causes (6 percent). The percentage of outages due to Animals was the highest cause of outages. As the number of outage events due to Animals is trending downward, even though there was an increase in 2015, the number of outage events due to Lightning and Unknown causes has remained relatively flat. The number of outages due to Defective Equipment and Vegetation are both trending upward. The Defective Equipment and Vegetation categories now include outage categories that in the past were separately identified. To improve reliability, Gulf continues to install animal protection on all major equipment and transformers. Gulf added Animal related outages as a stand-alone initiative in 2016 to its Root Cause Mitigation program. Through the Root Cause Mitigation program, Gulf will review feeders with a high number of Animal related outages and install additional animal protection when needed. In addition, Gulf continues to encourage its employees to report vegetation conditions so those issues can be remedied as soon as possible.

Gulf's top five causes of outages were listed as Animals, Defective Equipment, Vegetation, Lightning, and Unknown. Animal (27 percent) caused outages was the number one cause of outages followed by Defective Equipment (23 percent), Vegetation (18 percent), Lightning (17 percent), and Unknown (6 percent). The number of outages decreased for three of the top five outage categories in 2015 when compared to 2014, which were outages due to Defective Equipment, Lightning, and Unknown as shown in **Figure 3-29**. The Defective Equipment and Vegetation categories now include outage categories which in the past were separately identified.

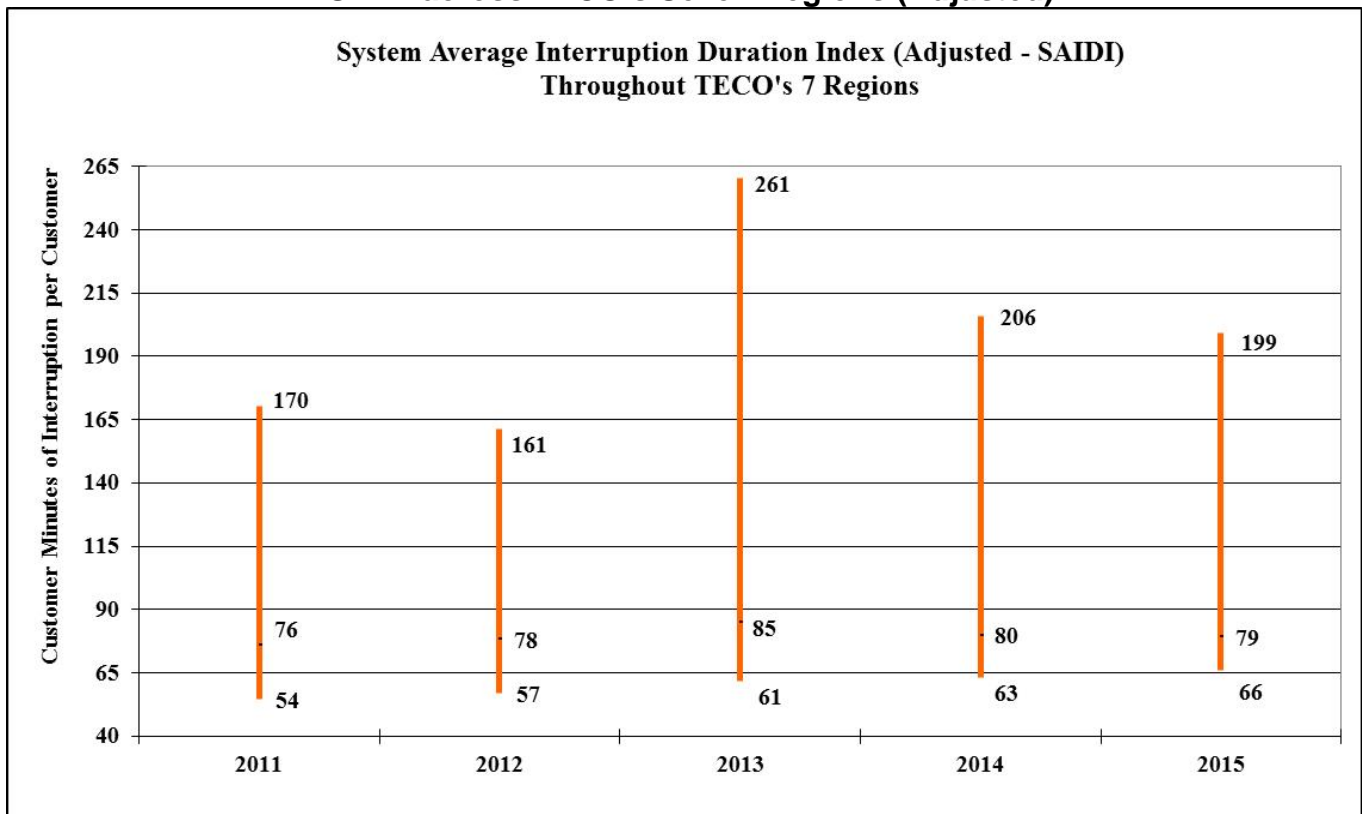
**Figure 3-30.**  
**SAIDI across TECO's Seven Regions (Adjusted)**

**Figure 3-30** shows the adjusted SAIDI values recorded by TECO's system. Two of the seven TECO regions had an increase in SAIDI performance during 2015, with Dade City having the highest SAIDI performance results for the five-year period of 2011 to 2015. The lowest SAIDI index for the seven regions appears to be trending upward. The average SAIDI index decreased 1 percent from 2014 to 2015 and appears to also be trending upward. The Central, Eastern, and Winter Haven regions recorded the lowest SAIDI indices for the five-year period. Dade City, Plant City, and South Hillsborough regions have the fewest customers and represent the most rural, lowest customer density per line mile in comparison to the other four TECO divisions.

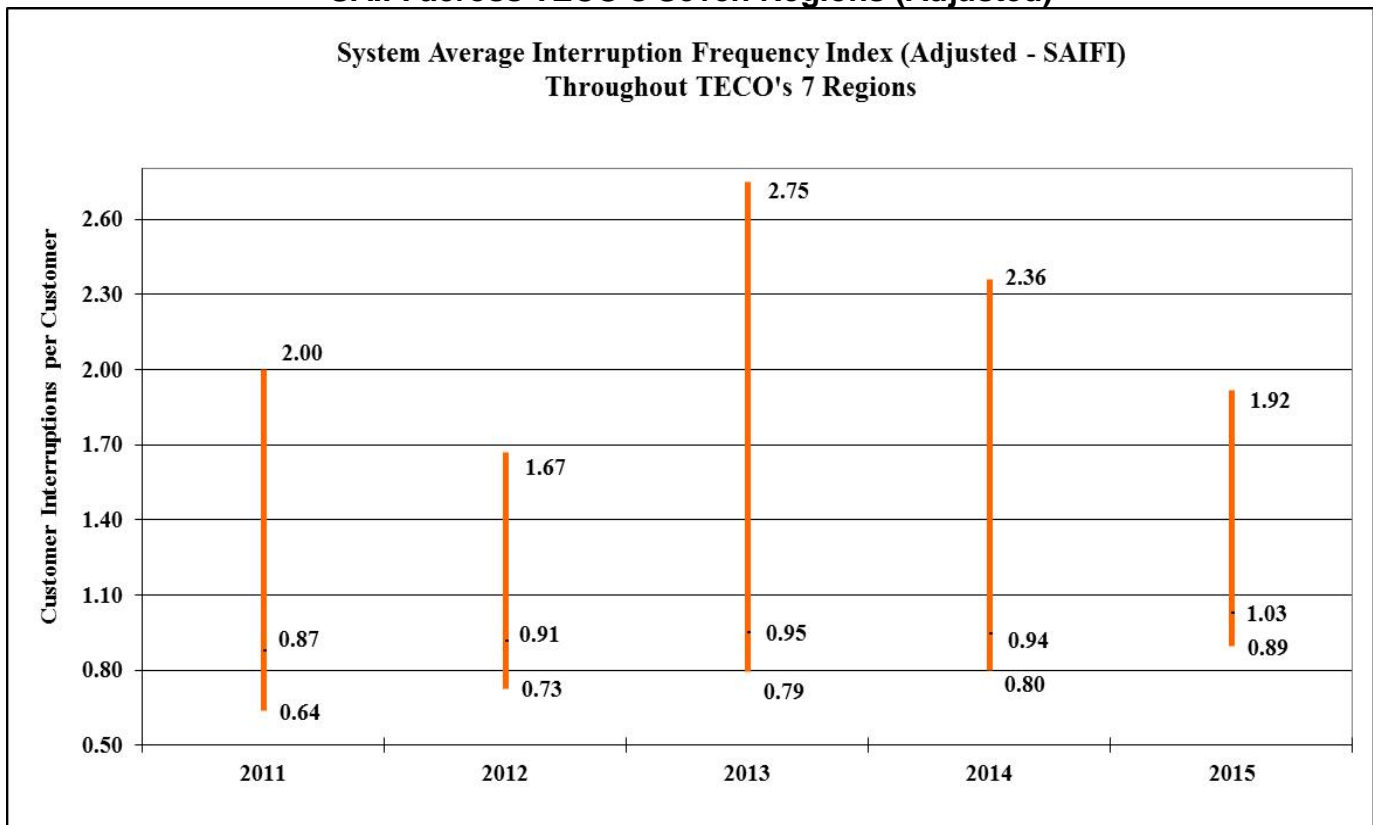
**Figure 3-31.**  
**SAIFI across TECO's Seven Regions (Adjusted)**

**Figures 3-31** illustrates TECO's adjusted frequency of interruptions per customer reported by the system. TECO's data represent a 9 percent increase in the SAIFI average from 0.94 interruptions in 2014 to 1.03 interruptions in 2015. TECO's Dade City region continues to have the highest frequency of service interruptions when compared to TECO's other regions. The maximum, minimum, and average SAIFI are all trending upward.

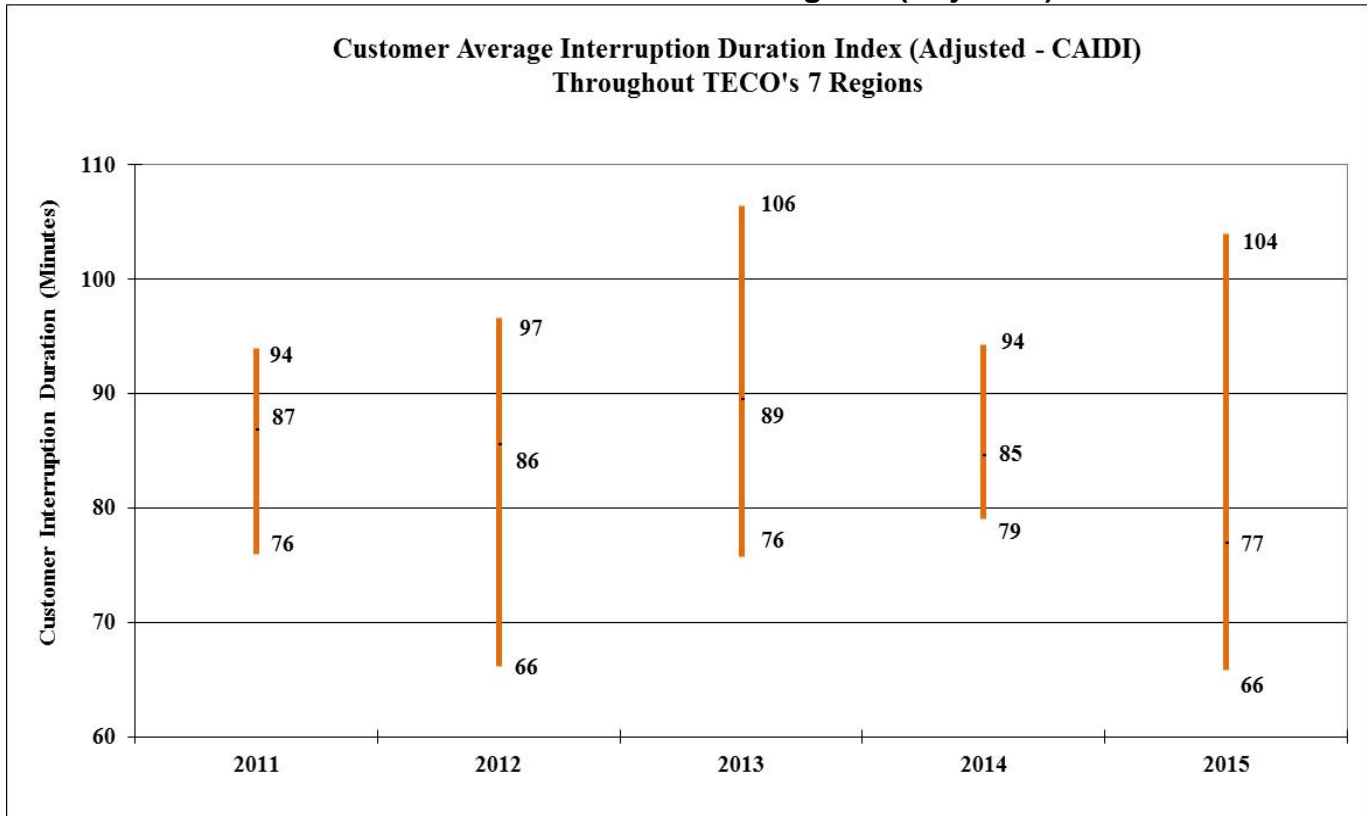
**Figure 3-32.  
CAIDI across TECO's Seven Regions (Adjusted)**

**Figure 3-32** charts the length of time that a typical TECO customer experiences an outage, which is known as CAIDI. The highest CAIDI minutes appear to be confined to the Dade City, Eastern, and Western regions. Winter Haven, Eastern, and Central regions have had the lowest (best) results for the last five years. The average CAIDI is trending upward at this time suggesting TECO's customers are experiencing longer lasting outages, even though there was a 9 percent decrease in the average CAIDI when comparing 2014 to 2015.

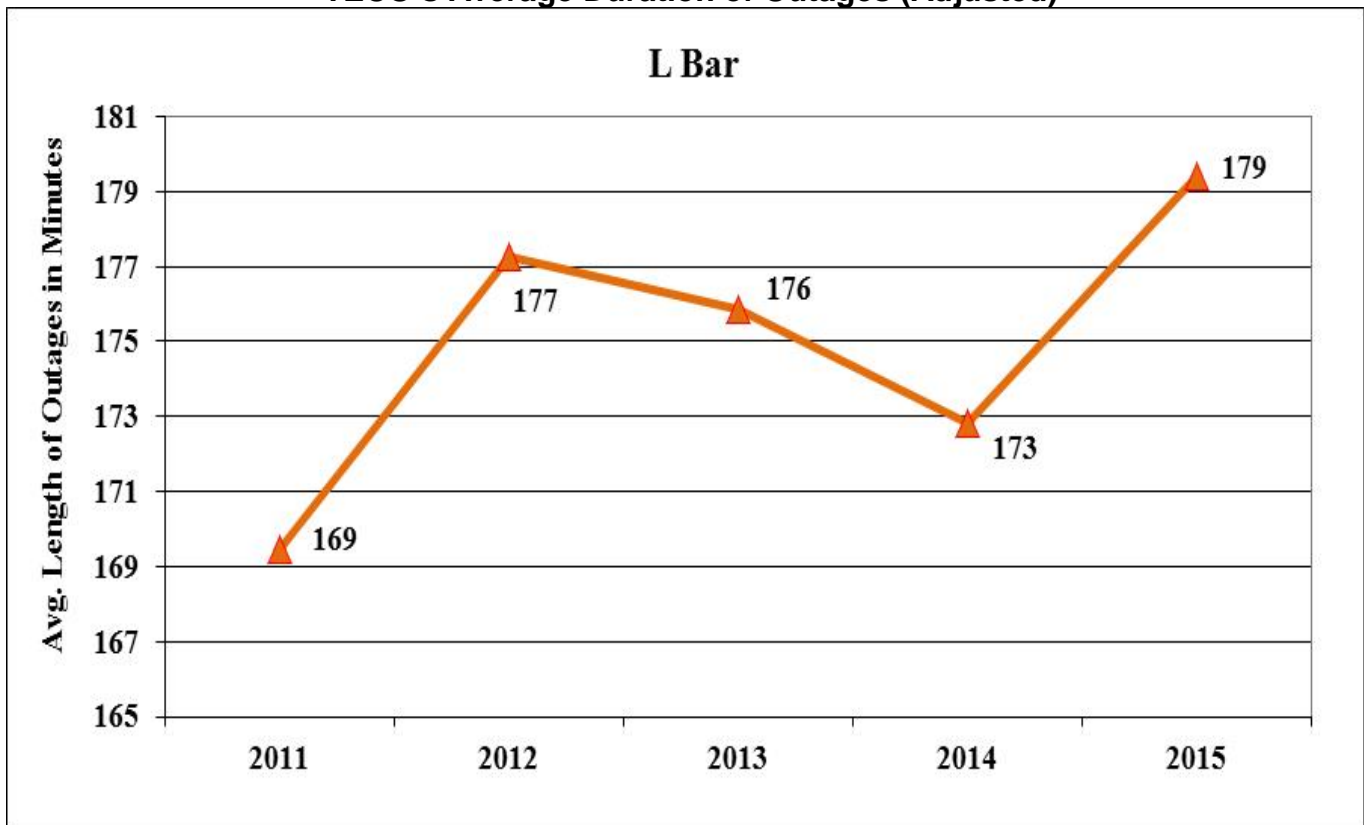
**Figure 3-33.**  
**TECO's Average Duration of Outages (Adjusted)**

**Figure 3-33** denotes a 3 percent increase in outage durations for the period from 2014 to 2015 for TECO. The average length of time TECO spends restoring service to its customers affected by outage events, excluding hurricanes and other allowable excluded outage events is shown in the L-Bar index. The L-Bar index continues to be trending upward for the five-year period of 2011 to 2015, suggesting longer restoral times.
