***Review of  
Florida's  
Investor-Owned  
Electric Utilities***

***2 0 1 5  
Service Reliability Reports***

**State of Florida  
Florida Public Service Commission  
Division of Engineering**

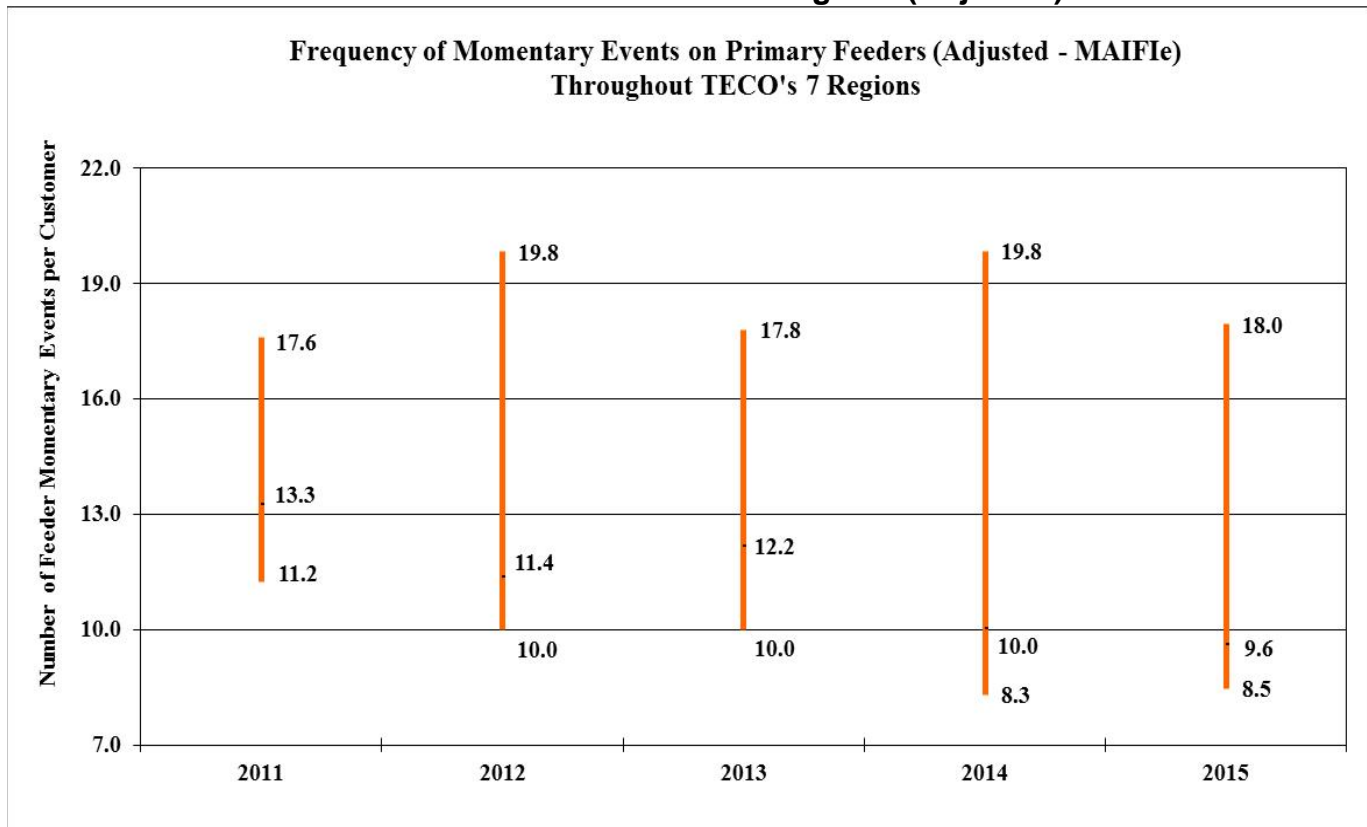
**Figure 3-34.**  
**MAIFle across TECO's Seven Regions (Adjusted)**

**Figure 3-34** illustrates TECO's number of momentary events on primary circuits per customer recorded across its system. In 2015, the MAIFle performance improved over the 2014 results in all regions except Central and South Hillsborough. The average MAIFle decreased 4 percent from 2014 to 2015. **Figure 3-34** shows that the average MAIFle is trending downward, which suggest an improvement in performance over the five-year period of 2011 to 2015.

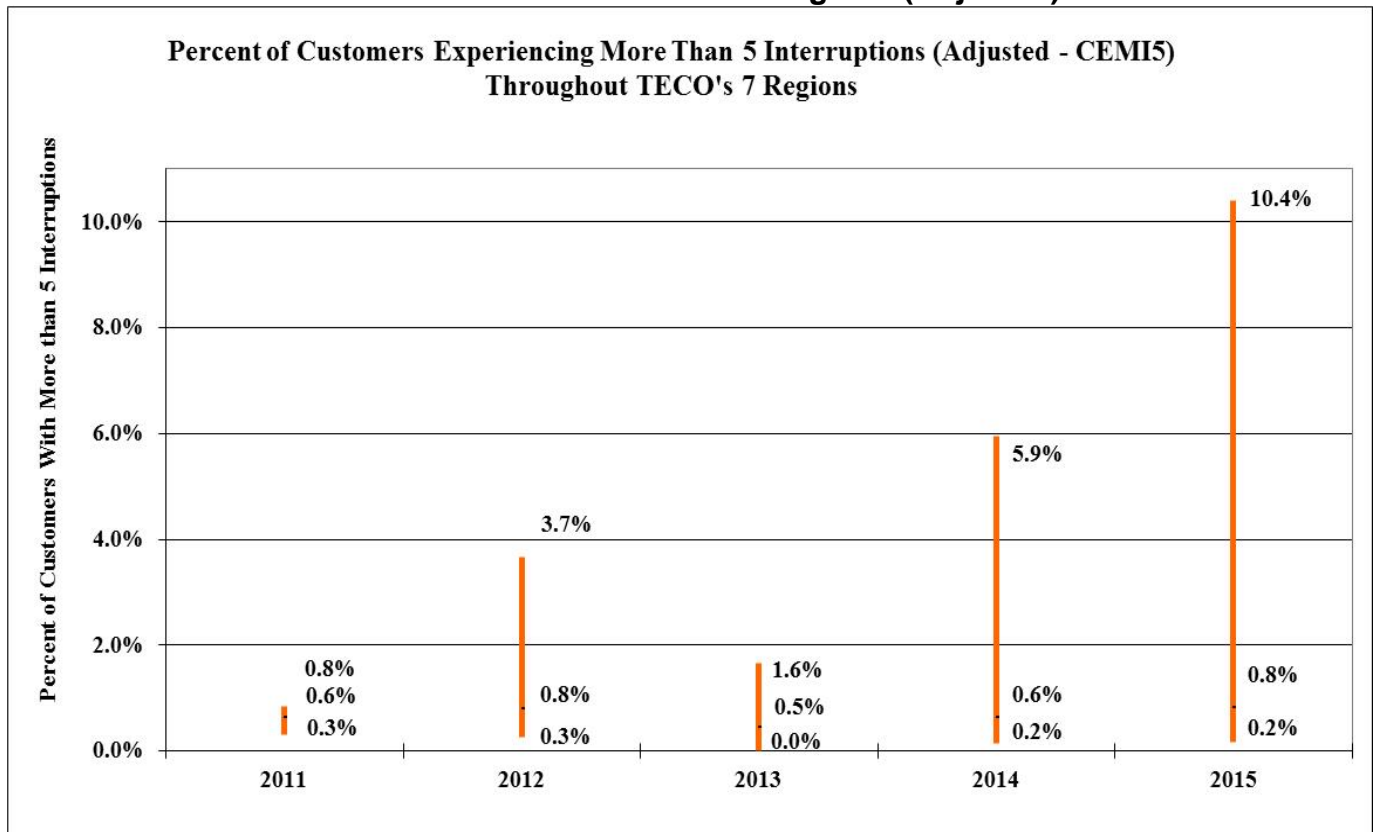
**Figure 3-35.  
CEMI5 across TECO's Seven Regions (Adjusted)**

**Figure 3-35** shows the percent of TECO's customers experiencing more than five interruptions. Three regions in TECO's territory experienced a decrease in the CEMI5 results for 2015. The Dade City, Plant City, South Hillsborough, and Western regions experienced an increase in the CEMI5 index. Dade City reported the highest CEMI5 percentage for 2015. With TECO's results for this index varying for the past five years, the average CEMI5 index appears to be trending slightly upward indicating a decline in performance. There was a 25 percent increase in the average CEMI5 index from 2014 to 2015.

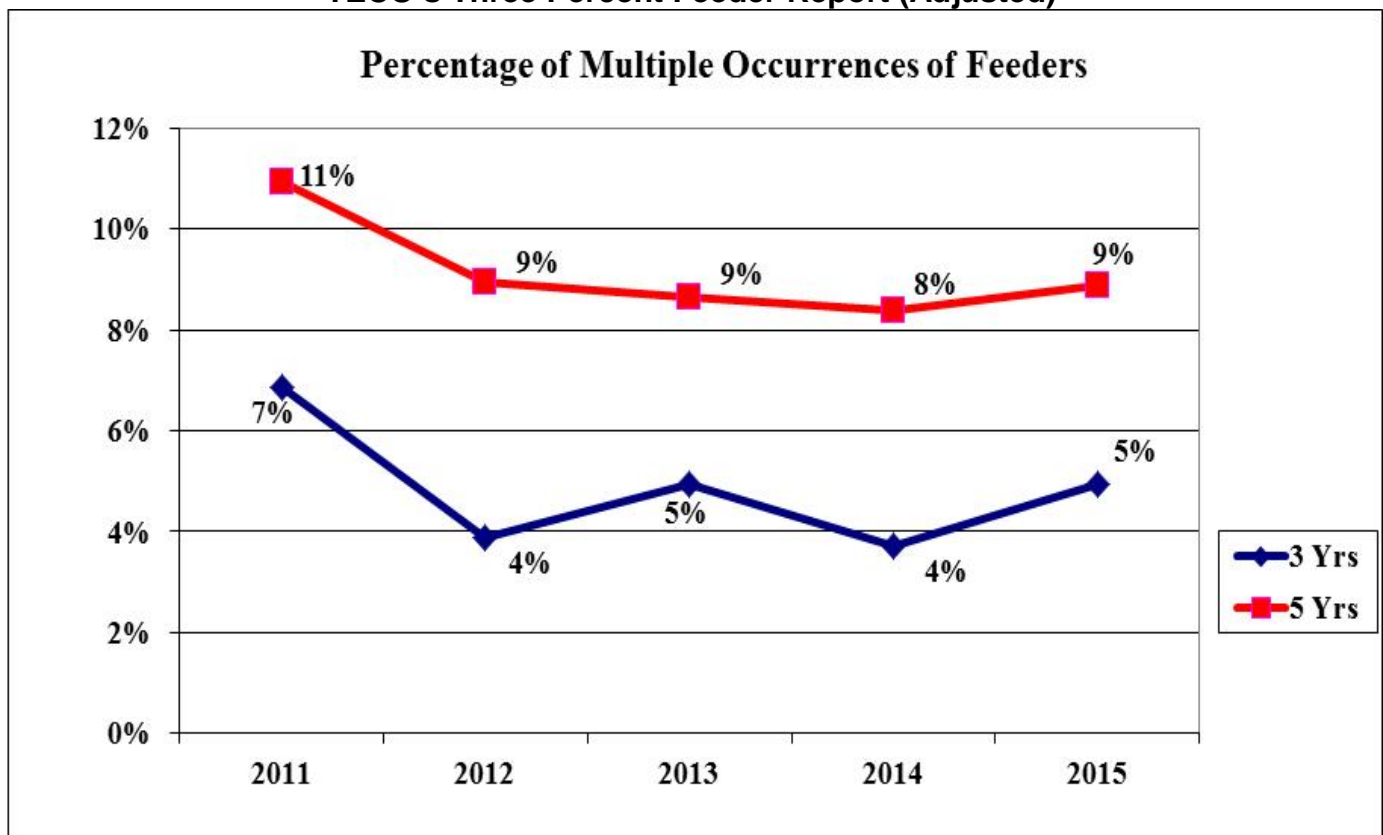
**Figure 3-36.**  
**TECO's Three Percent Feeder Report (Adjusted)**

**Figure 3-36** represents an analysis of TECO's top three percent of problem feeders that have reoccurred (appeared on the Three Percent Feeder Report) on a five-year and three-year basis. The graph is developed using the number of recurrences divided by the number of feeders reported. The five-year average of outages per feeder increased by 11 percent from 2014 to 2015 and the three-year average of outages also increased from 4 percent in 2014 to 5 percent in 2015. Both the five-year average of outages per feeder and the three-year average of outages appear to be trending downward for the five-year period of 2011 to 2015.

Staff notes that two feeders were on the Three Percent Feeder Report for three years, the last two years consecutively. Four circuit outages were reported for each feeder. The causes for the outages were animals, electrical, down wire, and vegetation. In 2015, the corrective action undertaken by TECO included: hotspot tree trimming, full circuit tree trimming, installation of a recloser, pole replacement, and replacement of defective transformers and lightning arresters. TECO stated that it will continue to monitor circuit outage performance as part of its daily and ongoing review of system reliability and will respond accordingly at a regional level.

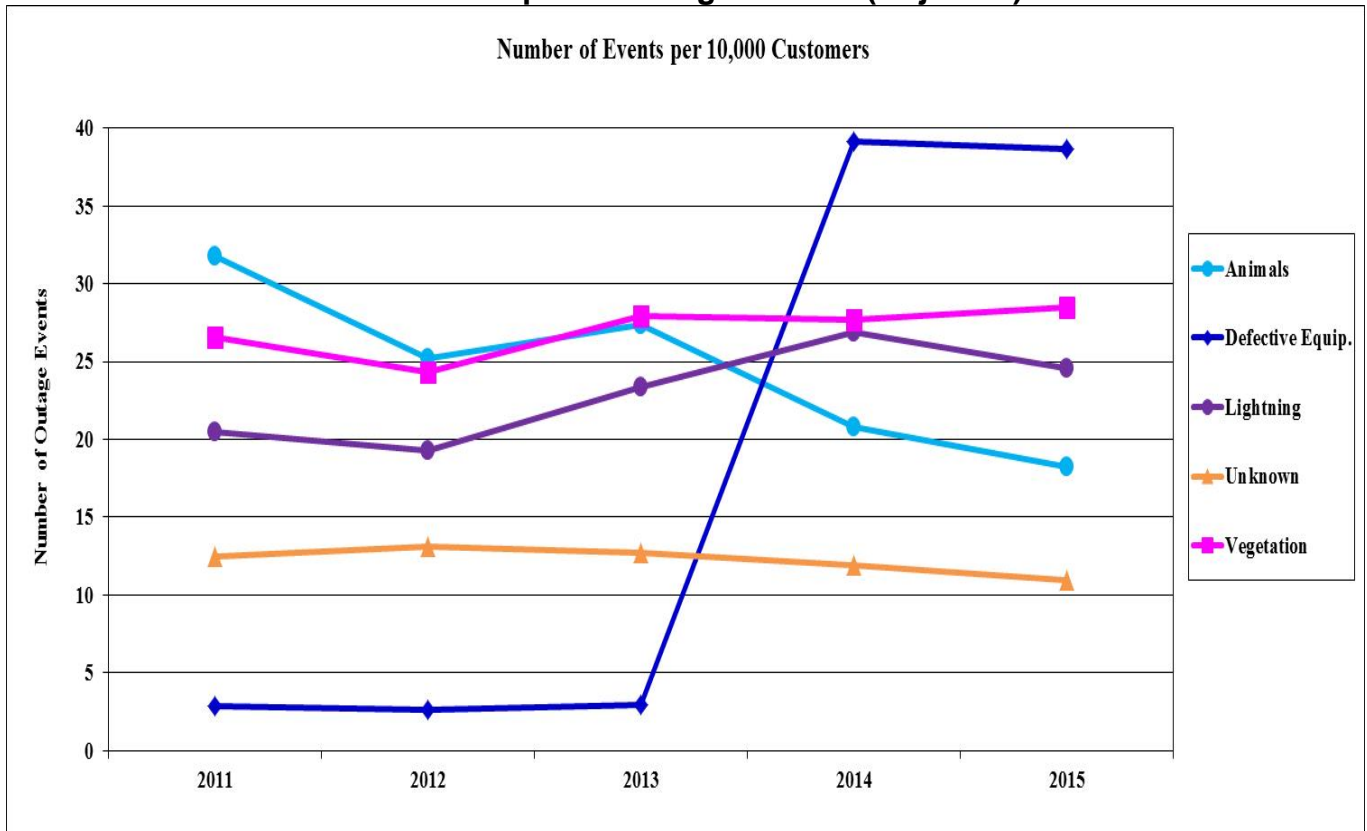
**Figure 3-37.**  
**TECO's Top Five Outage Causes (Adjusted)**

**Figure 3-37** shows the top five causes of outage events on TECO's distribution system normalized to a 10,000-customer base. The figure is based on TECO's adjusted data of the top 10 causes of outage events and represents 89 percent of the total outage events that occurred during 2015. For the five-year period, the five top causes of outage events included Defective Equipment (28 percent), Vegetation (21 percent), Lightning (18 percent), Animals (13 percent), and Unknown Causes (8 percent) on a cumulative basis. Defective equipment is the highest cause of outages for 2015. Beginning in 2014, the Defective Equipment category now includes outage categories that in the past were separately identified. Vegetation and Lightning causes are the next two top problem areas for TECO. The outages due to Vegetation increased 3 percent from 2014 to 2015. The outages from Lightning decreased 9 percent for the same time period. The numbers of outages due to Defective Equipment, Lightning and Vegetation causes are trending upward while the number of outages due to Unknown is remaining relatively flat. The number of outages due to Animals is trending downward.

TECO continues to review processes and updates equipment to mitigate outages caused by Defective Equipment. TECO has reviewed the common outage occurrences, which led to changes in: (1) materials; (2) workmanship issues; and (3) construction practices. This will help reduce, minimize or even eliminate these types of outages. TECO installed reclosers, sectionalizers, and animal guards. Lightning arresters that failed were replaced. TECO inspects the primary meter cabinets annually. In 2016, TECO plans to install smart switches in its service area to sectionalize the circuits when a fault occurs to restore power to the unaffected portions of the circuits.

Defective Equipment (28 percent) and Vegetation (21 percent) were the largest contributors to TECO's causes of outage events followed by Lightning (18 percent), Animals (13 percent), and Unknown (8 percent). **Figure 3-37** illustrates the top five outage causes showing Defective Equipment and Lightning related causes are trending upward, even though there were decreases of 0.9 percent and 9 percent, respectively, from the previous year. Vegetation related outage events are trending upward and there was an increase of 3 percent from 2014 to 2015. Unknown related causes are remaining relatively flat even though there was a decrease of 8 percent in 2015. Animal related causes are trending downward and decreased by 12 percent from the previous year. Beginning in 2014, the Defective Equipment category now includes outage categories that in the past were separately identified.

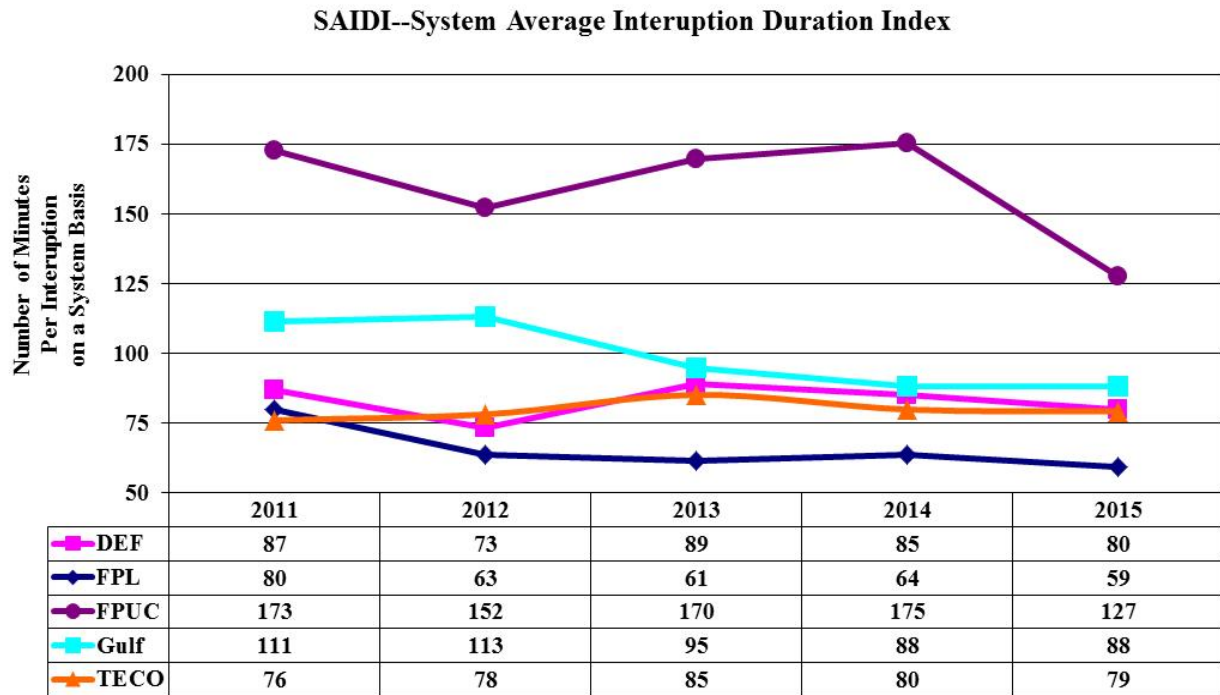
**Figure 4-1.  
System Average Interruption Duration (Adjusted SAIDI)**

**Figure 4-1** indicates that TECO's SAIDI trend has gradually risen since 2011, while DEF, FPL, FPUC, and Gulf appear to be trending downward. Comparing 2014 SAIDI values to 2015 SAIDI indices, all utilities, except Gulf, have decreased. Gulf's SAIDI value did not change from 2014 to 2015. DEF's SAIDI value has fallen 6 percent, FPL fell 8 percent, FPUC fell 27 percent, and TECO fell 1 percent from 2014 to 2015.

SAIDI is the duration of an interruption per retail customer served within a specified area of service over a given period. It is determined by dividing the total Customer Minutes of Interruption by total Number of Customers Served for the respective area of service.

The inter-utility trend comparison focuses on a graphical presentation that combines all of the IOUs' distribution reliability indices for the years 2011 to 2015. **Figures 4-1** through **4-3** apply to all five utilities while **Figures 4-4** and **4-5** do not apply to FPUC because it is not required to report MAIFle and CEMI5 due to the size of its customer base. The adjusted data is used in generating the indices in this report and is based on the exclusion of certain events allowed by Rule 25-6.0455(4), F.A.C. Generalizations can be drawn from the side-by-side comparisons; however, any generalizations should be used with caution due to the differing sizes of the distribution systems, the degree of automation, and the number of customers. The indices are unique to each IOU.

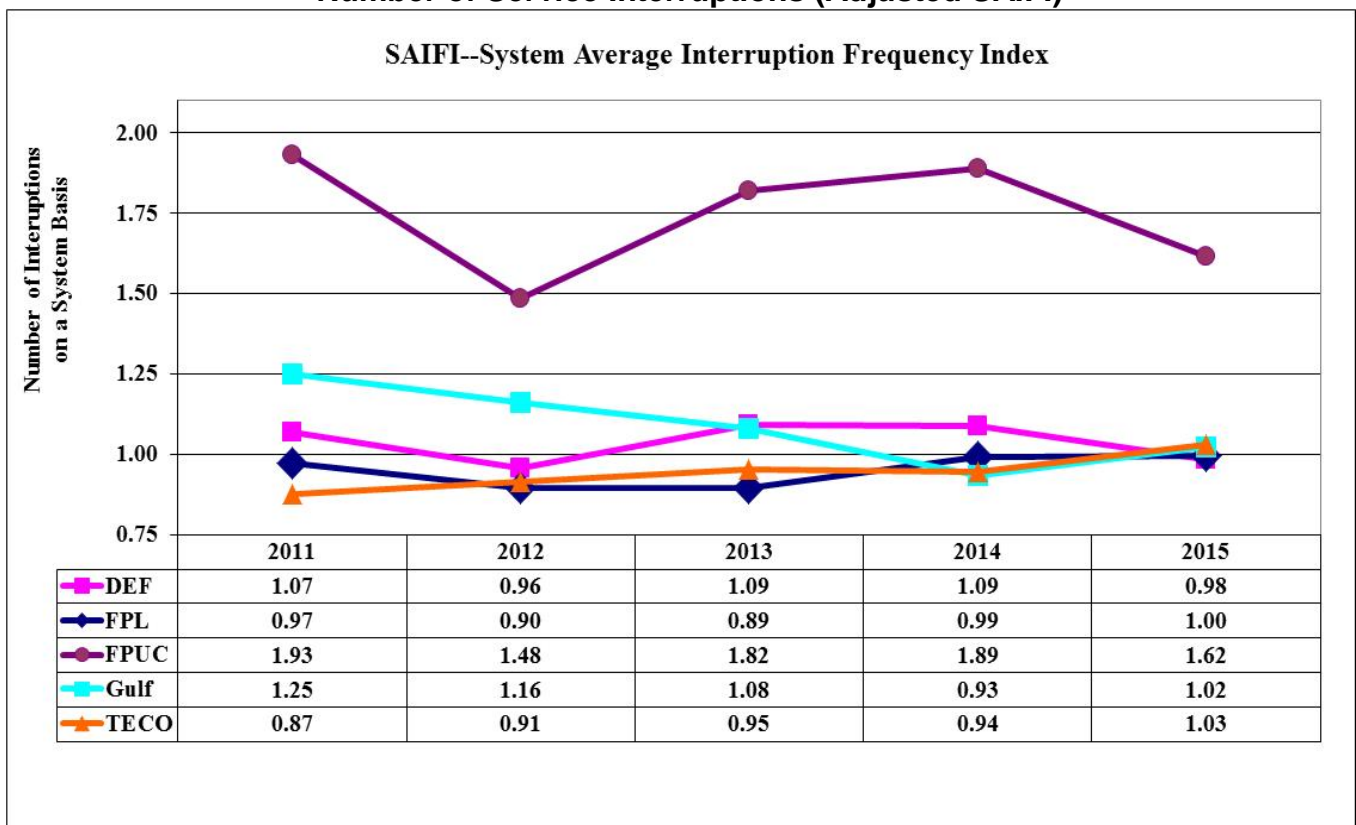
**Figure 4-2.**  
**Number of Service Interruptions (Adjusted SAIFI)**

**Figure 4-2** is a five-year graph of the adjusted SAIFI for each IOU. The 2015 data shows DEF and FPUC's SAIFI values decreased (improved) from the 2014 results as FPL, Gulf and TECO's SAIFI values increased. Over the five-year period of 2011 to 2015, FPL and TECO's SAIFI values are all trending upward. DEF, FPUC, and Gulf's SAIFI value is trending downward for the period of 2011 to 2015.

SAIFI is the average number of service interruptions per retail customer within a specified area of service over a given period. It is determined by dividing the Sum of Service (aka Customer) Interruptions (CI) by the total Number of Customers Served for the respective area of service.

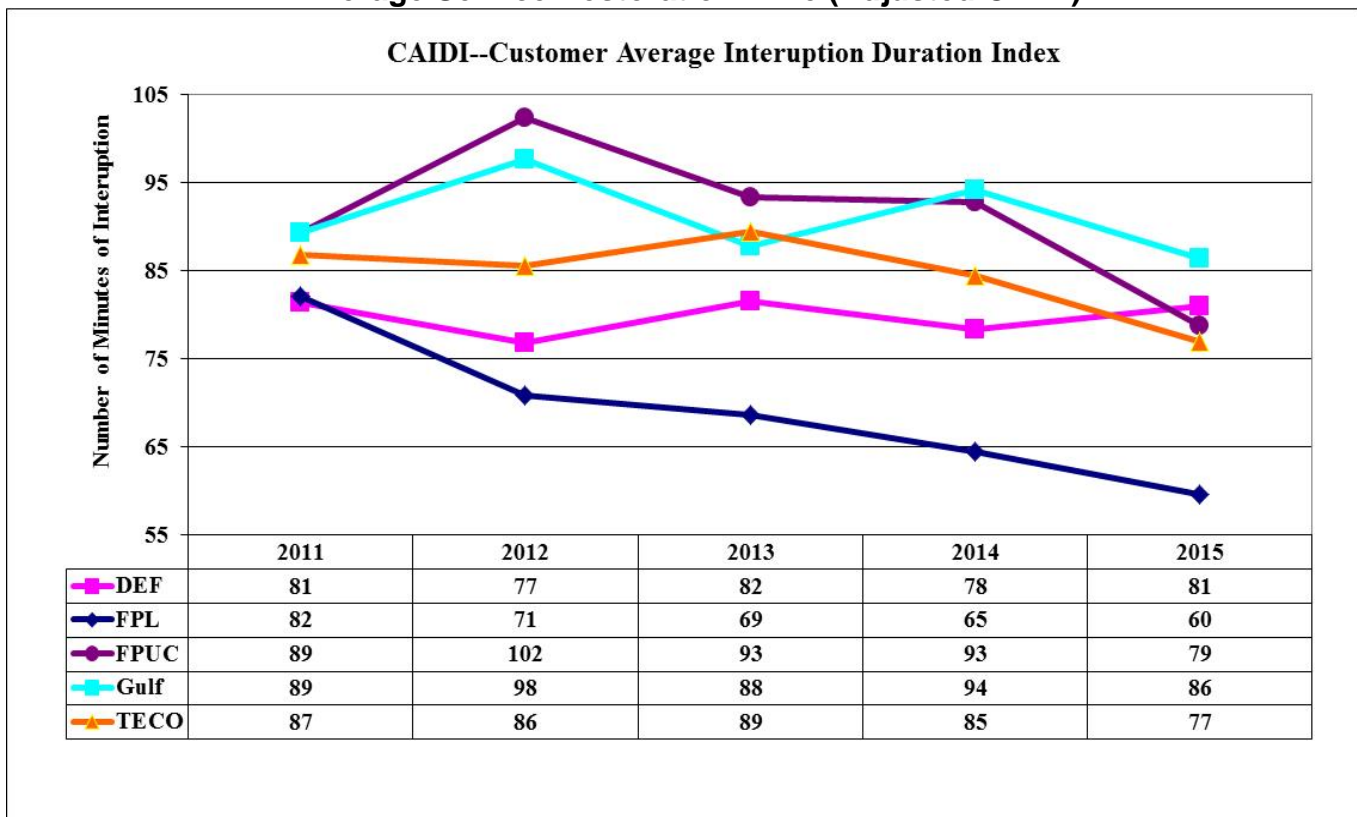
**Figure 4-3.**  
**Average Service Restoration Time (Adjusted CAIDI)**

**Figure 4-3** is a five-year graph of the adjusted CAIDI for each IOU. FPL, FPUC, Gulf, and TECO had a decrease in the CAIDI from 2014 to 2015 while DEF had an increase in the CAIDI. All utilities, except DEF, CAIDI values are trending downward for the five-year period of 2011 to 2015. DEF's CAIDI value is staying relatively flat for the same period.

CAIDI is the average interruption duration or the time to restore service to interrupted customers. CAIDI is calculated by dividing the total system CMI by the number of customer interruptions, which is also SAIDI, divided by SAIFI.

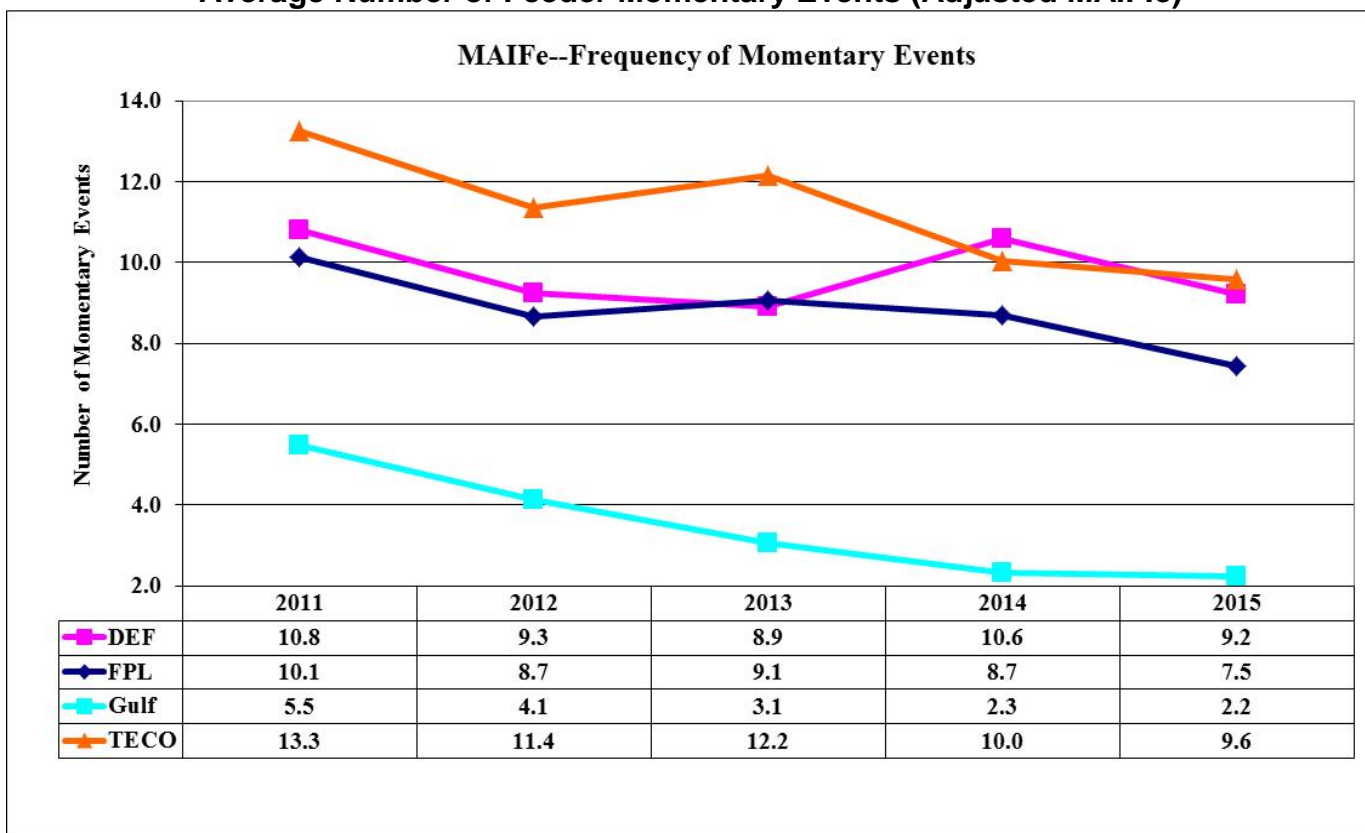
**Figure 4-4.**  
**Average Number of Feeder Momentary Events (Adjusted MAIFle)**

**Figure 4-4** shows a five-year graph of the adjusted MAIFle for DEF, FPL, Gulf, and TECO. DEF, FPL, Gulf and TECO's MAIFle indices are all trending downward for the five-year period of 2011 to 2015. Comparing the MAIFle for 2014 to 2015, DEF decreased by 13 percent, FPL decreased by 14 percent, Gulf decreased by 4 percent and TECO decreased by 4 percent. FPUC is exempt from reporting MAIFle and CEMI5 because it has fewer than 50,000 customers.

MAIFle is the average frequency of momentary interruptions or the number of times there is a loss of service of less than one minute. MAIFle is calculated by dividing the number of momentary interruptions events recorded on primary circuits (CME) by the number of customers served.

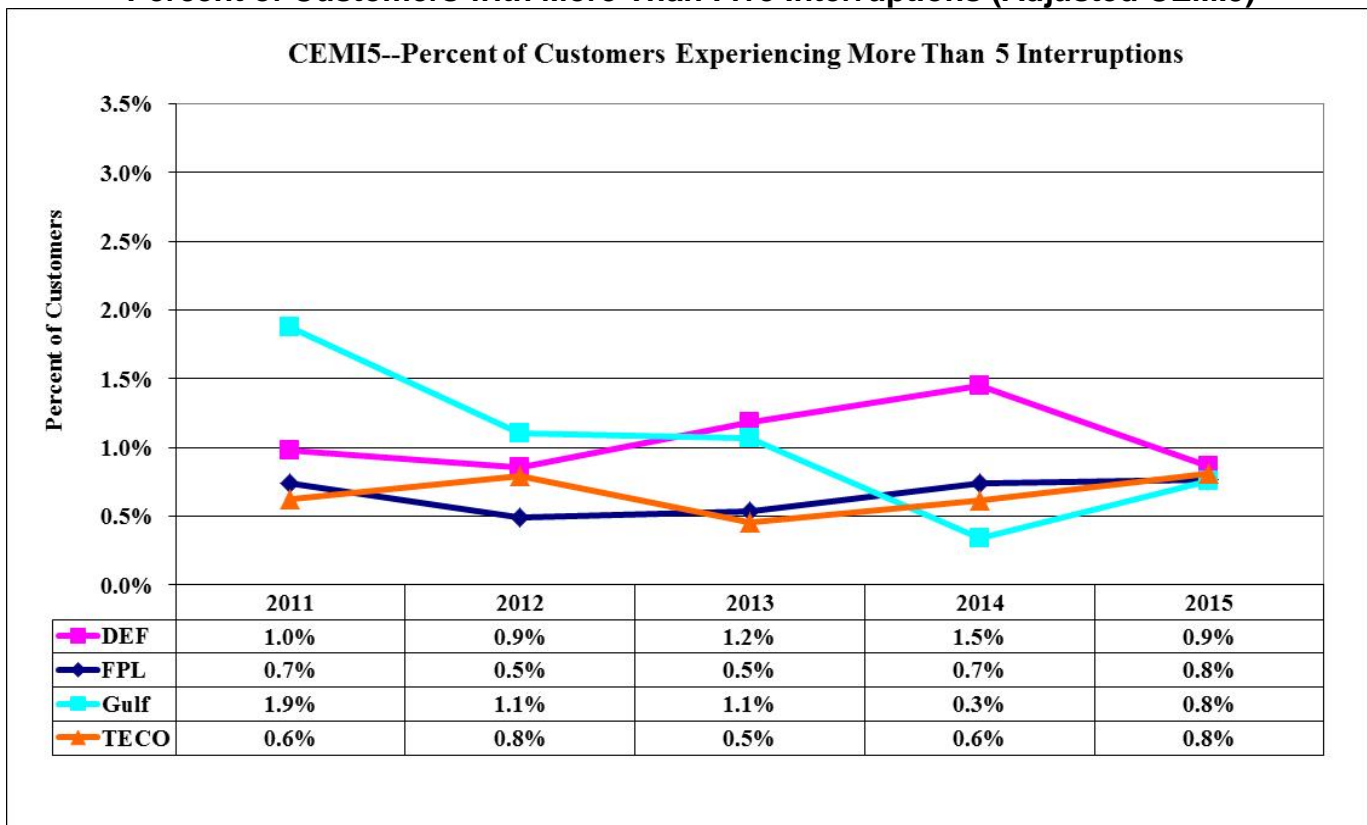
**Figure 4-5.**  
**Percent of Customers with More Than Five Interruptions (Adjusted CEMI5)**

**Figure 4-5** is a five-year graph of the adjusted CEMI5 for FPL, Gulf, DEF, and TECO. CEMI5 is a percentage. It represents the number of customers that experienced more than five service interruptions in the year divided by the total number of customers. In 2015, FPL, Gulf, and TECO's CEMI5 percent all increased to 0.8 percent from 0.7 percent, 0.3 percent, and 0.6 percent, in 2014. FPL and TECO are trending slightly upward as Gulf is trending downward for the period of 2011 to 2015. DEF's CEMI5 had a 13 percent decrease in the percent of customers experiencing more than five interruptions in 2015 compared to its 2014 results. DEF's CEMI5 index is trending slightly upward for the five-year period.

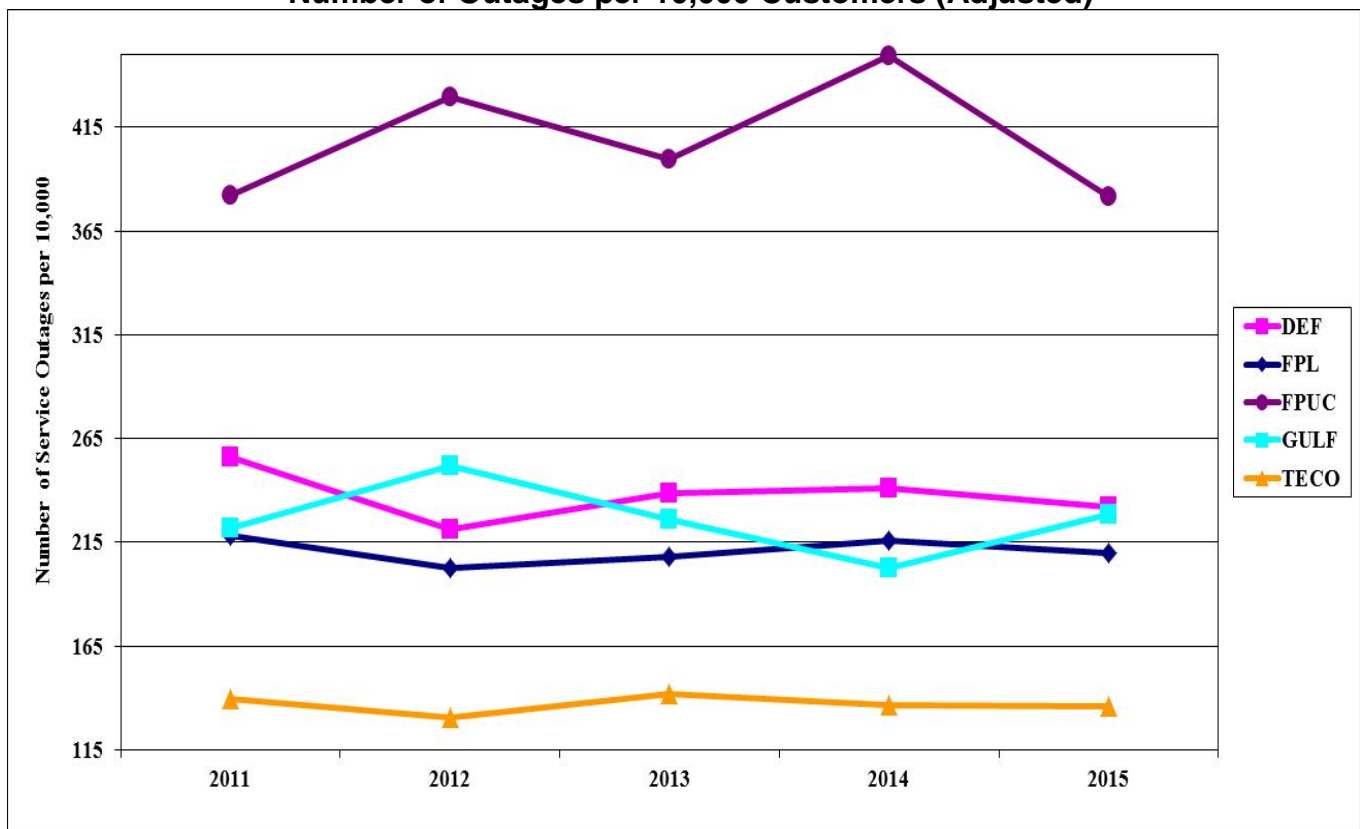
**Figure 4-6.**  
**Number of Outages per 10,000 Customers (Adjusted)**

**Figure 4-6** shows the number of outages per 10,000 customers on an adjusted basis for the five IOUs over the last five years. The graph displays each utility's adjusted data concerning the number of outage events and the total number of customers on an annual basis. The number of FPL outages decreased from 101,981 in 2014 to 100,563 in 2015, and the number of outages per 10,000 customers is trending downward for the five-year period. TECO's results are trending upward for the five-year period. DEF's number of outages decreased for 2015 and the results are trending downward for the five-year period. Gulf's number of outages increased for 2015, and is trending upward for the five-year period. FPUC's results increased for 2011 to 2012, decreased for 2012 and 2013, increased for 2013 to 2014 and decreased for 2014 to 2015. Due to the small customer base, the line graph for FPUC could be subject to greater volatility.

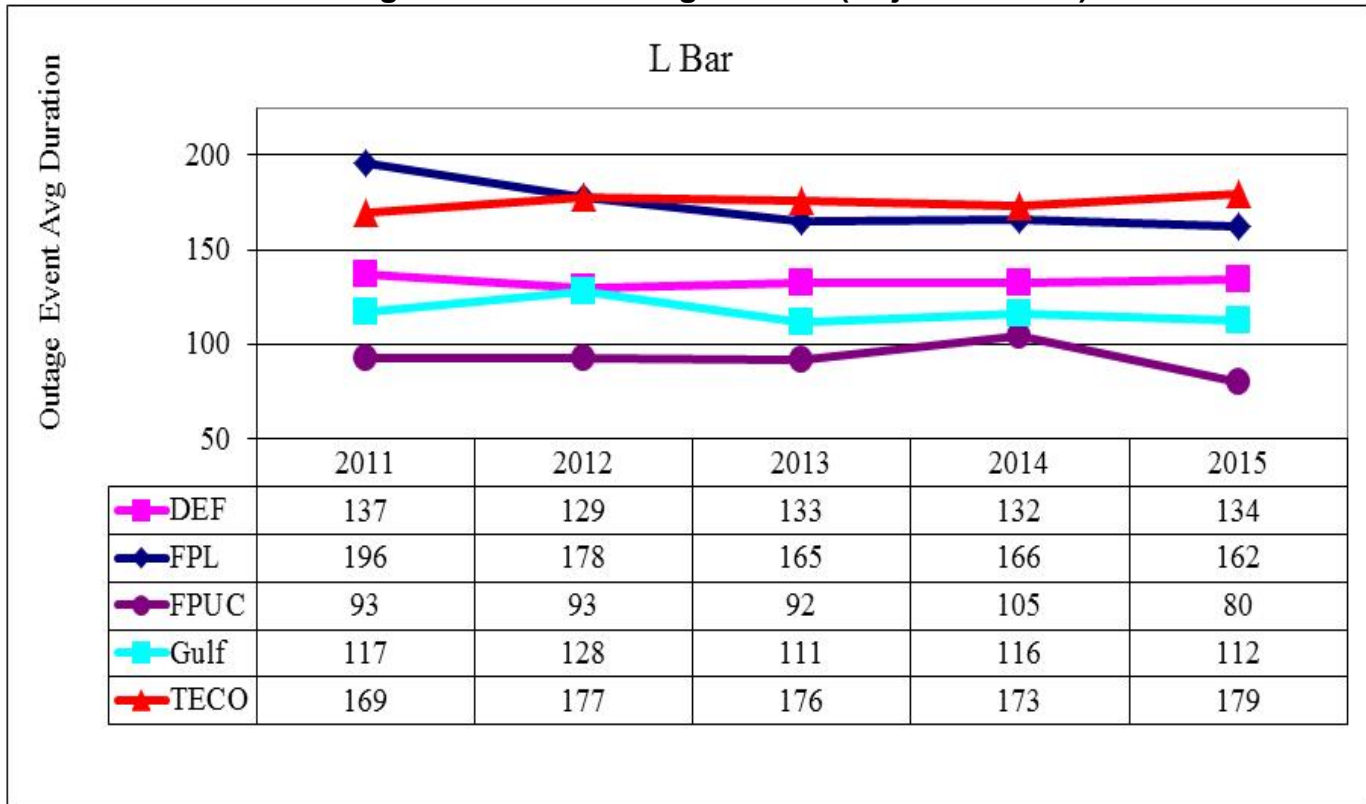
**Figure 4-7.**  
**Average Duration of Outage Events (Adjusted L-Bar)**

**Figure 4-7** represents the average duration of outage events (Adjusted L-Bar) for each IOU. From the data shown, it appears that the utilities are more consistent with their restoral times for the five-year period of 2011 to 2015.

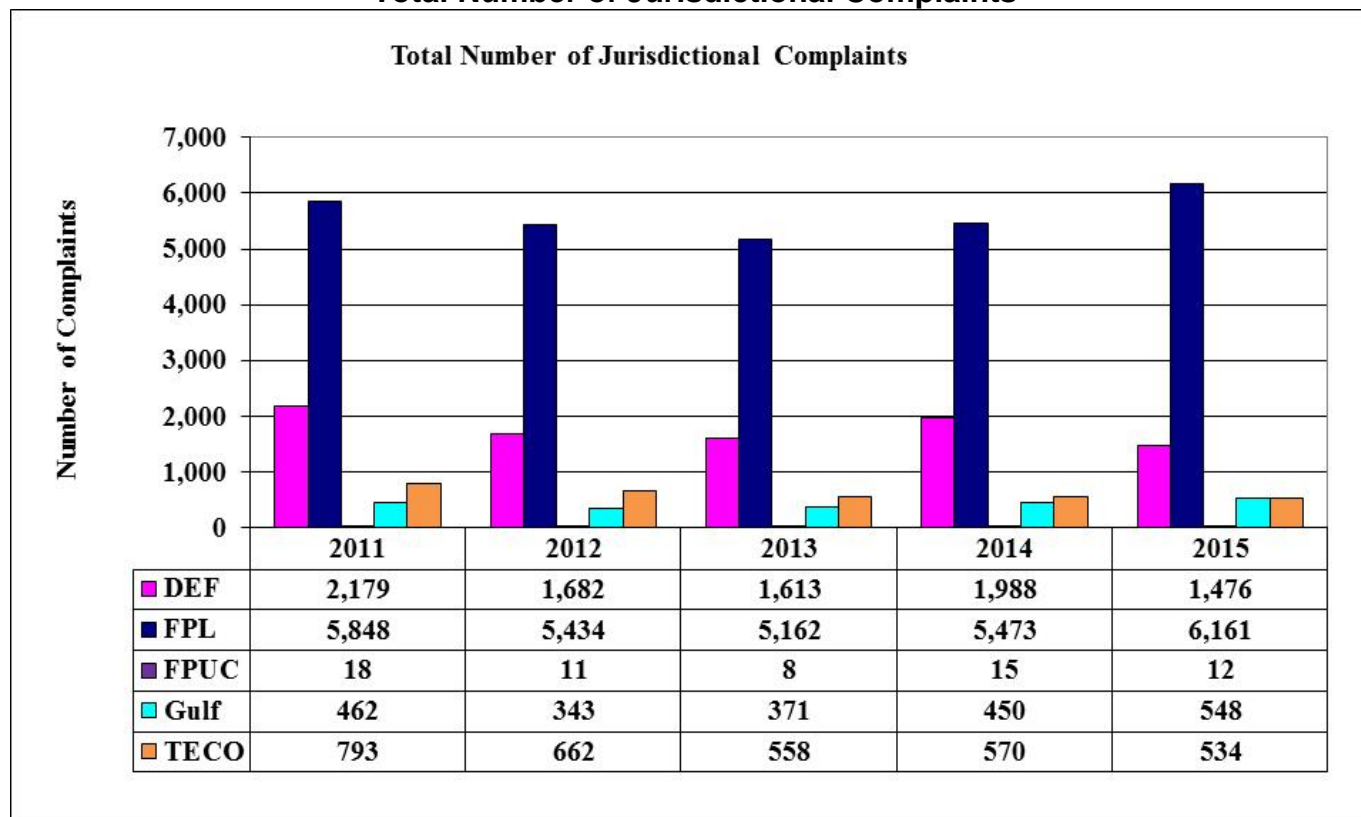
**Figure 4-8.  
Total Number of Jurisdictional Complaints**

**Figure 4-8** shows the total number of jurisdictional complaints<sup>17</sup> for each IOU. In comparing the number of complaints by the different companies, the total number of customers should be considered. FPL has the higher number of complaints, but FPL also has more customers than the other companies.

Figures 4-8, 4-9, 4-10, and 4-11 represent consumer complaint data that was extracted from the Commission's Consumer Activity Tracking System (CATS). Each consumer complaint received by the Commission is assigned a code after the complaint is resolved. Reliability related complaints have 10 specific category types and typically pertain to Trees, Safety, Repairs, Frequent Outages, and Momentary Service Interruptions.

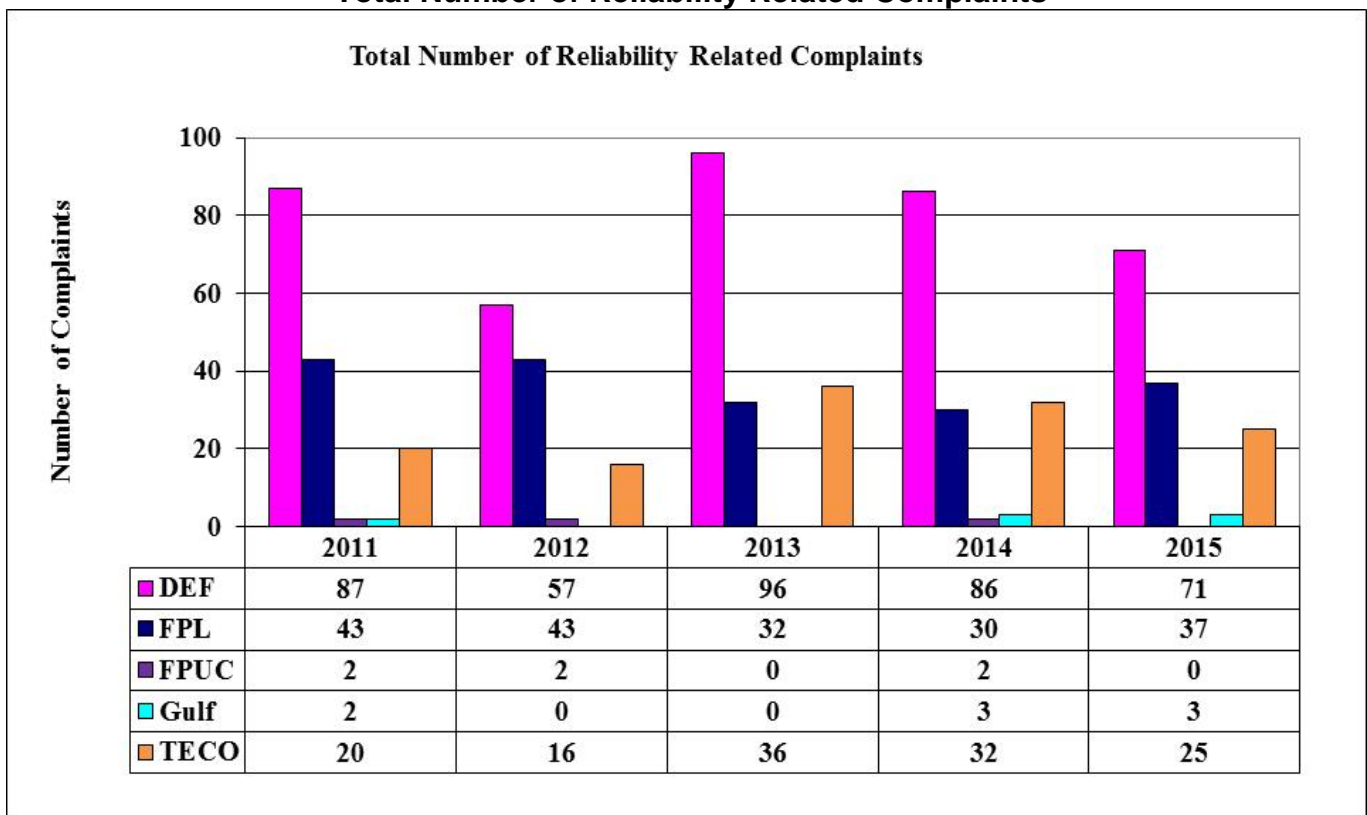
**Figure 4-9.**  
**Total Number of Reliability Related Complaints**

**Figure 4-9** charts the total number of reliability related complaints for the IOUs. DEF is showing the largest amount of reliability complaints for the five-year period of 2011 to 2015 with FPUC and Gulf showing the least amount. DEF, FPL, and FPUC are trending downward in the number of reliability complaints, while Gulf and TECO are trending upward.

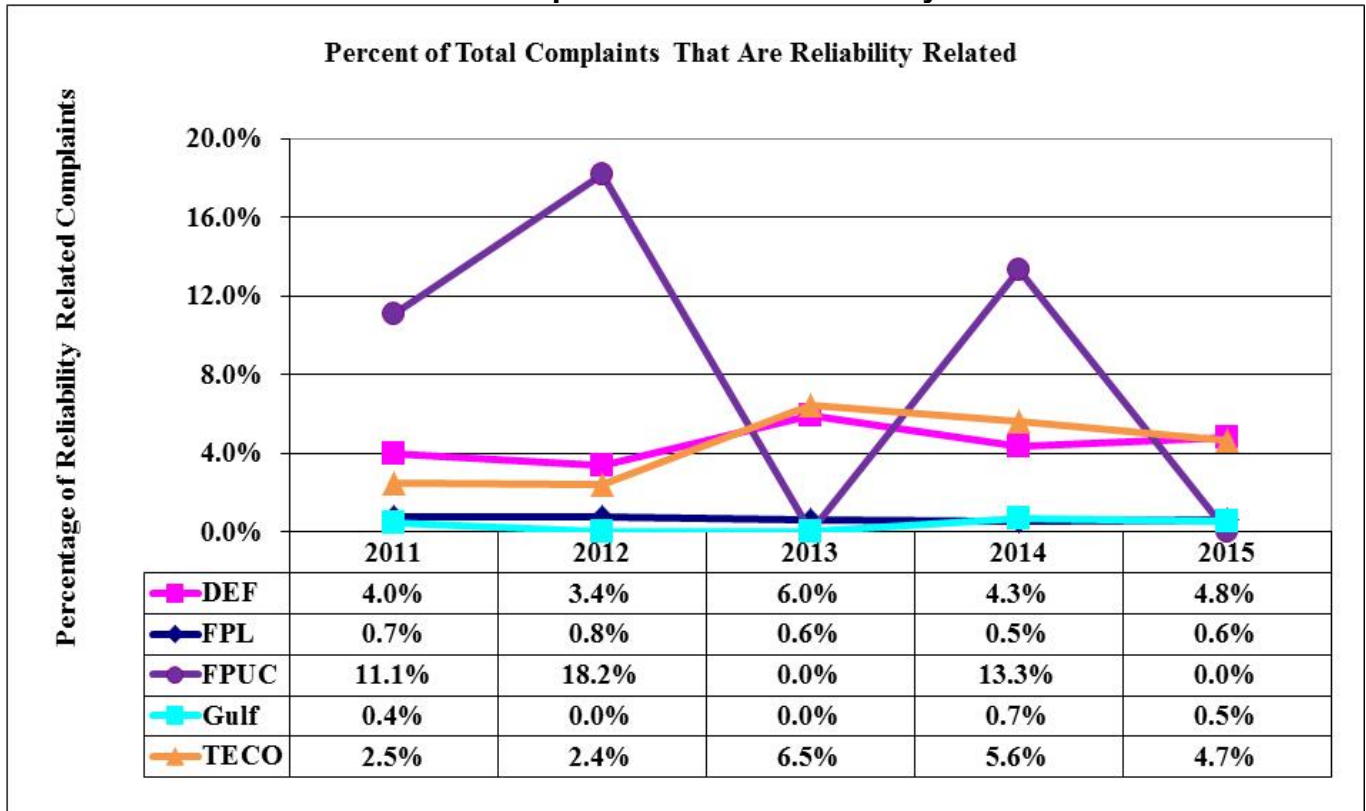
**Figure 4-10.  
Percent of Complaints that are Reliability Related**

**Figure 4-10** shows the percentage of reliability related customer complaints in relation to the total number of complaints for each IOU. FPL and FPUC's are trending downward as DEF, Gulf, and TECO are trending upward. The percentages of FPUC complaints compared to the other companies appears high, however FPUC has fewer customers and fewer complaints in total.

FPL's reliability related complaints percentage received by the Commission in 2015 was 0.6 percent, which is higher than the 0.5 percent received in 2014. FPL's reliability related complaints are trending downward as shown in **Figure 4-10**, even with the increase in 2015.

The percentage of complaints reported to the Commission against Gulf that were reliability related was 0.5 percent in 2015. This is lower than the 0.7 percent recorded last year. Gulf's percent of total complaints for the five-year period of 2011 to 2015 is trending upward despite the decrease in 2015. Overall, Gulf has the lowest percentage of total complaints that are reliability related as shown in **Figure 4-10**.

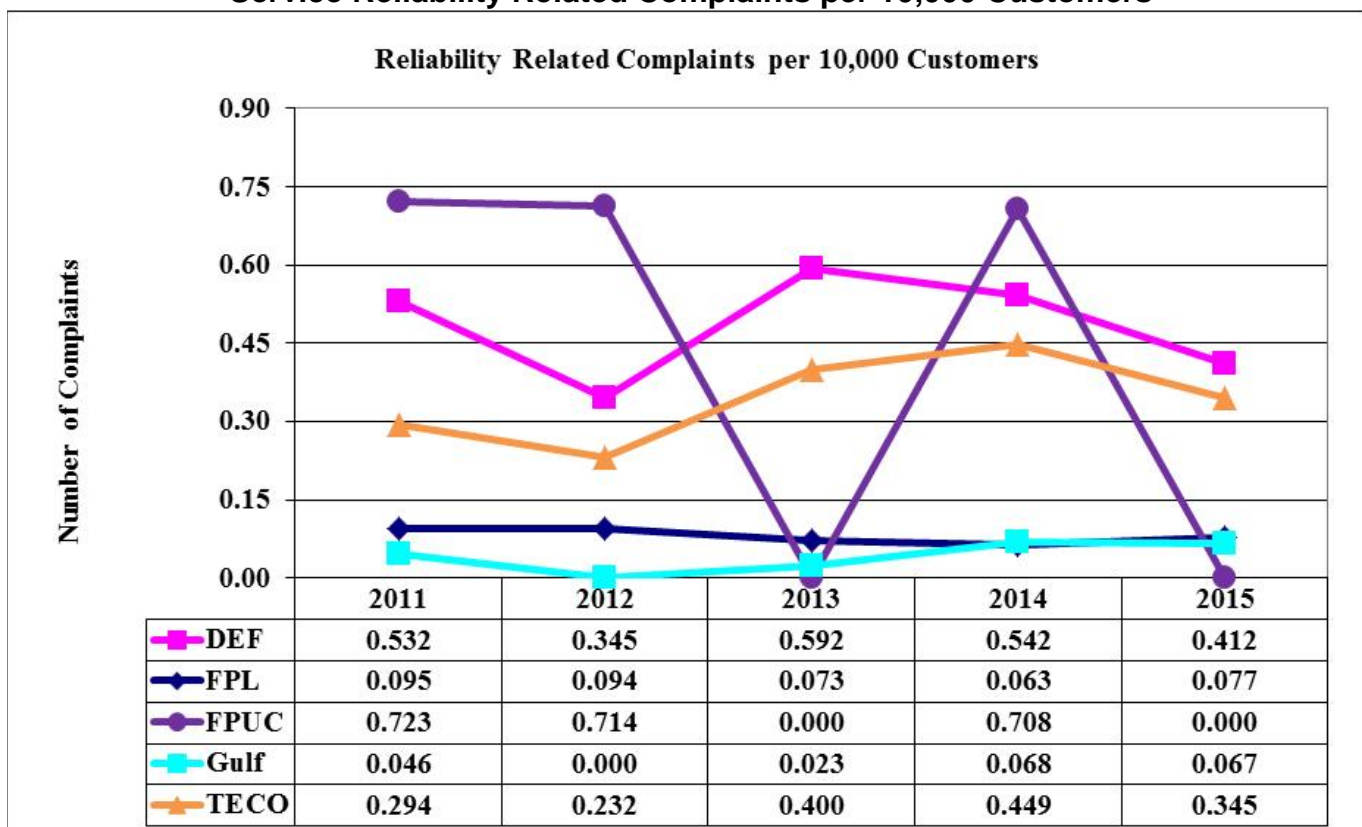
**Figure 4-11.**  
**Service Reliability Related Complaints per 10,000 Customers**

**Figure 4-11** charts the volume of reliability related complaints per 10,000 customers for the IOUs. The volume of service reliability complaints is normalized to a 10,000-customer base for comparative purposes. This is calculated for each IOU by dividing the total number of reliability complaints reported to the Commission by the total number of utility's customers. This fraction is then multiplied by 10,000 for graphing purposes.

All the IOUs have less than one reliability complaint per 10,000 customers since 2011. For the five-year period, FPL and FPUC continue to trend downward as DEF is staying relatively flat. Gulf and TECO are trending upward for the five-year period. The volatility of FPUC's results can be attributed to its small customer base, which typically averages 28,500 customers.
